THE JOANEDA HOUSE
57 Treasury Street, St. Augustine, Florida

HISTORIC STRUCTURE REPORT

Historic Preservation Program, DCP, University of Florida

2023

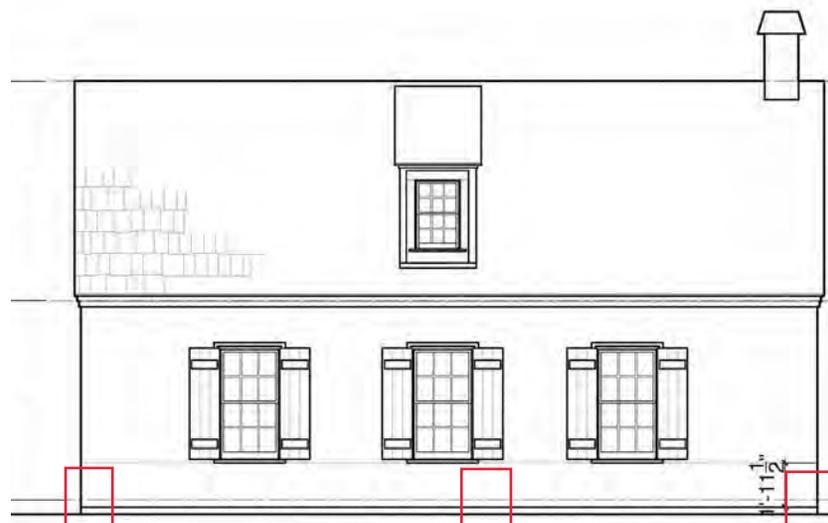
A: North façade, looking S and down

At the north-east corner of the building, where the wall meets the ground, there is damaged stucco (B). Similar damage is visible on the buildings northwest corner (C).

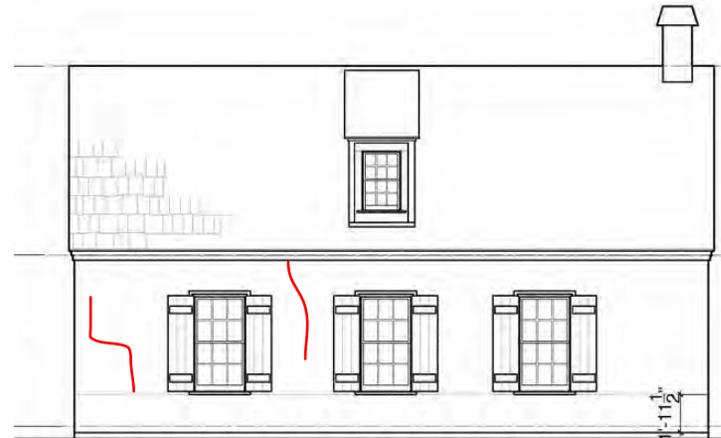
A: North façade, looking S

A vertical crack is located between the central and easternmost windows

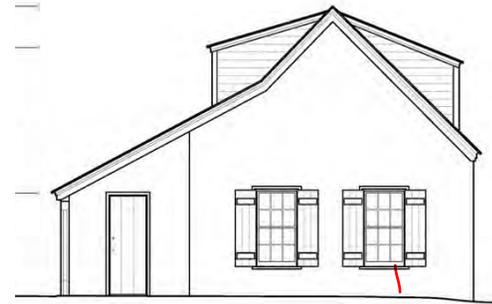
A: West facade, looking SE and up

A vertical crack is located on west façade’s northernmost section (A), and diagonal crack runs across the façade (B).

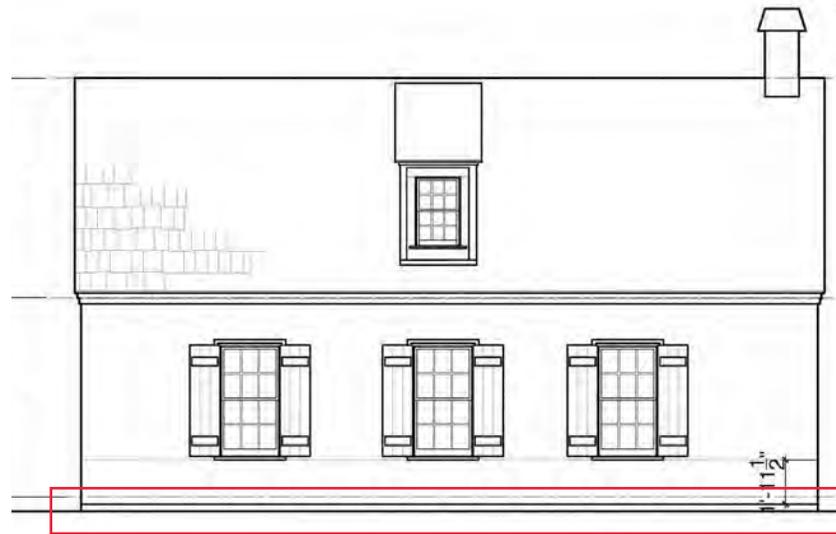
A: North façade, looking W and down

The yellow painted concrete curb along the building's north façade existed prior to the restoration. Currently, the westernmost part and the easternmost part of the curb are in poor condition (A; B).

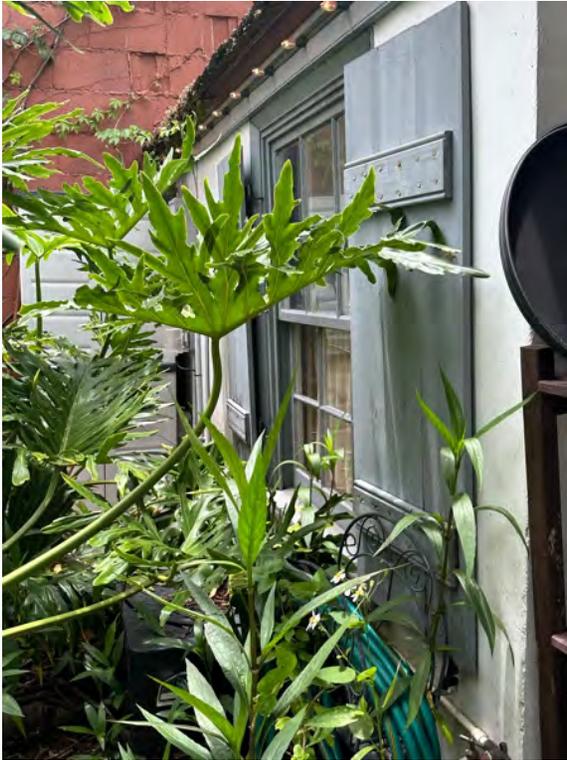
B: South façade, looking NW

- the plants along the western section of the South façade are contributing to the deterioration of historic coquina masonry and are damaging the window sills and frames

While the landscaped areas of the Joaneda House's courtyard are in good condition (A), the plants that are located close to the building's exterior walls are causing damage (B). The plants, that grow underneath the window on the South façade, is damaging the wall and windowsill (B, C).

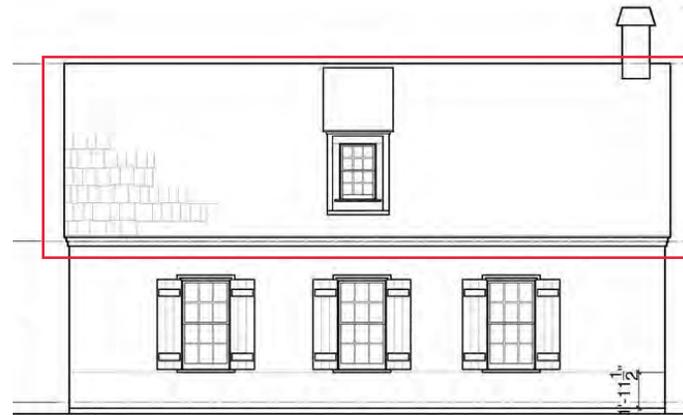
A: Roof, S slope, looking SW

- the location of flowerboxes above the windowsills contributes to the deterioration of sills
- the wood roof shakes are in fair condition; however the climate and vegetation are hastening the deterioration process of the material

The cedar shakes are in fair condition, especially on the north slope of the gable roof (A, B).

- Develop a set of building usage guidelines for tenants; including guidelines for types of materials that are stored in the building. Consider limiting flammable materials and weight for stored items on the Loft floor framing.
- Plan for repairs to wood elements of the building, including shutters and window frames.
- Remove existing flower boxes as the rebar holding the boxes to the masonry are causing deterioration.
- Keep plantings trimmed and away from the building facades and roofs.
- Monitor and inspect roof condition, make necessary repairs as needed.

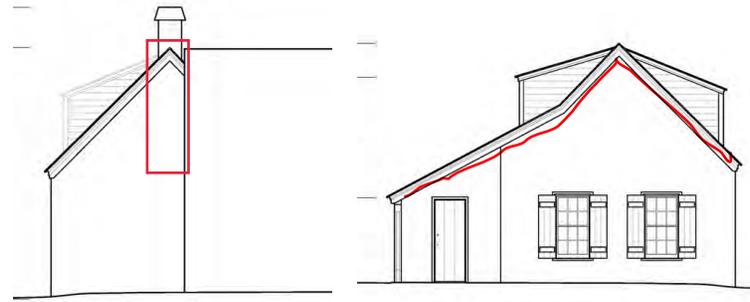
A: West façade, looking SE and up

There is approximately 1” gap located between the beaded fascia and wall on all four facades of the Joaneda House and the building’s walls (E). The fascia is fastened with nails that are rusting and causing damage to the wood (D).

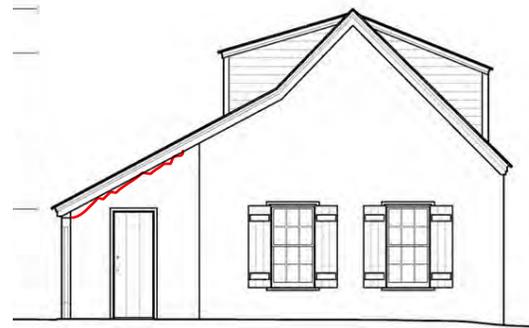
A: Porch, ceiling, looking E and up

The paint is starting to peel on several planks (C).

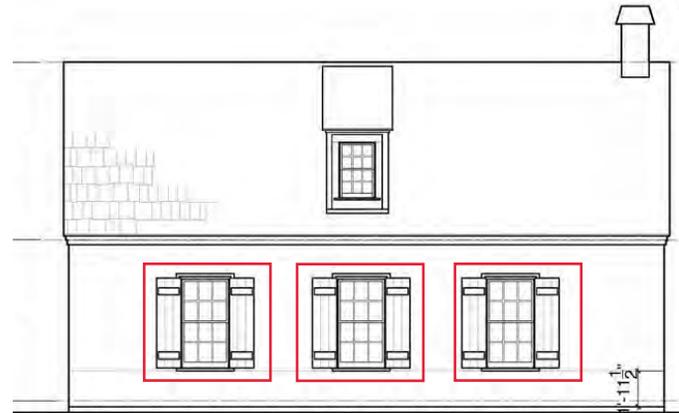
A: Window 1W1, looking N

- many of the wood elements, such as the shutters, window frames, and window sills, are in poor condition
- the metal rods that hold the flowerboxes in front of the windows, are embedded in the historic coquina masonry and are contributing to its deterioration

The nails and hinges, are rusting and expanding, contributing to the deterioration of shutters. The metal rods, that hold flowerboxes, are inserted between the window jambs, and are aggravating the condition (E).

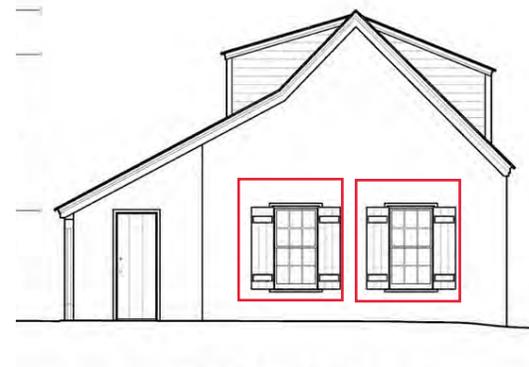
A: Window 1E1, looking N

The metal rods, that hold flower boxes, are inserted between the window jambs, and are aggravating the condition (D).

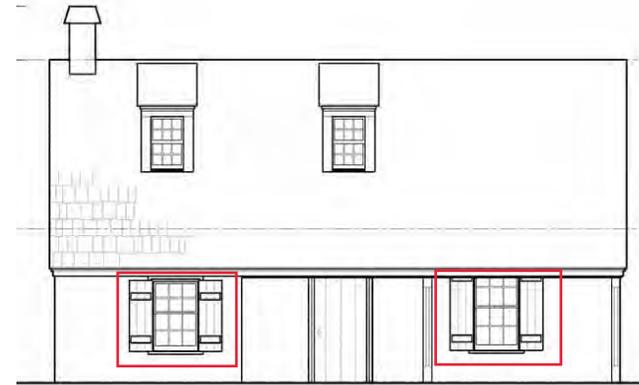
A: Window 1S1, looking NE

The shutters and window frames of window 1S2 are in poor condition. The wood shutters are rotting. The plants that grow beneath the window retain moisture against the wall and are aggravating the condition (B). The nails and hinges are rusting and expanding, and are contributing to the deterioration of shutters (C). There is a crack in one of the panes of window 1S2 (D).

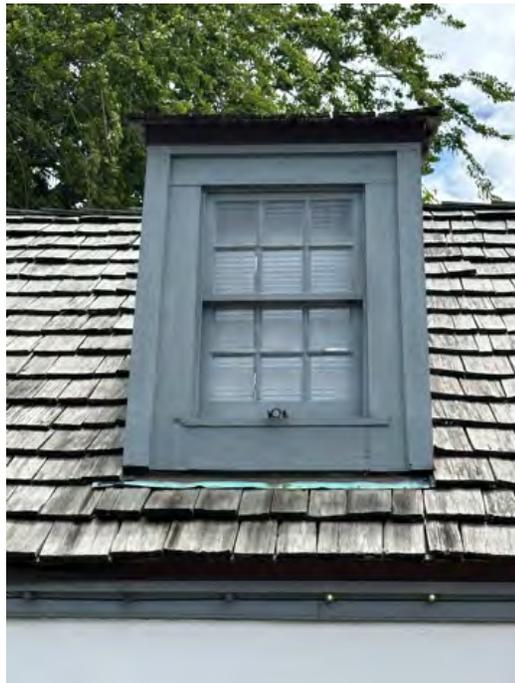
A: Window 2N1, looking E and up

There is a minor split between the frame stiles and the bottom rail.

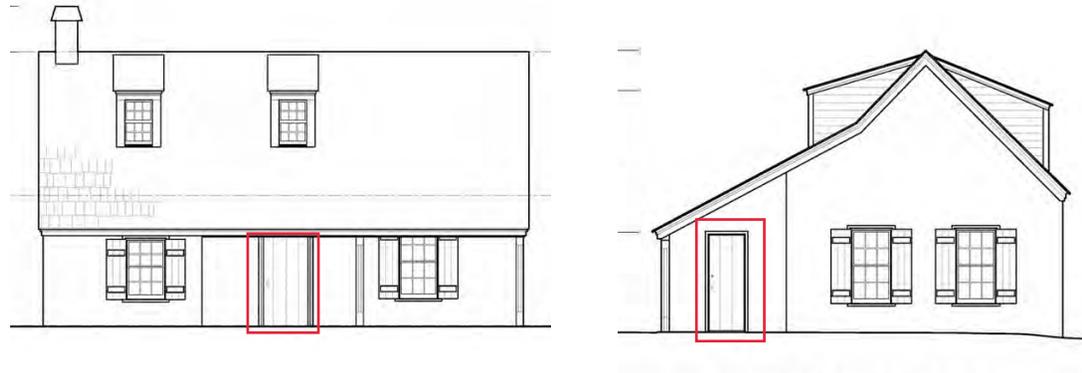
A: West Room, door D1, looking NE

The two exterior entry doors, D1 and D2, are in good condition (A, C). The main entry door (D1) appears to be recently painted (B).

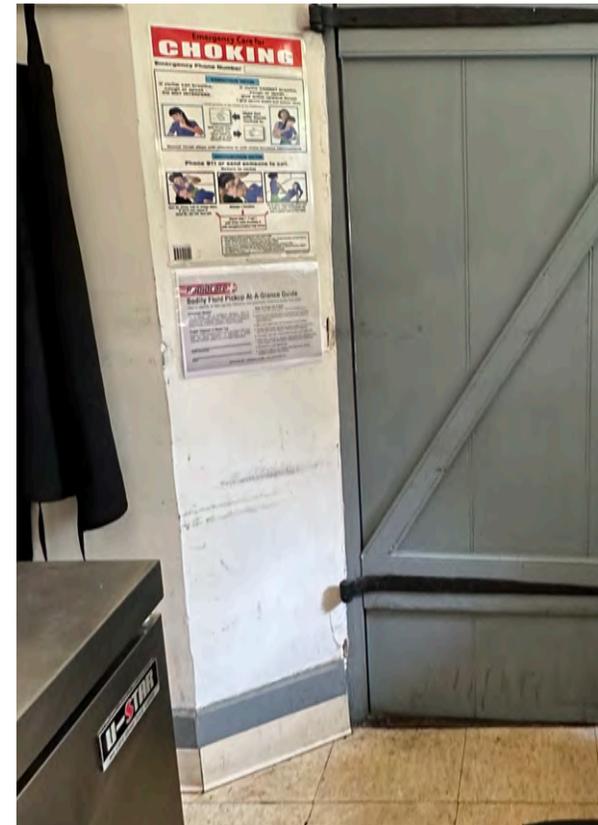
B: South Room, looking E

In general, the interior of the Joaneda House is in good condition. No major areas of concern are noted on either the ground floor or on the upper level. However, the equipment, such as wine shelves, bar, and storage shelves impeded the inspection of the condition of interior plaster (A). Several spots of plaster and paint damage were noted in the South Room (B).
