# **THE DEMESA-SANCHEZ HOUSE**

43 St. George St. Augustine, Florida

## **HISTORIC STRUCTURE REPORT**

Historic Preservation Program, DCP, University of Florida

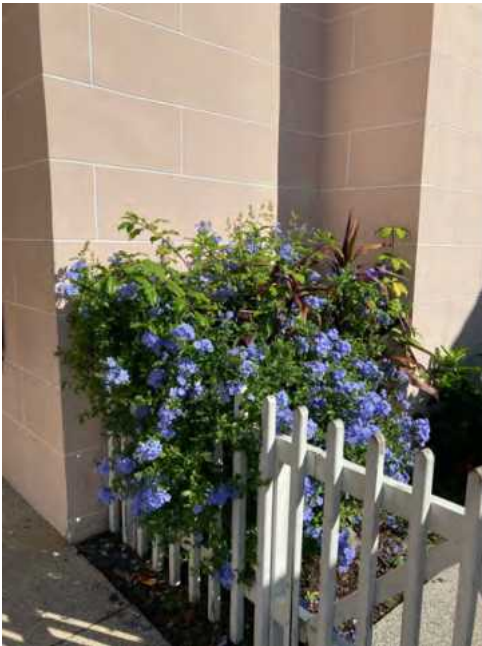
Some paving and site features impede site water flow away from the building. The westernmost concrete walkway that leads to the south façade should be either removed or replaced to promote drainage of water away from the building.

*A: West Wing, S facade, looking NE*

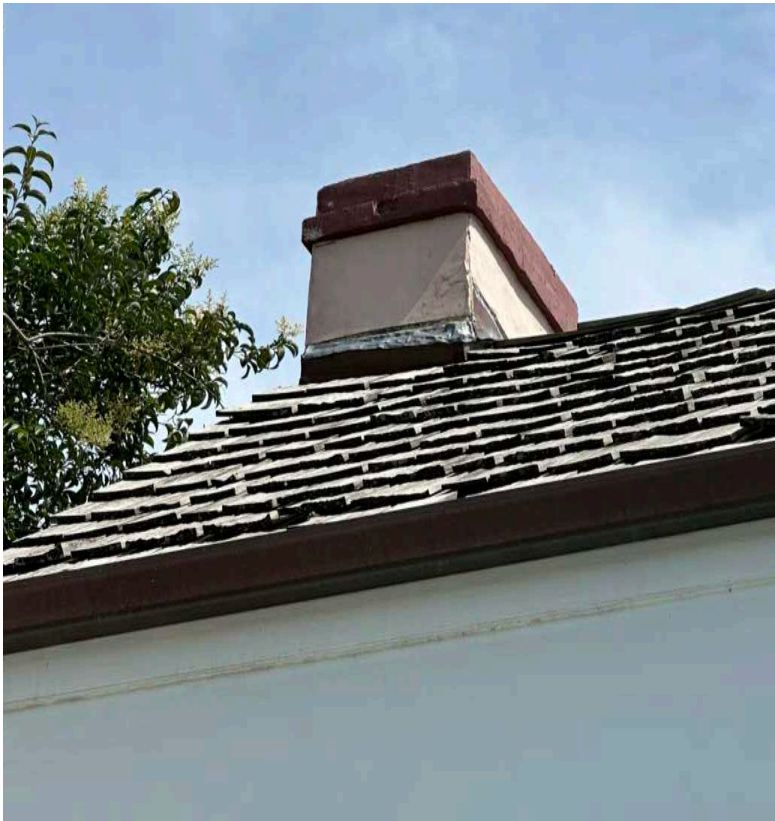
Overall, the flashing materials appear to be in good condition at the chimney/roof penetrations at the east chimney and the south chimney. The drip edges appear secure and in good condition. The gutters and downspouts appear to be well-fastened and in good condition (C).

*B: East Wing, roof's N slope, looking SE and up*

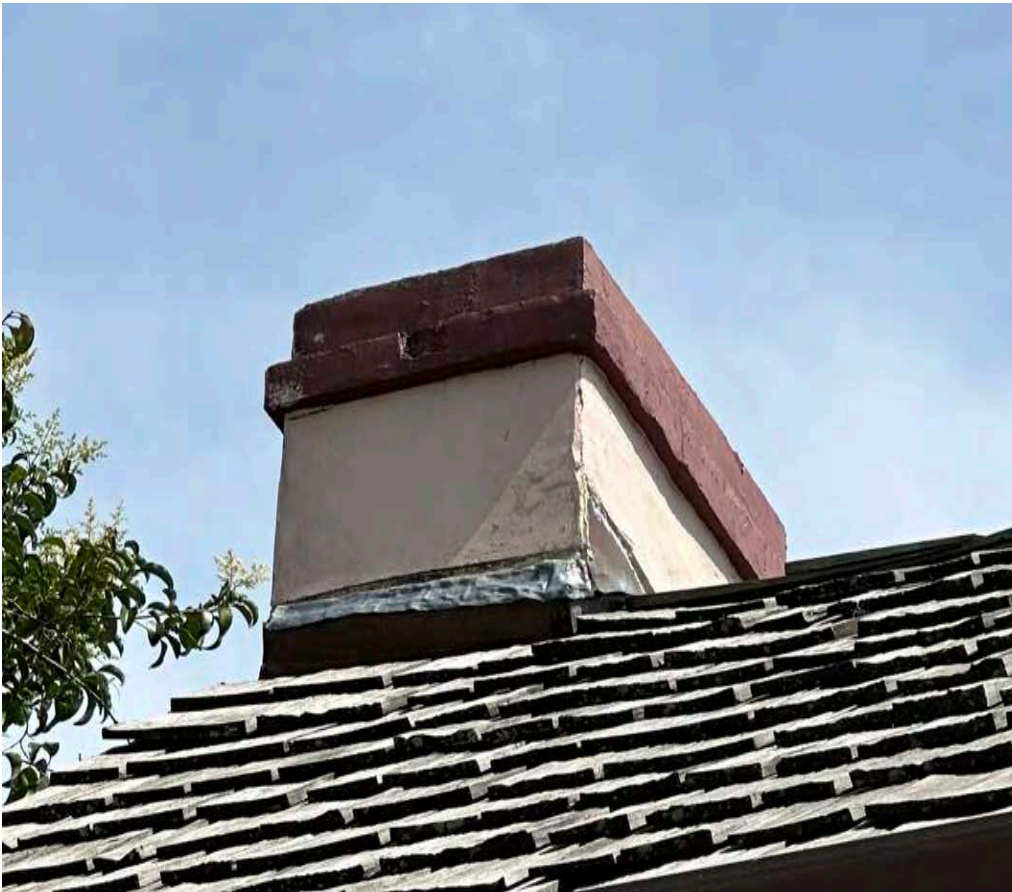
The east wall chimney's painted stucco, masonry and cap appear to be in good condition on the exterior

*D: East Wing, E wall chimney, looking SE and up*

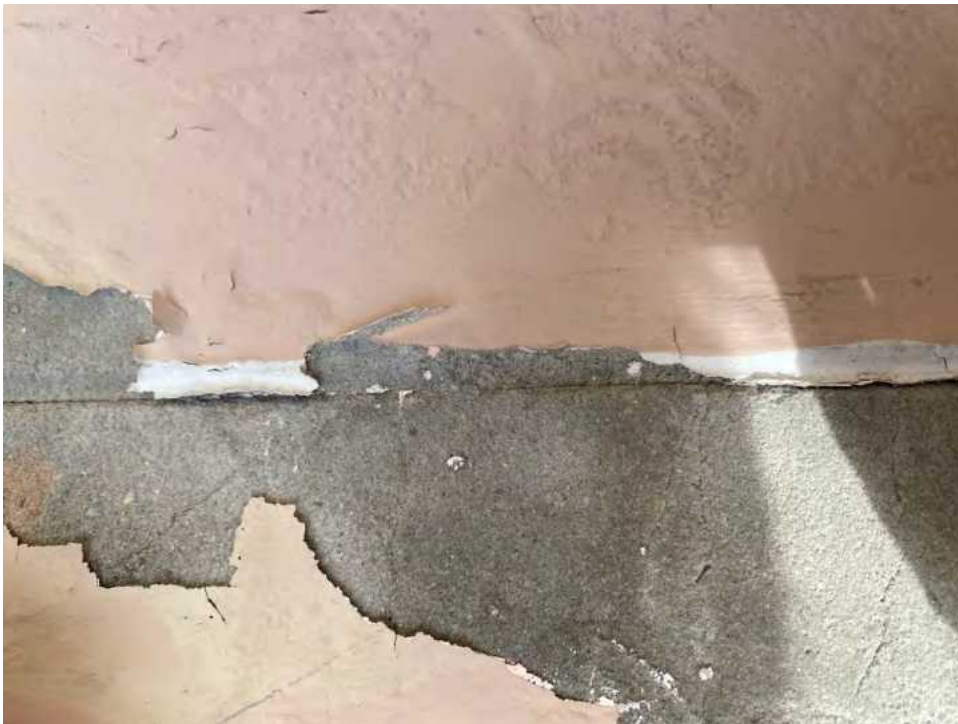
The moisture issues that are visible on the first-floor interior walls (see Interiors) are not readily apparent on the exterior walls. Further investigation is needed, see Recommendations section.

*B: East Wing, S facade, looking N*

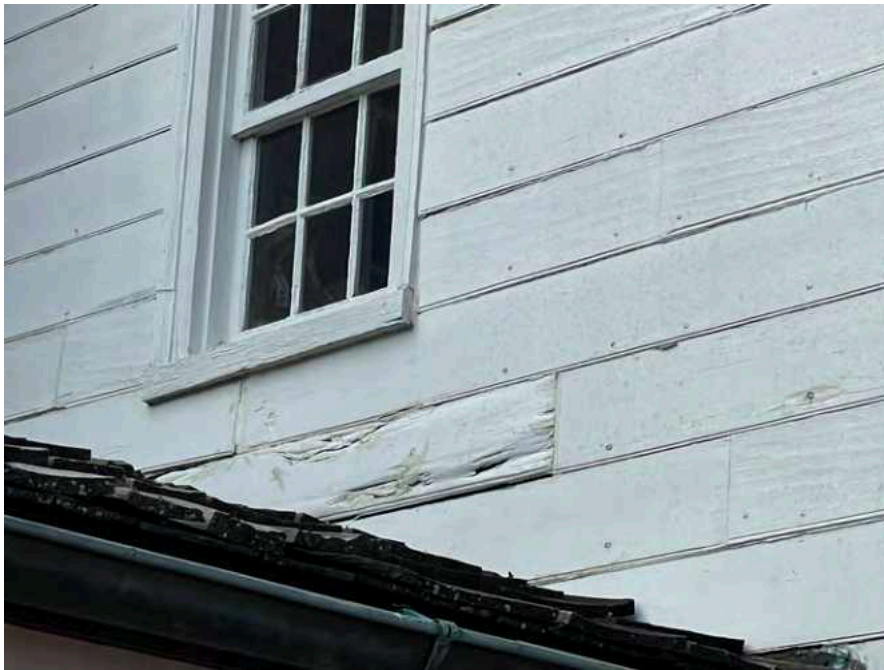
Repairs to this material were observed during the Fall 2022 site visits. The condition of this material now appears to be good.

*E: East Wing, S facade, looking NE, November 2022*

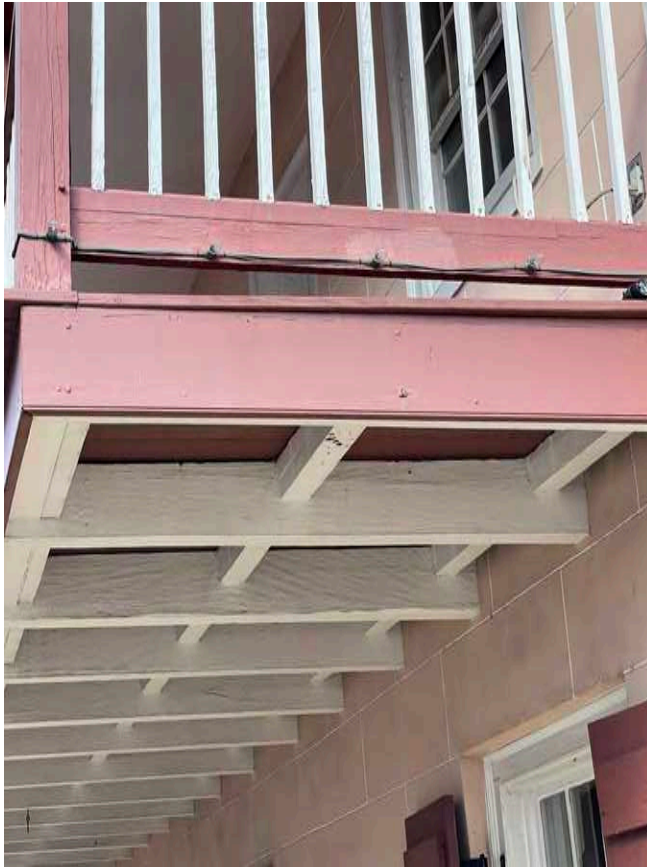
Most of the wood elements of the balcony are in good condition (A, B, C, D). The woodwork applied to the façade at the upper south-west corner displays some minor damage and chipped paint (E).

*D: West Wing, Balcony, looking NE and up*

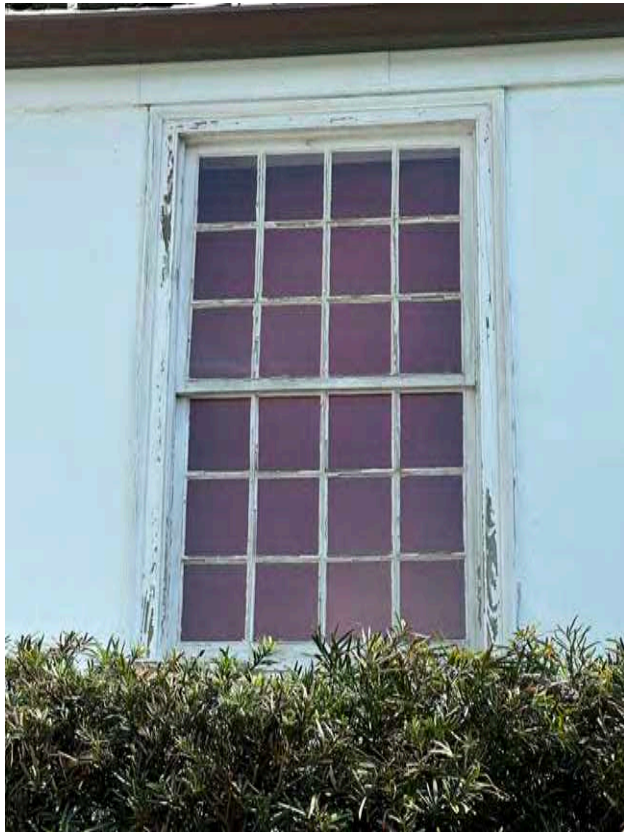
Window 2N2 appears in fair condition, with significant amount of peeling paint on the frames and sash, the sill appears to have some rot (A). Shrubs obscure most of the sill board from view.

*A: East Wing, N facade, looking S Window 2N2*

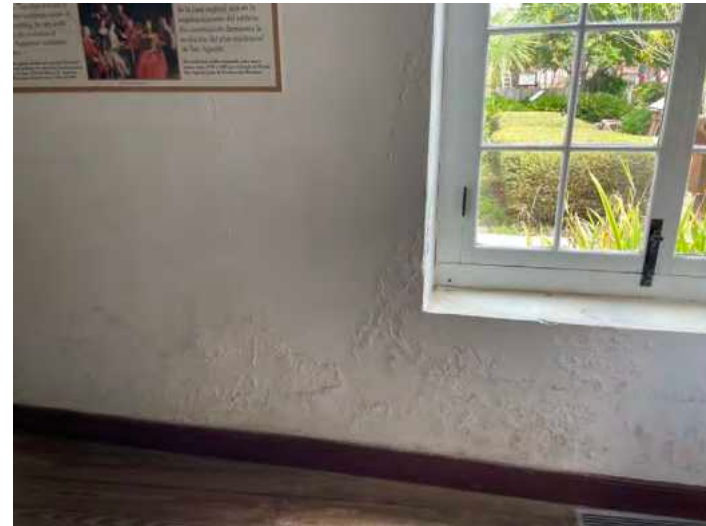
- The electrical system was designed for minimal power distribution to reinforce the interpretation of the site as a Territorial-era property. Careful thought was given in the previous restoration to strategic placement of hard-wired wall outlets, to maintain the historic character of the spaces. In some areas, temporary power cords are now used to supplement need for power for other uses. See Recommendations section (C).

*A: Room 104, E wall, looking SE and down*

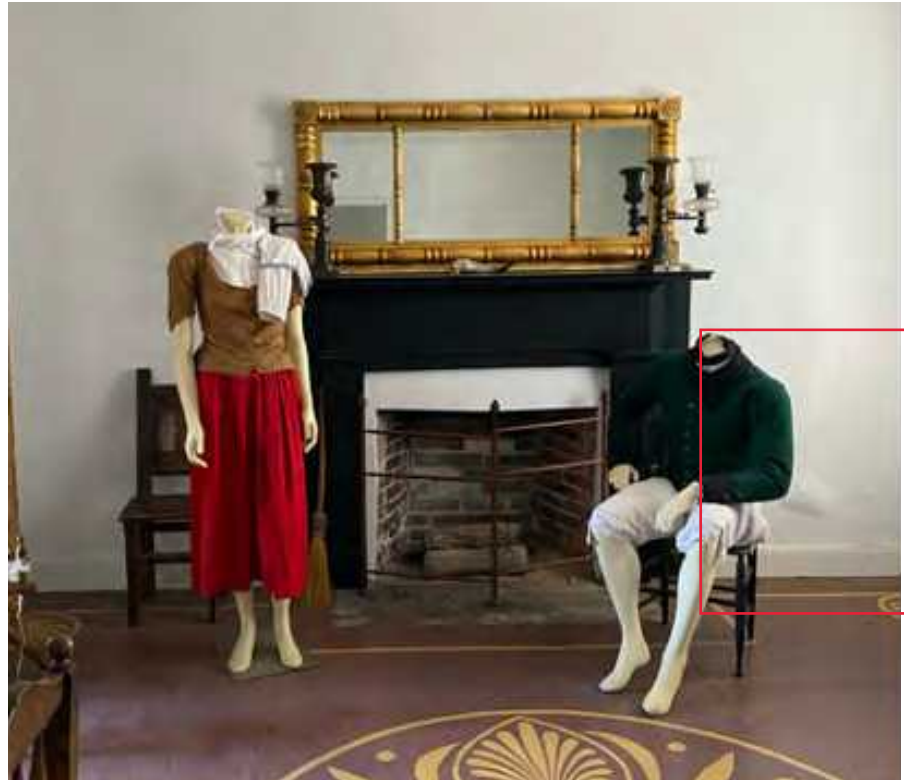
There is a small area of bubbling painted plaster on the south wall to the west of the fireplace (B).

*A: Room 101, looking S*

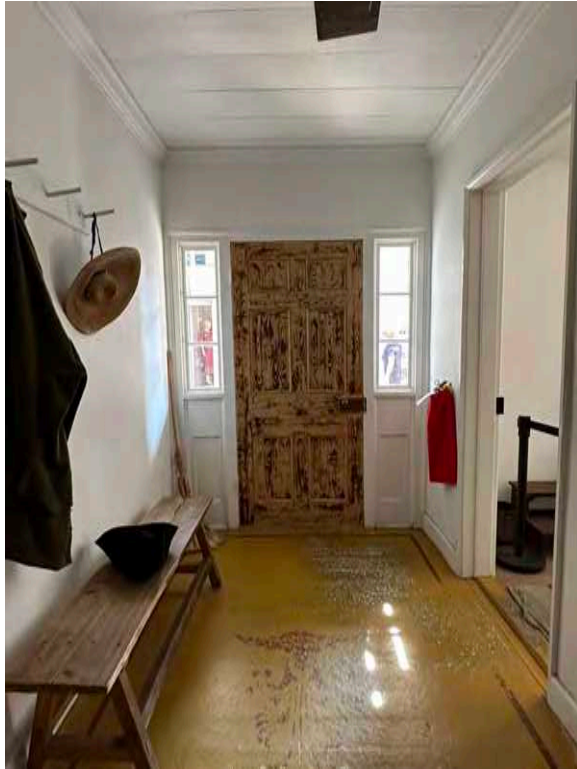
Painted ornament on the wood floor is fading away (B).

*A: Room 102, looking W*

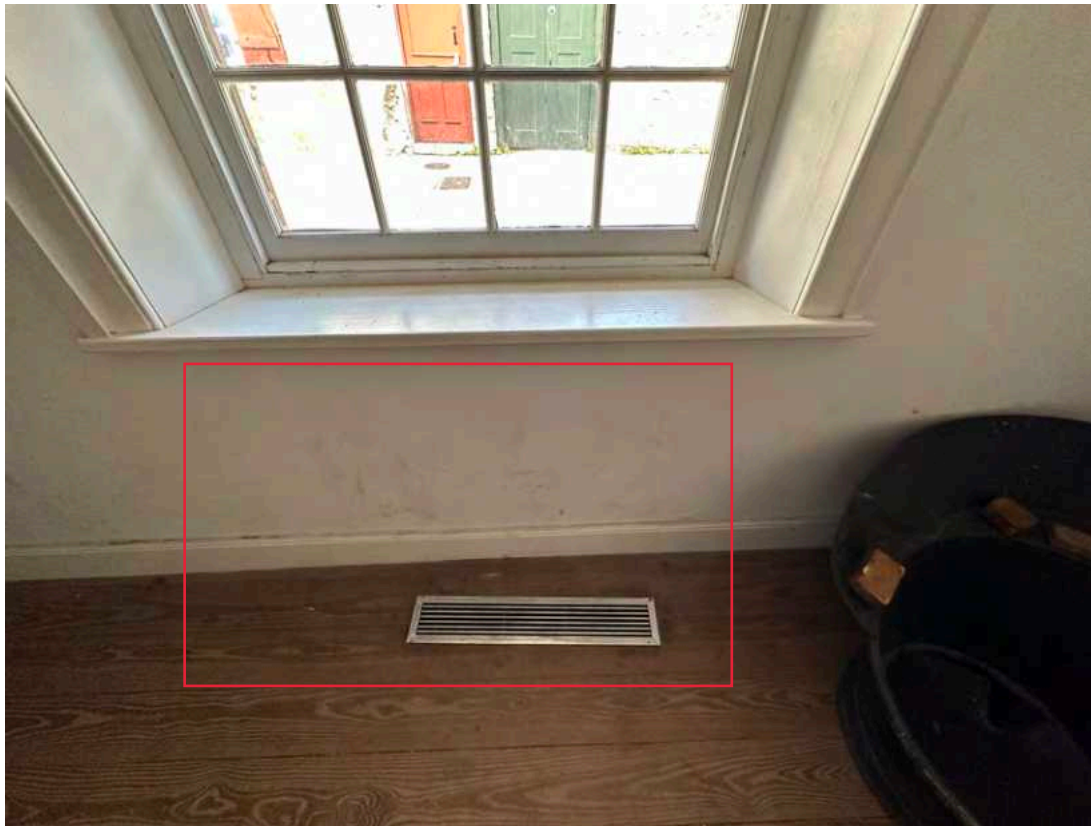
Minor plaster damage on lower area of wall near and below sill area of window 1W2, vertical plaster crack on east wall.

*A: Room 103, looking W*

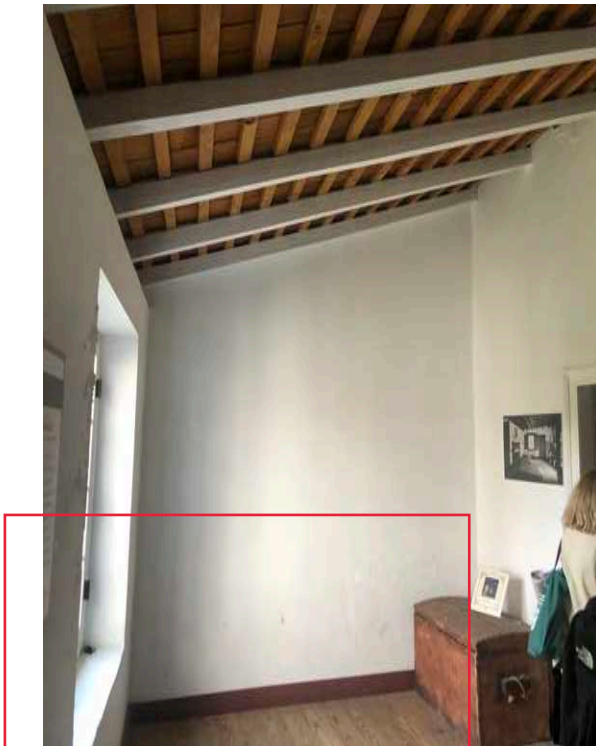
- west wall, high on the wall under the exposed beams (A)
- west wall, low on wall next to the wood staircase (A)
- south wall, low on wall below sill height (B)
- east wall, around the window opening (1E1), more extensive plaster damage along the wall below the window sill height (C)

*B: Rooms 104 and 105, looking S*

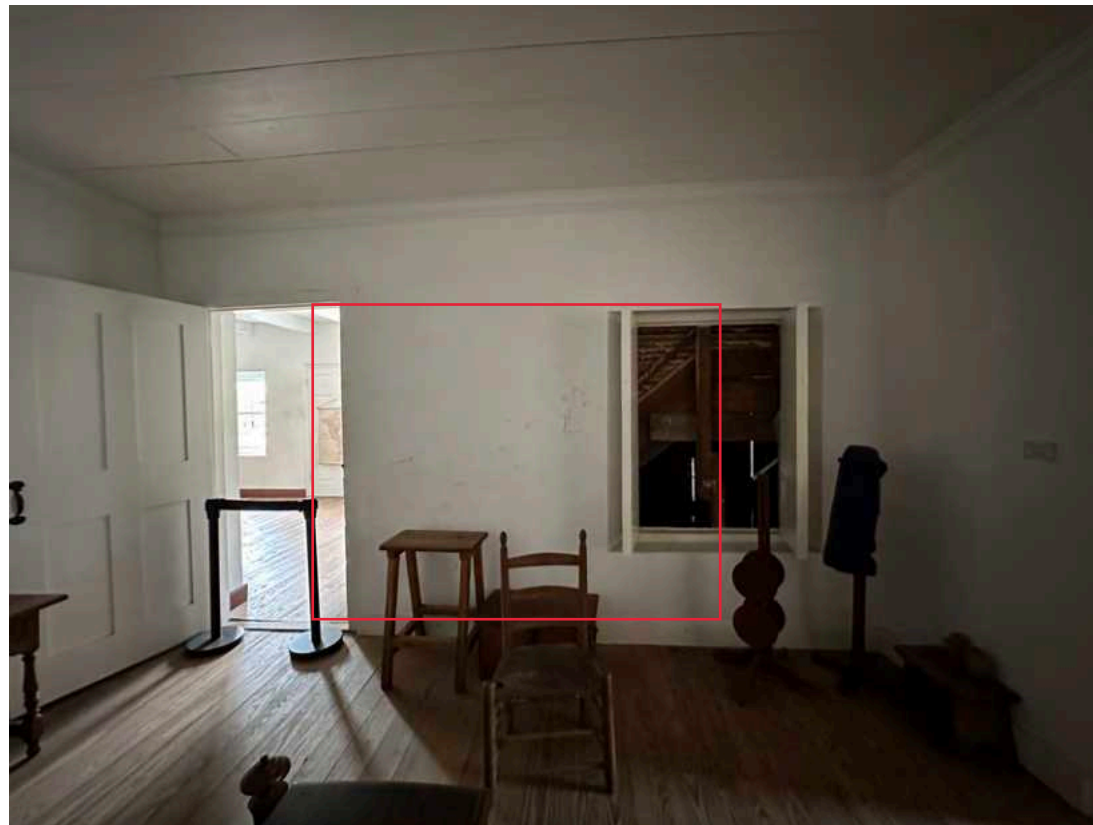
Some evidence of plaster damage on the south wall (A).

*A: Room 106, looking NE*

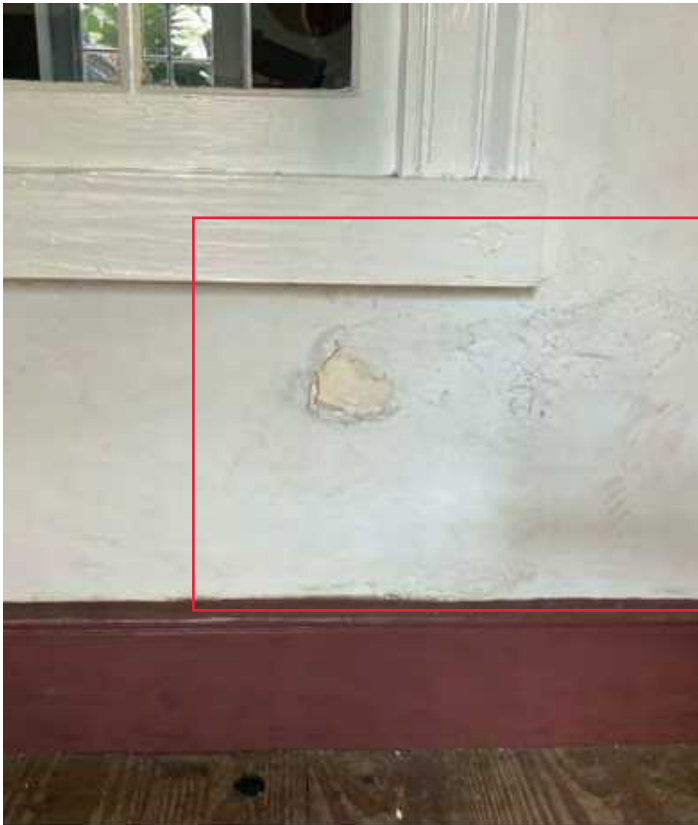
Plaster damage on north wall and low on the south wall (A, B).

*A: Room 107, looking N*

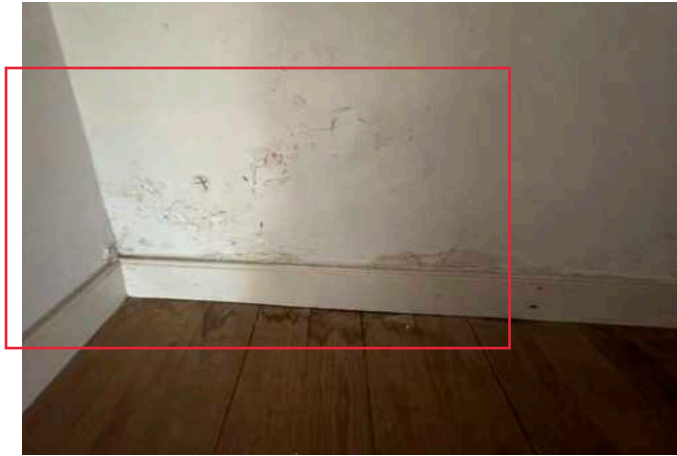
Plaster damage at all walls (A, B, C). At north wall damage is with corresponding water stain on wood floor. Significant deterioration of plaster along the south wall.

*A: Room 108, looking NW*

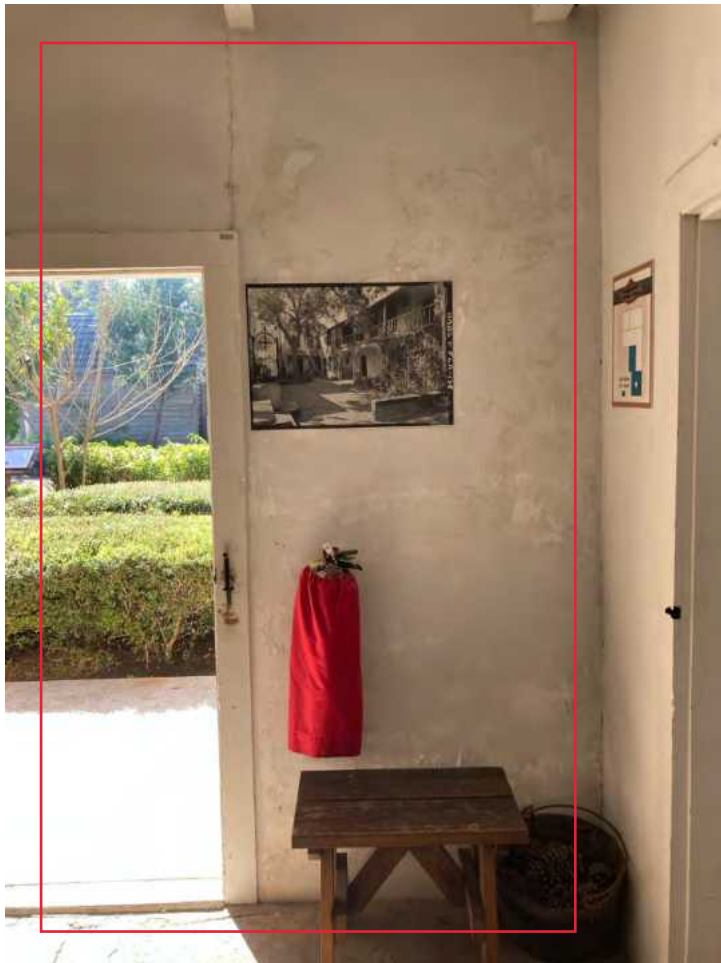
Plaster damage at south and east walls (A, B).

*A: Room 110 , looking S*

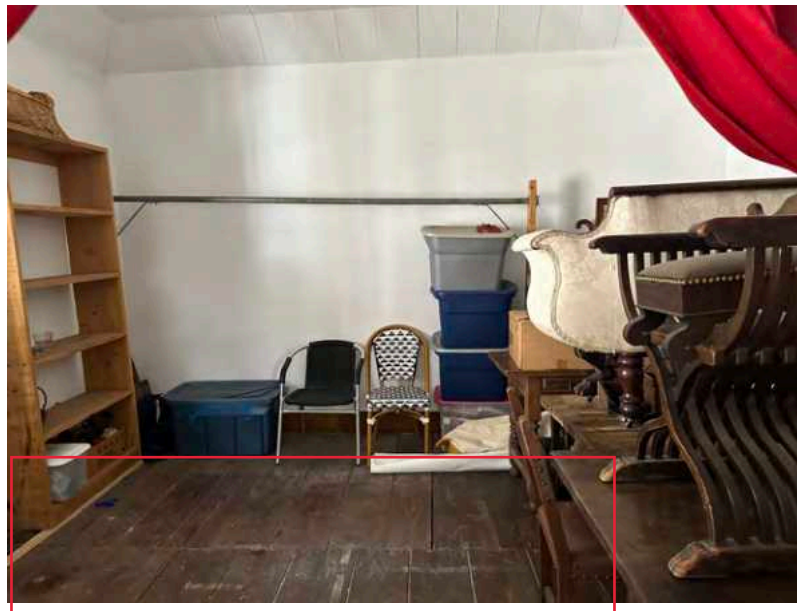
Limited visibility, plaster damage on the north (exterior wall), and around the window 2N1 sill area (B).

A: Room 202, looking N

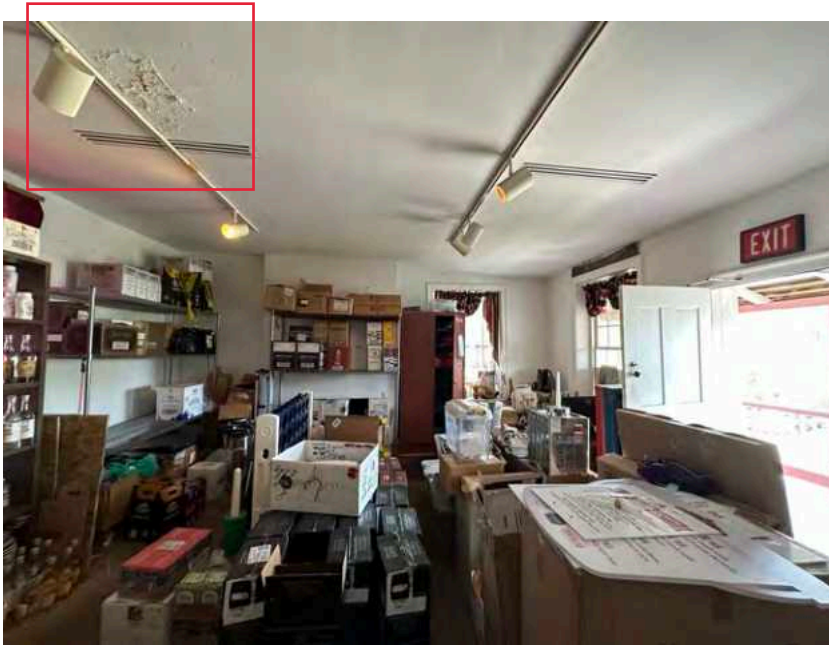
Limited visibility due to contents of space, plaster damage at ceiling near north wall (A, C) and near the window 2N1 (B).

*A: Room 210, looking E*
