**The Watson House**

206 Charlotte Street, St. Augustine, Florida

HISTORIC STRUCTURE REPORT

Historic Preservation Program, DCP, University of Florida

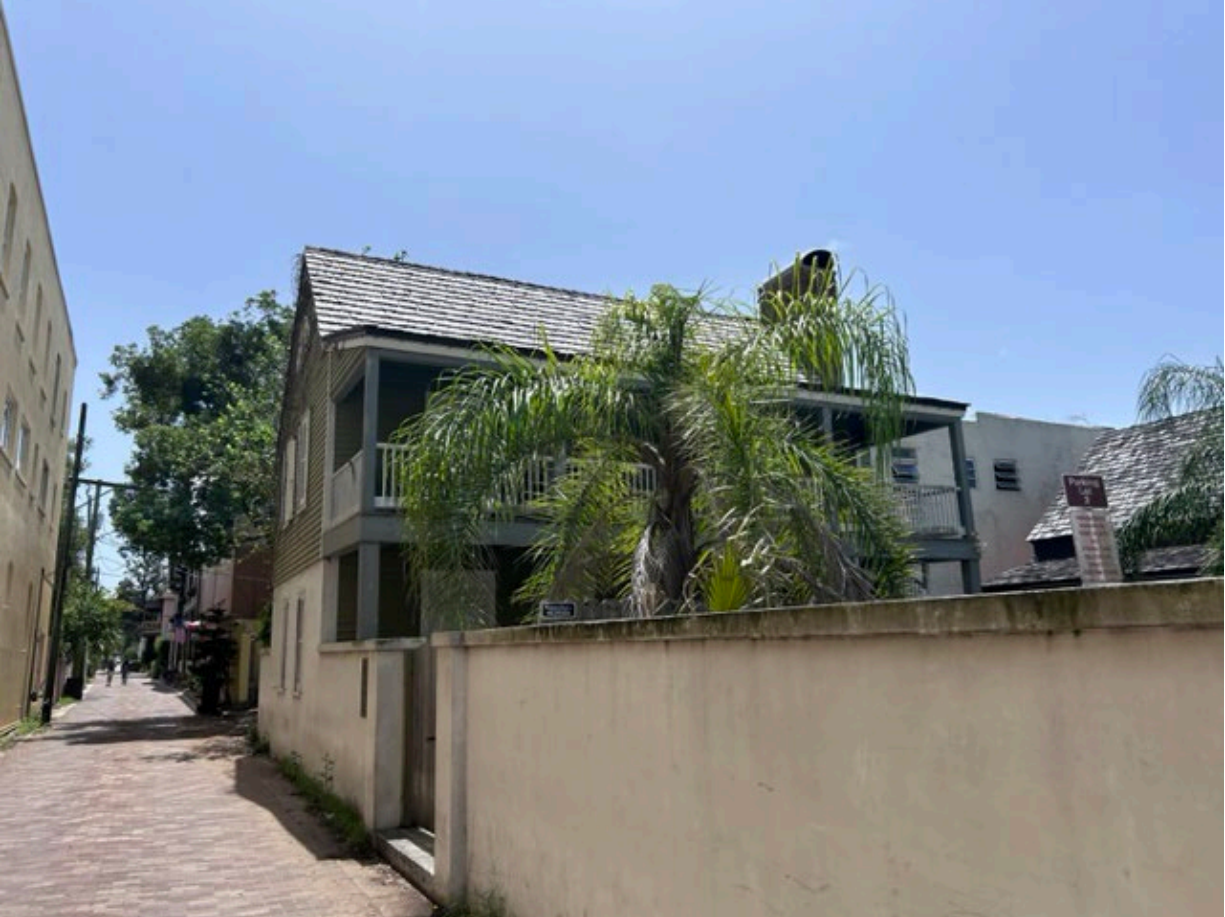
**Figure 2.** View of the Watson House property looking south on Charlotte Street.

Unlike most buildings on Charlotte Street to the north and south, the entryway to the Watson House is not situated along the street. Instead, the building's entrances are within the yard, accessed by the gravel parking lot or the door in the masonry wall along Charlotte Street. The building is bordered by a masonry wall which extends from the Watson House along the street on the east (Figure 2). The north perimeter of the property is defined by a wooden fence and low-lying vegetation (Figure 3). The wooden fence continues to the west, dividing the shared parcel between the Watson House and the Spanish Military Hospital Museum (Figure 4). To the south, the Watson House is abutted to an adjacent building, with a gap of no more than three feet between the structures (Figure 5).

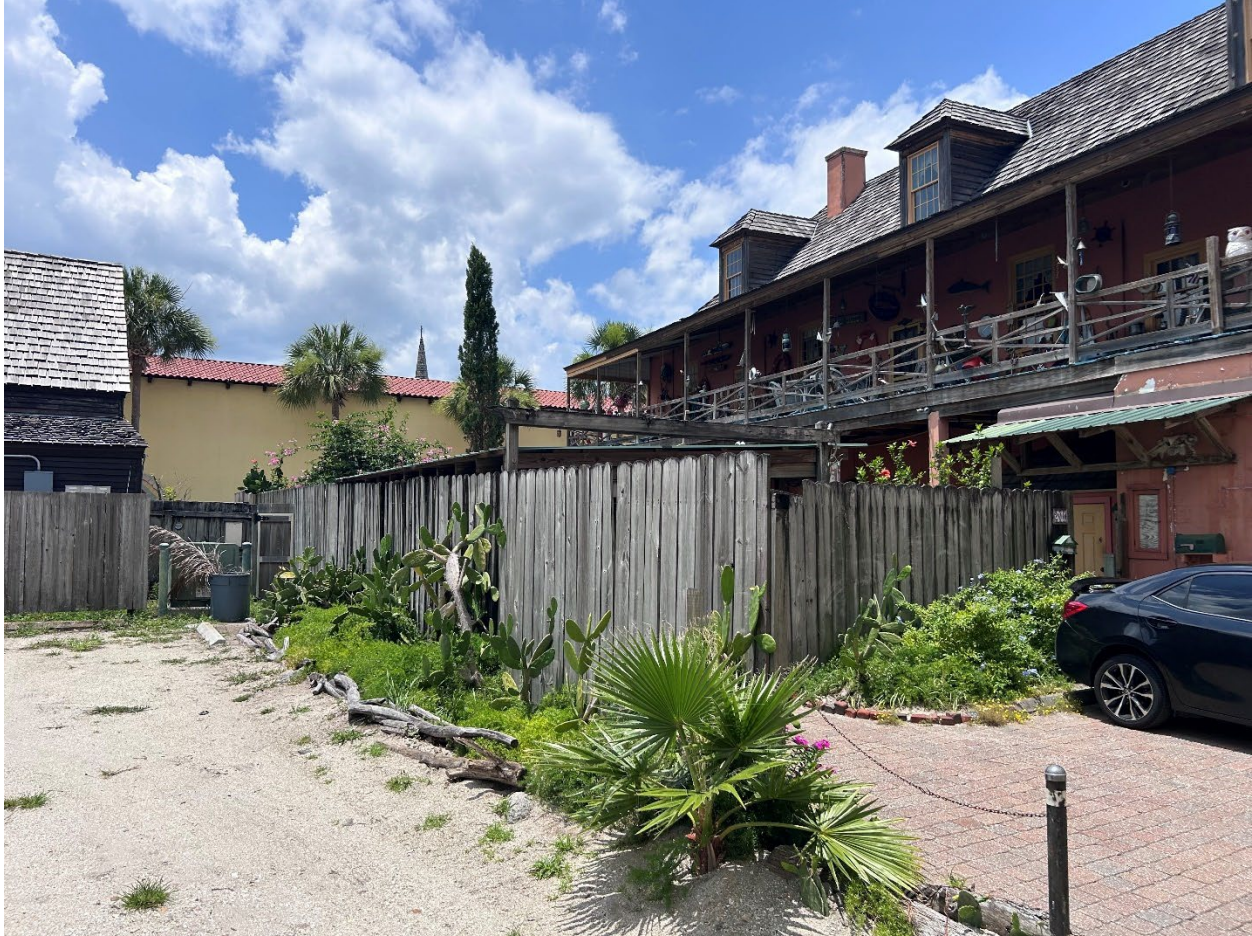
**Figure 3.** View of the northwest corner of the Watson House property. Note the wooden fence that separates the property from the Spanish Military Hospital Museum (left) and the former Florida Heritage House (right).

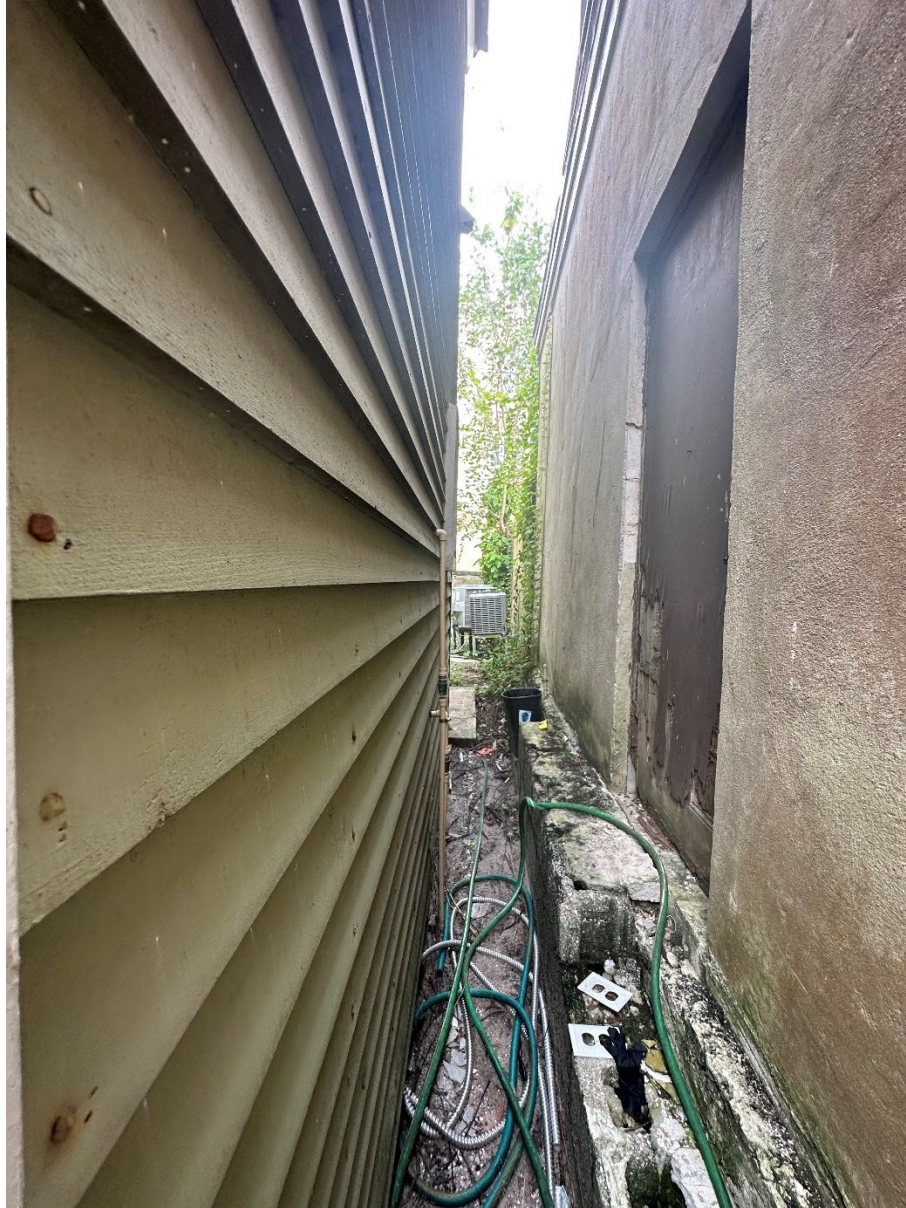
**Figure 5.** View of the south boundary of the Watson House property. Note the neighboring building to the right.

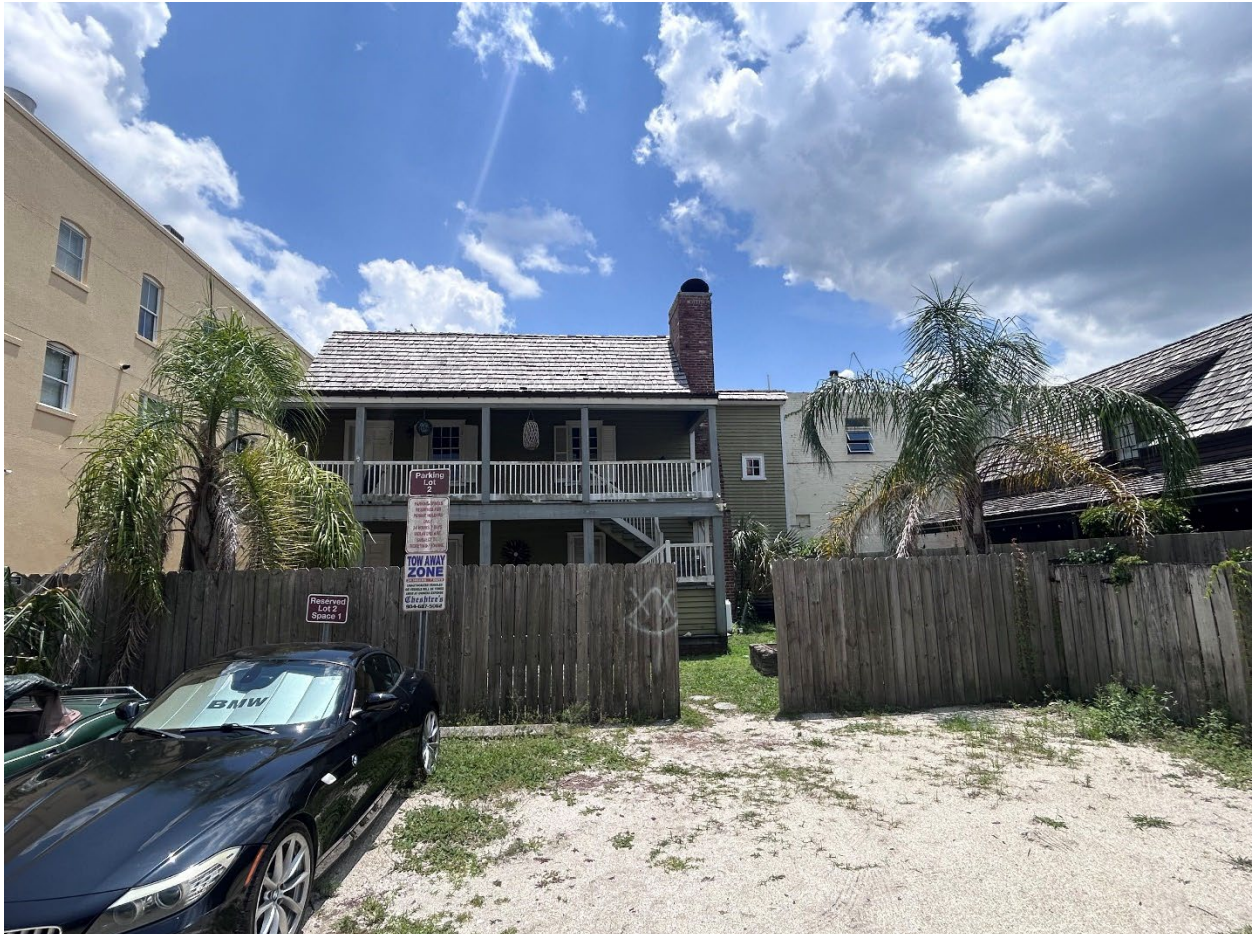
The property of the Watson House is visually divided into two distinct areas. The area designated for parking at the Watson House is an adjacent lot to the north of the building separated by a wooden fence with a small opening to the yard beyond (Figure 6). The parking area measures roughly twenty-eight feet by thirty-nine feet, the shorter dimension being parallel to the north-south axis. The space is mostly unpaved and the transition from Charlotte Street's

**Figure 6.** View of the Watson House from the parking lot.

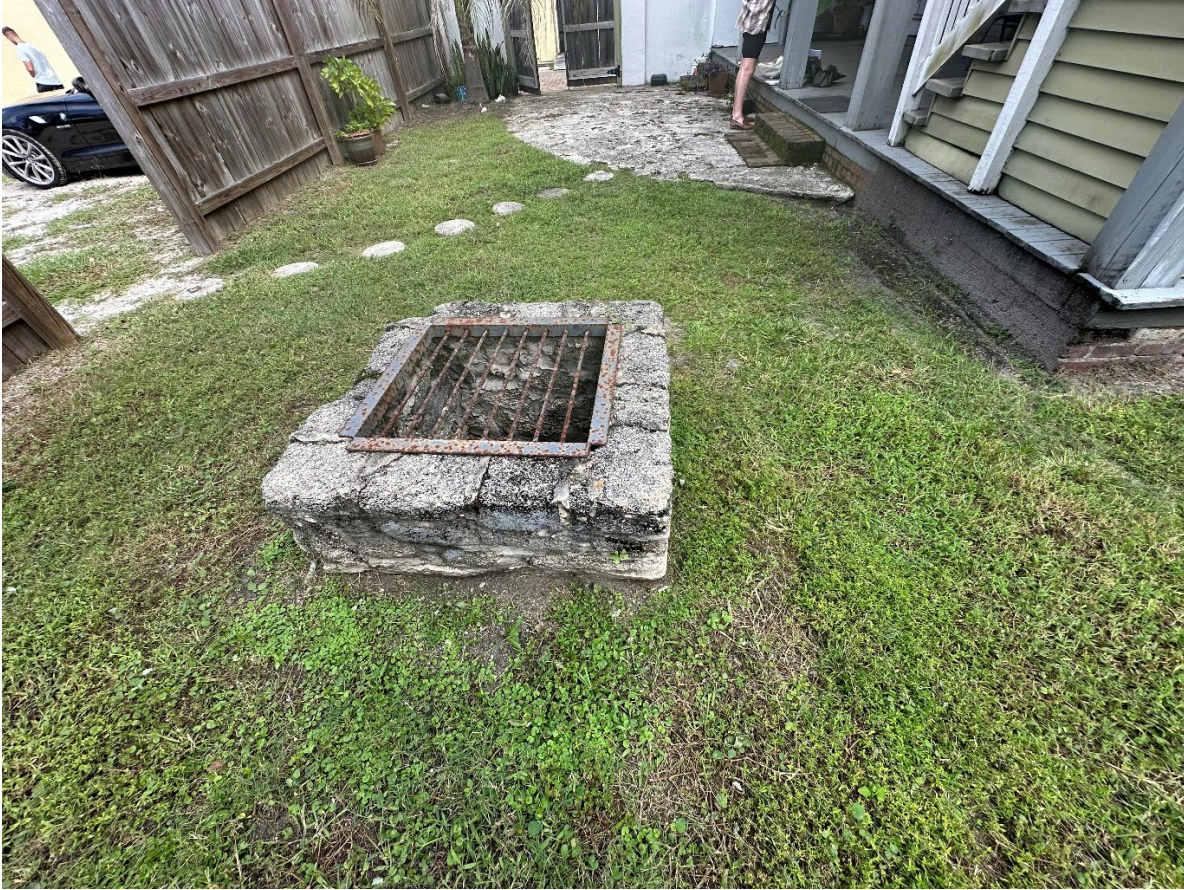
**Figure 7.** Yard view of the Watson House facing east. Note the masonry well, the concrete stepping stones, and the concrete pad in front of the porch.

There is a masonry well within the yard approximately seven feet to the northwest of the Watson House. This structure appears to be made of a coquina-like material with a clear indication of having been reconstructed or restored at a previous, undocumented time. The top of the well is covered with a metal grate. It is clear that the well is in a state of disuse considering its condition and the stagnant water that is retained within the bottom of the structure.

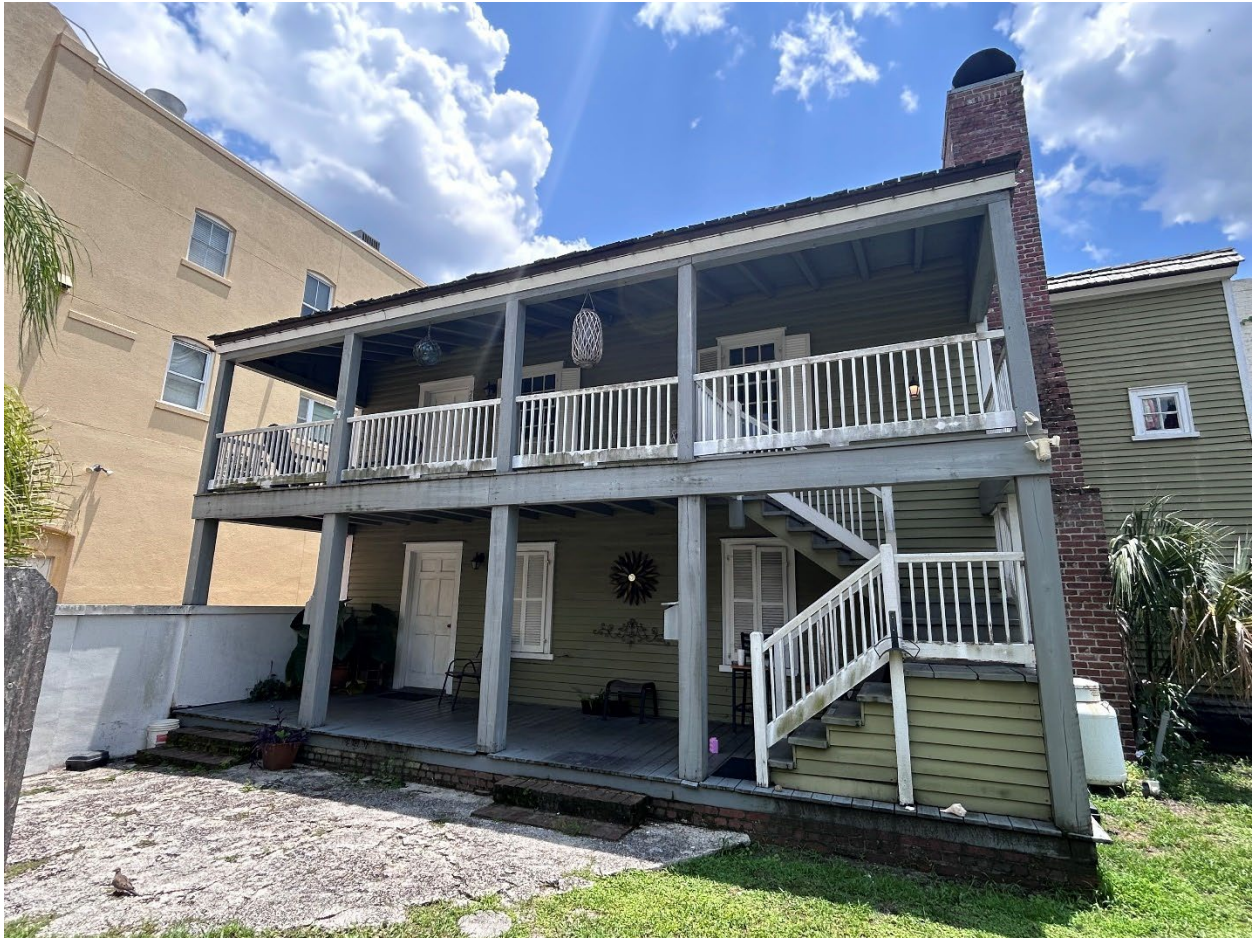
The north side of the Watson House is the primary façade which includes the porch and both entrances to the building. The foundation rises approximately a foot from the ground to a wooden porch deck. Two pairs of brick steps lead upward from a circular paved pad to the porch. On both the first and second floors, a six-panel wooden door is offset to the left with a pair of 6/9 double-hung sash windows with louvered wooden shutters to its right. The positions of these openings are symmetrical.

The porch is fully visible from the north façade. A total of ten cedar posts on the lower and upper end of the porch provide structural support. The rafters of the porch roof are exposed and clearly visible. The east side of the first-floor porch is enclosed by the masonry fence that extends from the house to the yard. The west side of the porch has a U-shaped staircase that leads to the second floor of the porch. The stairway and second floor share a simple wooden balustrade.

To the right of the porch the recessed ell of the building is visible. This section of the building is also sided with wooden clapboards and has a shed style roof with rectangular wooden shingles. On the north side of the building are two fixed four-pane windows, one on the first floor and the other on the second floor. These windows are just over a square foot in size and do not have shutters. On the ground directly in front of the ell is an extension off of the building several feet high with a rectangular shingle shed roof and metal flashing.

**Figure 8.** View of the Watson House’s front façade from the yard.

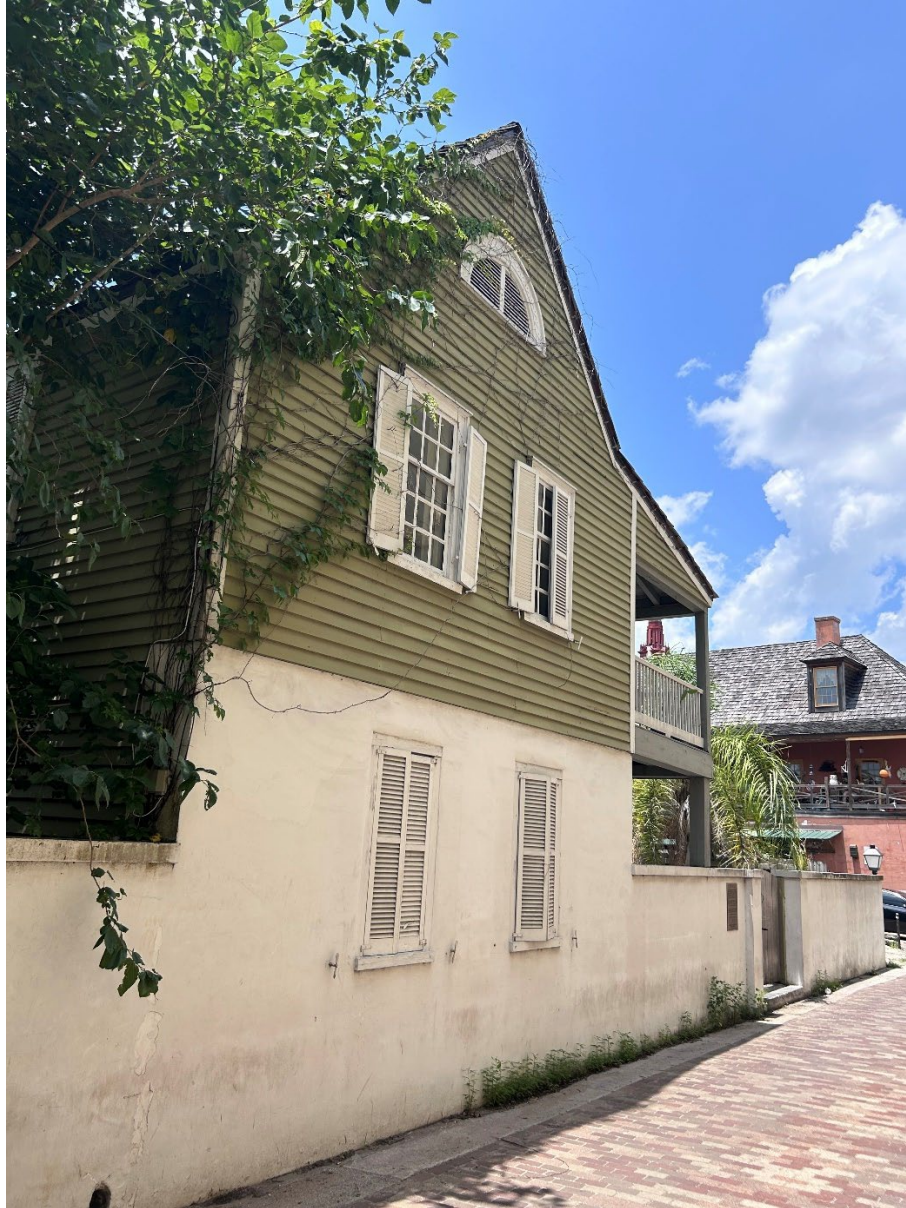
The east façade of the Watson House is the side visible from the street and exhibits significant architectural character. The first floor of the street façade is plastered masonry rather than wooden clapboard siding like the rest of the building. There are four 6/9 double-hung sash windows with louvered shutters on the east side of the Watson House. The lintels of the windows in the masonry wall are simpler than those of the windows on the rest of the building. Another unique feature of this side of the Watson House is its fan-shaped attic louver located symmetrically between and above the windows.

**Figure 9.** View of the Watson House's east façade from Charlotte Street, looking northwest.

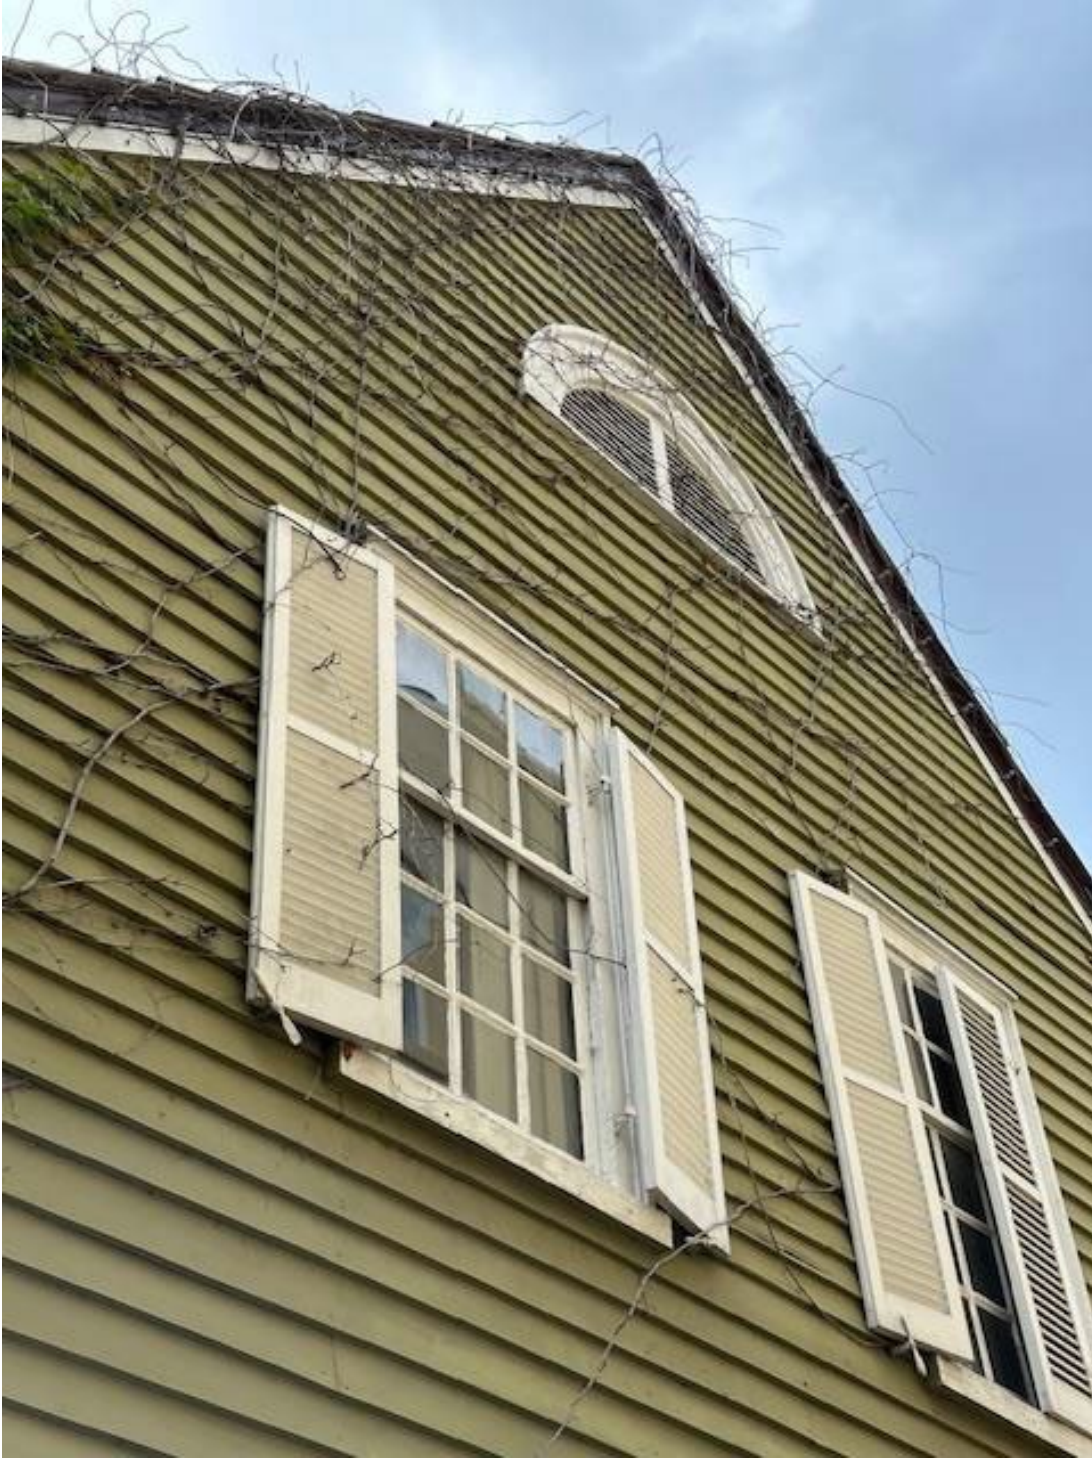
The Watson House has two window types and a total of fifteen windows. There are twelve 6/9 double-hung sash windows with louvered shutters around the building (Figure 10). These are located on the north, east, and south façades with four on each side. The frames of the windows in the lower masonry wall on the east façade are simpler than the rest. Most of the window frames have a slightly stylized head whereas the frames in the masonry wall have flat casings that are flush with the exterior wall (Figure 11).

**Figure 10.** View of the second floor windows and attic louver on the east façade of the Watson House.

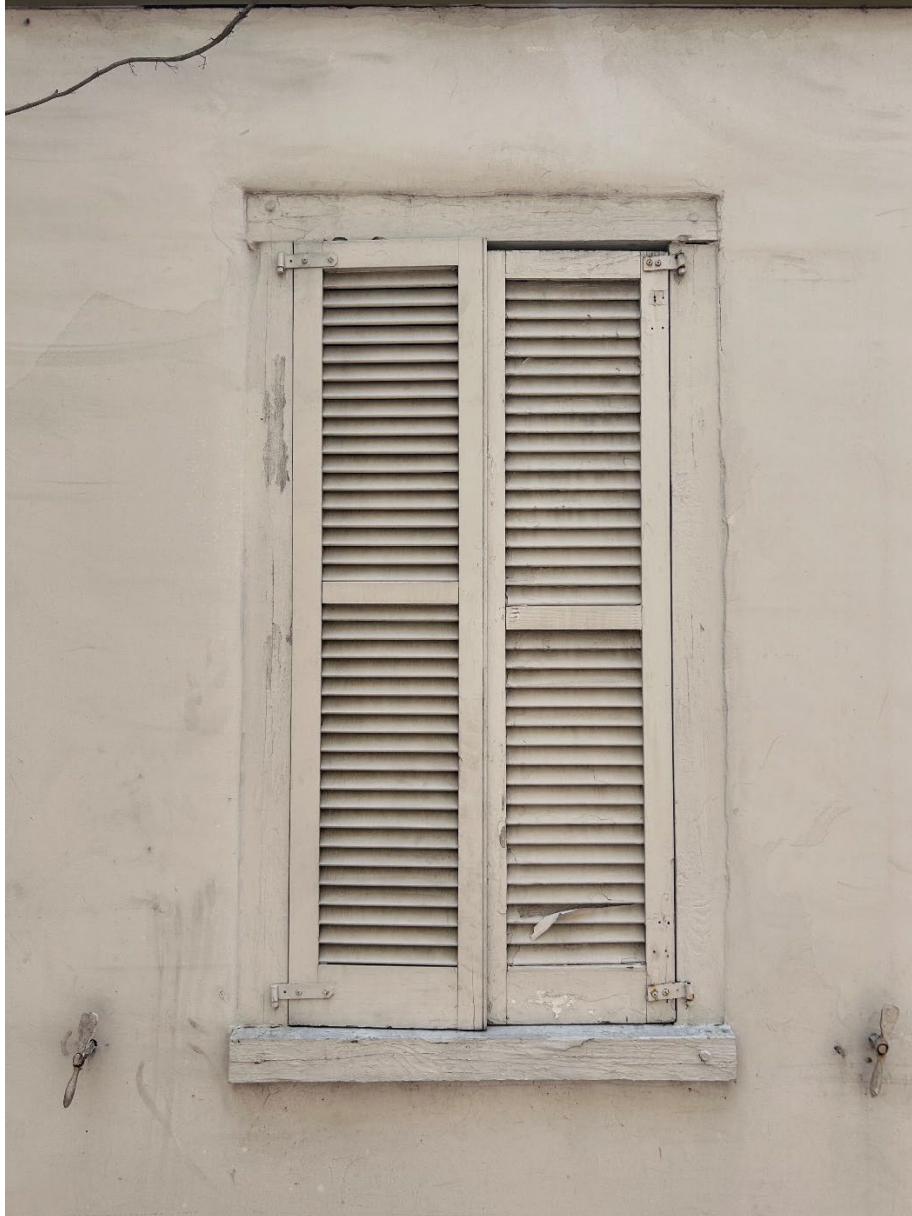
**Figure 11.** View of a first floor window on the east façade of the Watson House.

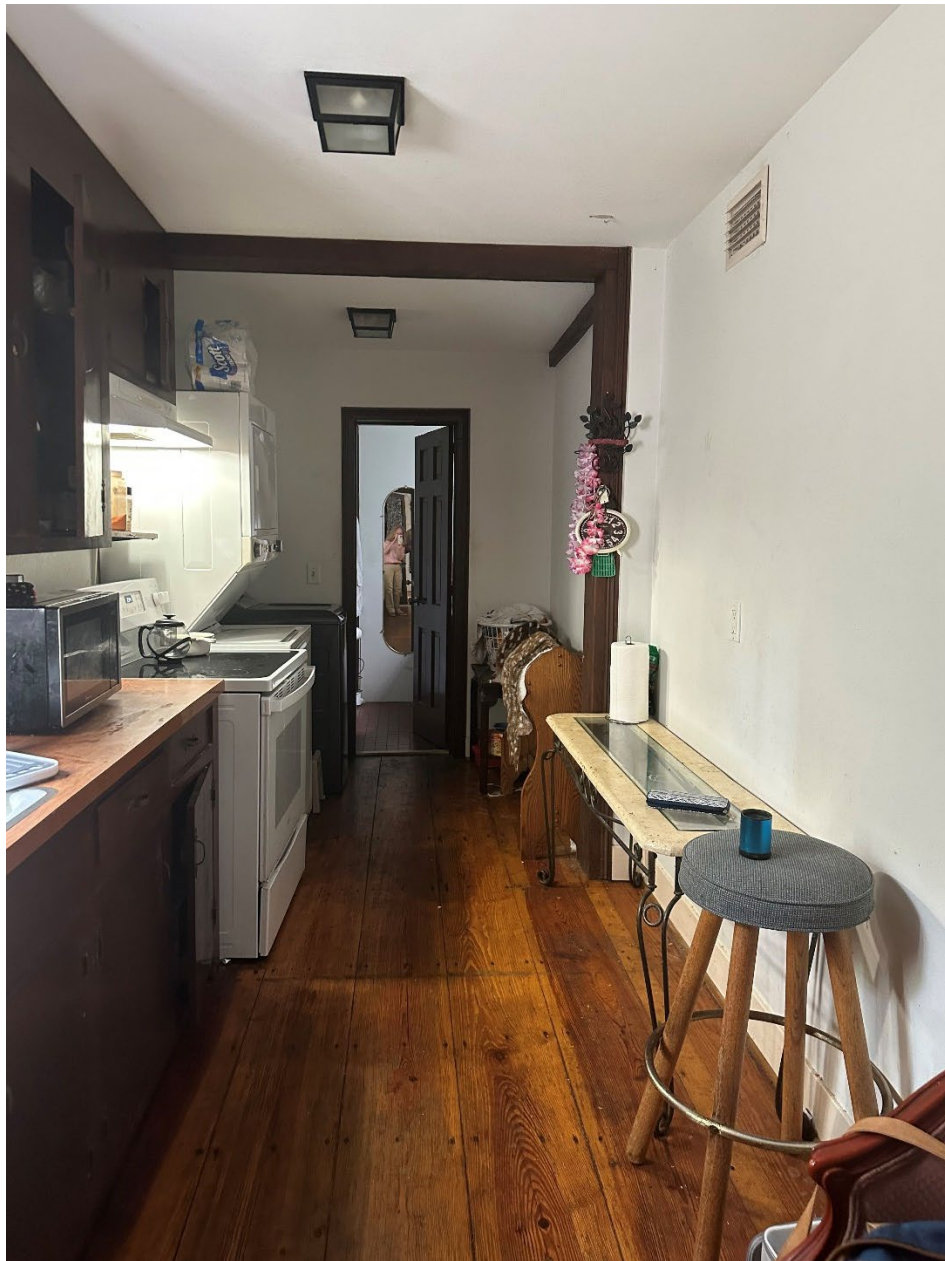
The kitchen on the first floor is several feet wide and just slightly longer than the entrance. The cabinets and appliances are set against the south wall. The room has wooden board flooring, and the walls are painted in an off-white color. The cabinets are painted in the same dark brown color as the doorways and trim. The ceiling is painted white and features two light fixtures. The west side of the kitchen narrows slightly, transitioning to the ell of the building. The

ell comprises a small section of the Watson House and contains two rooms, only one of which is separated by a doorway. There is a framed opening trimmed with casings painted dark brown, which defines a room with the laundry equipment. Beyond that, a door leads to the bathroom. This section is much smaller than the other rooms.

**Figure 12.** View of the first floor Kitchen in the Watson House. Note the doorway to the Bathroom in the back.

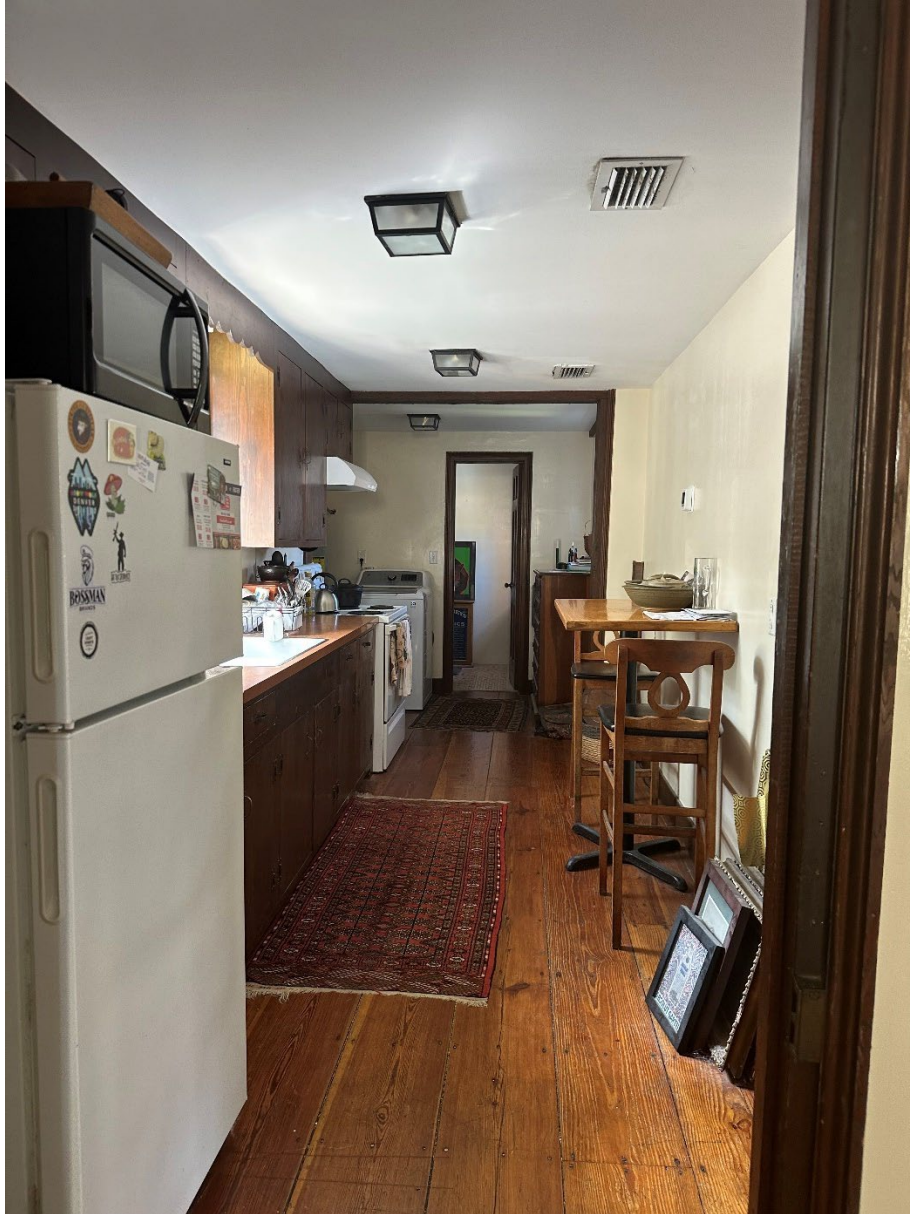
The kitchen on the second floor shares many similarities with the one on the first floor. There are three doorways in the room with the one on the east leading to the bedroom, the one on the northeast corner connecting to the living room, and the one on the west opening into the bathroom. The cabinets are painted the same color as the wooden trim and doorways and, along with the appliances, are located along the south wall. The flooring consists of wooden boards and the walls are painted in an off-white color. The ceiling is painted white with two light fixtures located within the room.

A section of the room narrows leading to the ell of the building and is denoted by a segment of dark brown wall and ceiling trim. This space is used for housing the washing machine and dryer and is not separated from the kitchen by any wall or doorway. The area is decorated like the rest of the interior and has a single light fixture in the ceiling. A doorway on the west wall of this space leads to the bathroom.

**Figure 16.** View of the second floor Kitchen in the Watson House. Note the doorway to the Bathroom in the back.

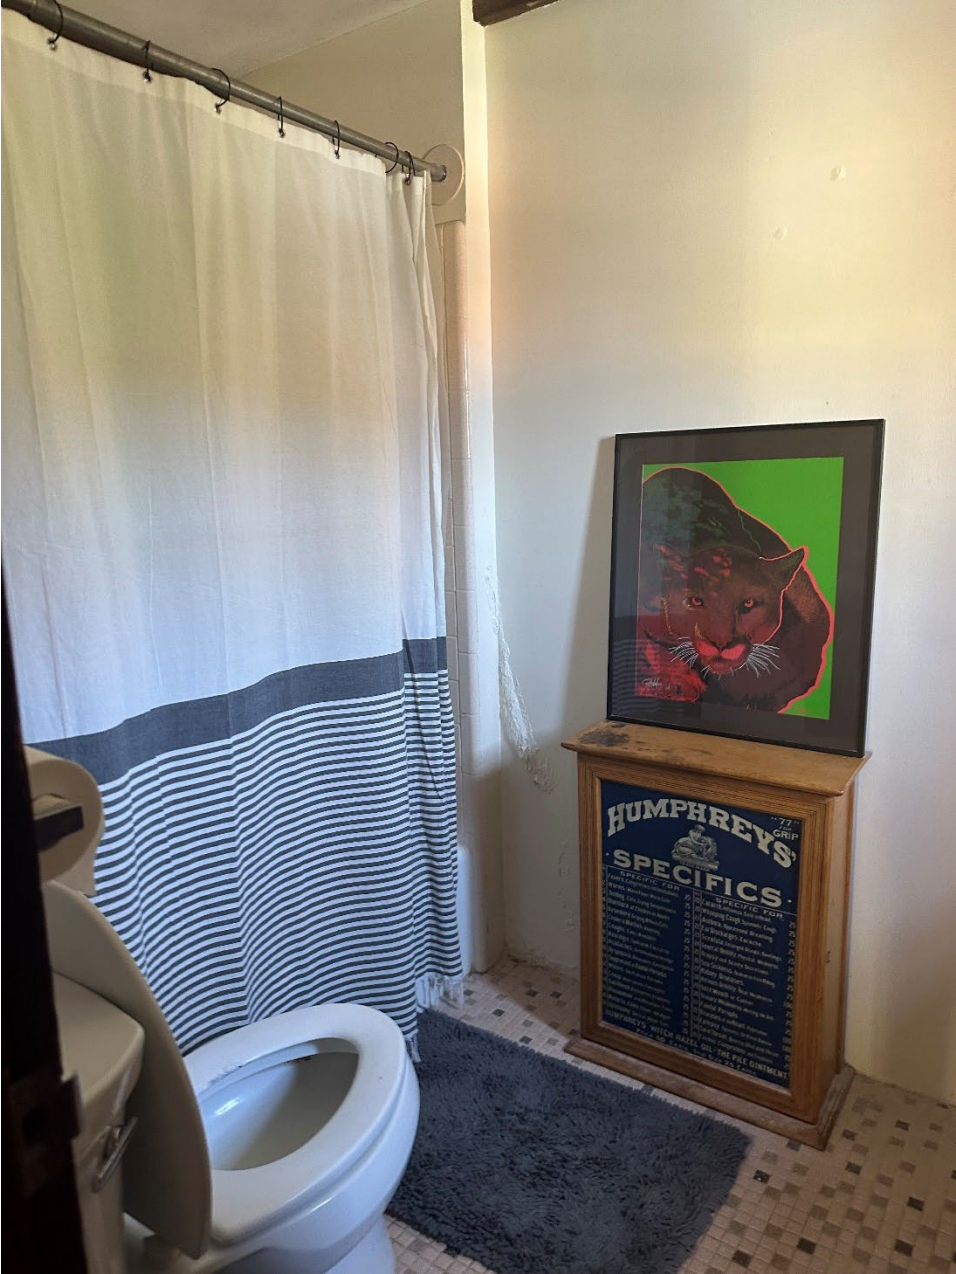
The bathroom on this floor is almost identical to the one on the first floor. The room has a toilet, and sink, and a shower/bath. A fixed four-pane window is located on the north wall. The flooring of the second floor bathroom is unique as it consists of mosaic tiles rather than wood

like the rest of the interior spaces. The walls are painted in an off-white color and the ceiling is painted white with dark brown wooden trim.

Figure 17. View of the second floor Bathroom in the Watson House.

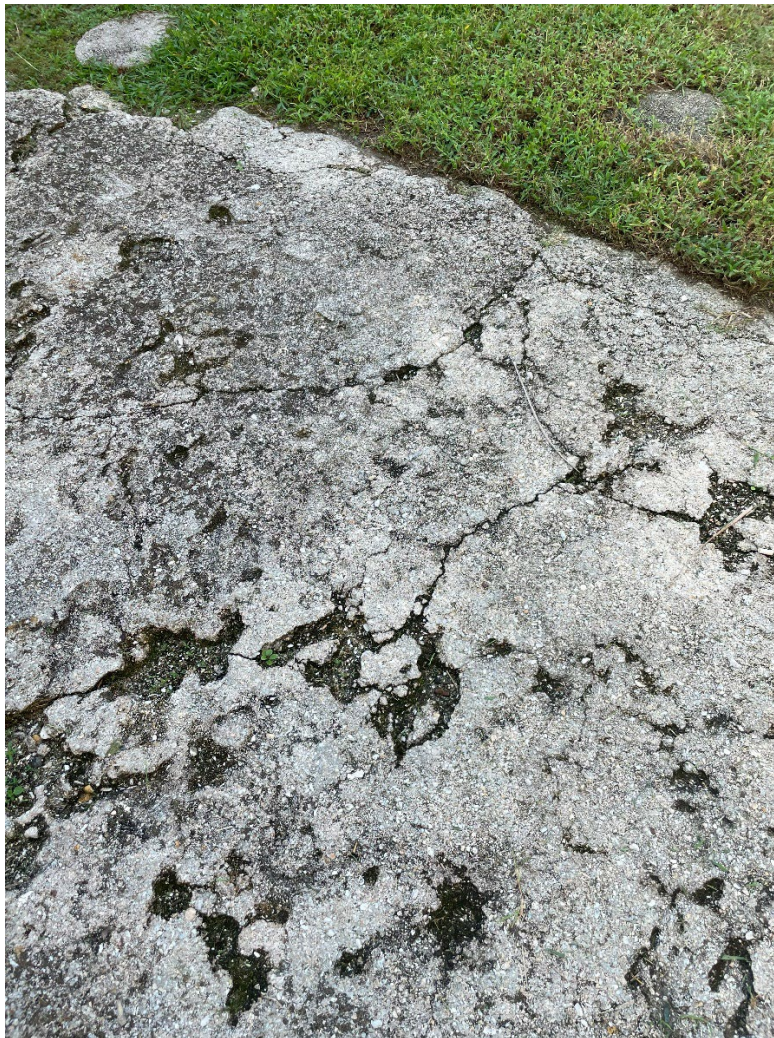
The condition of the overall landscape is fair. The parking area transitions roughly from the street to the partially surfaced lot. The grass in the immediate yard of the property is in good condition. The concrete pad in front of the porch of the Watson House is in poor condition with major cracks as well as significant chips and missing fragments. As this is the most traversed part of the yard and connects to the house itself, this is the most immediate concern in the landscape.

**Figure 1.** View of the concrete pad that leads to the porch of the Watson House.

- The concrete pad that connects the gate of the east yard wall to the porch of the building should be inspected for underlying structural issues. Pending the assessment, the pad should either be repaired and repainted or replaced with reinforced concrete
- Analyze the well on the property for historical significance and structural integrity. Unless research indicates that the well is significant to the Watson House, it is advisable to refrain from restoring it to better condition. For the time being, it would be best to clean the structure and repair the corners which have deteriorated the most.
- Conduct a thorough cleaning of the brick foundation and assess for any signs of damage

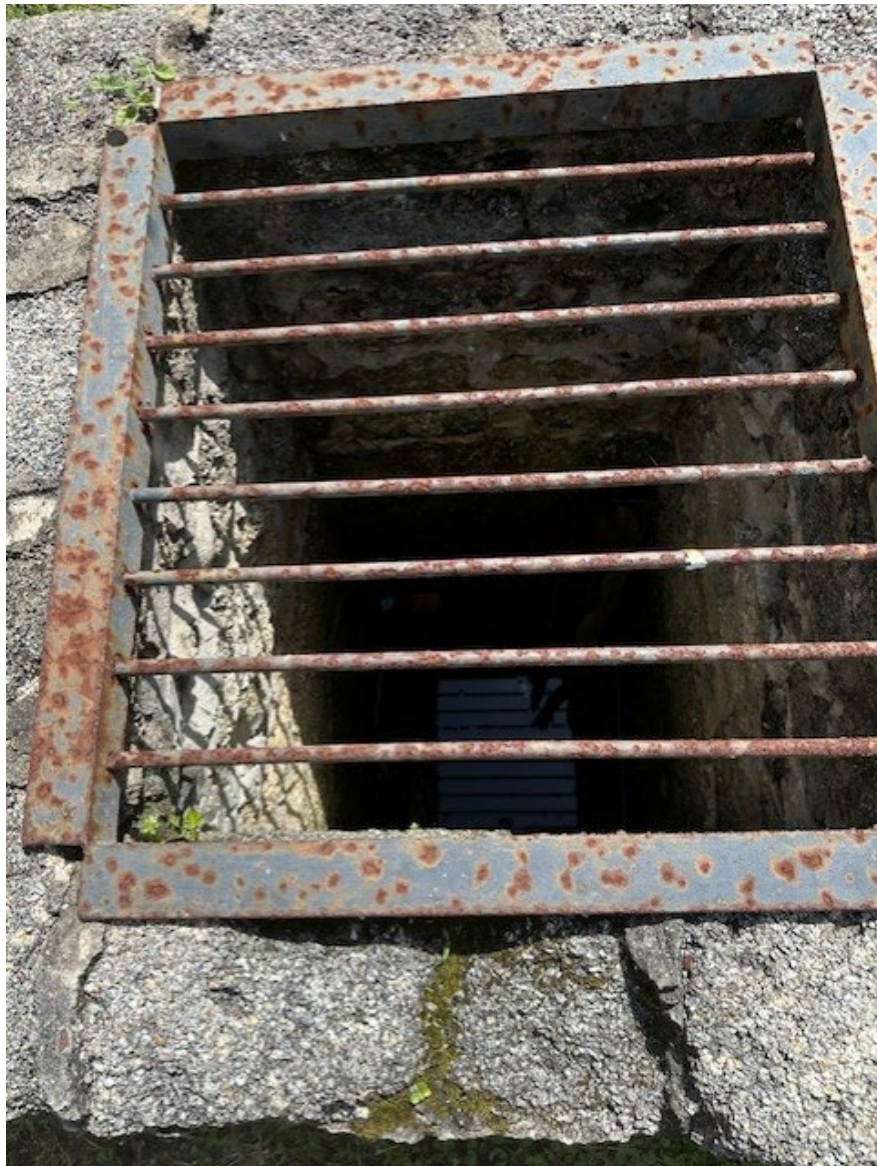
The well located within the yard is in poor condition. The masonry blocks of the well itself are significantly weathered. Furthermore, the metal grate covering the opening of the well is rusted. Because it is uncertain exactly how old the well is and if it is related to the reconstruction of the Watson House, its restoration is not urgent. A consideration should be made for the safety of those accessing the property because the well is below knee-level and has rough, sharp surfaces in addition to the rusted grate.

**Figure 2.** View of the well on the property of the Watson House.

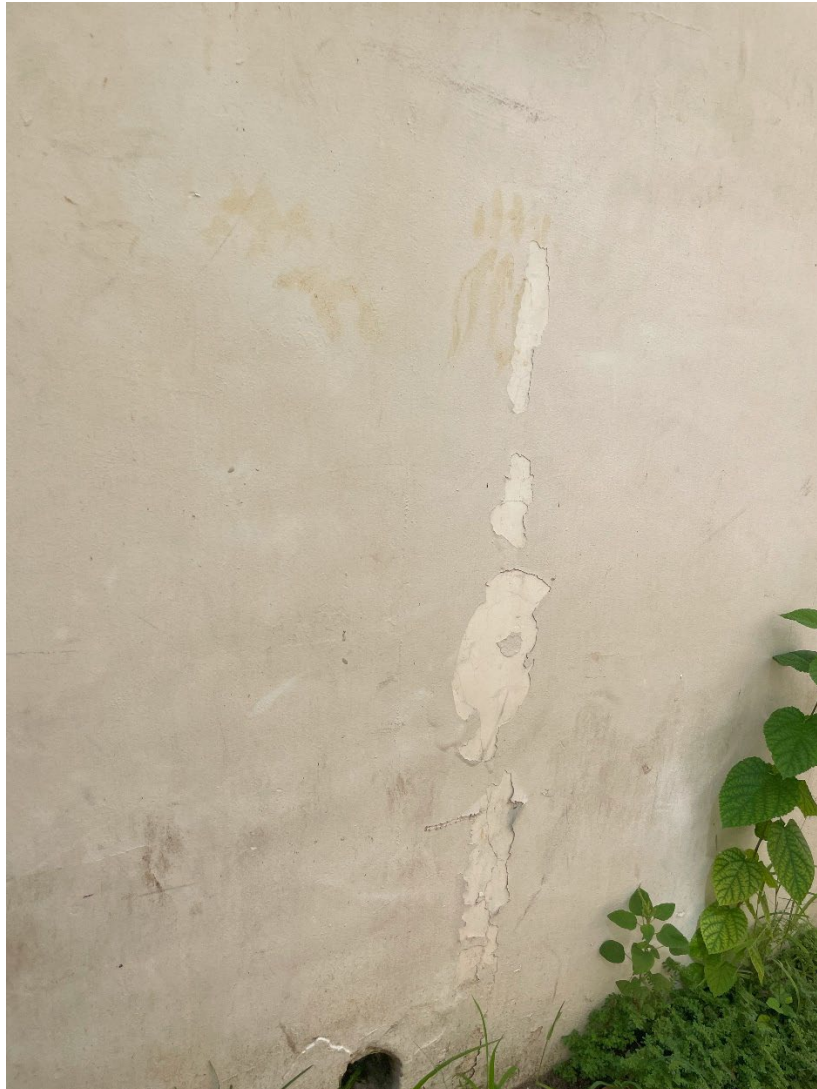
The condition of both the masonry fence and wooden fence on the property is good. It is apparent that the masonry wall in particular has been maintained with only minor signs of delamination (Figure 3). These areas are primarily on the street façade of the wall which receives light traffic. Additionally, the street is susceptible to flooding during storms which may stimulate weathering. All things considered, both the masonry and wooden fence appear to be devoid of any significant concerns.

**Figure 3.** View of the yard wall of the Watson House from Charlotte Street. Note the blistering and staining.

- Regularly inspect the wooden fence for rot, splitting, or damage and conduct general maintenance
- Regularly inspect the masonry yard wall for cracks, stains, or damage in the plaster or masonry and conduct general maintenance
- The blisters in the paint of the yard wall should be sanded and repainted

- Clean the exterior siding, foundation, and masonry wall with a light pressure wash or cleaning solution to remove the dirt, algae, and other residue
- Sand and repaint areas with blistered paint in the masonry wall

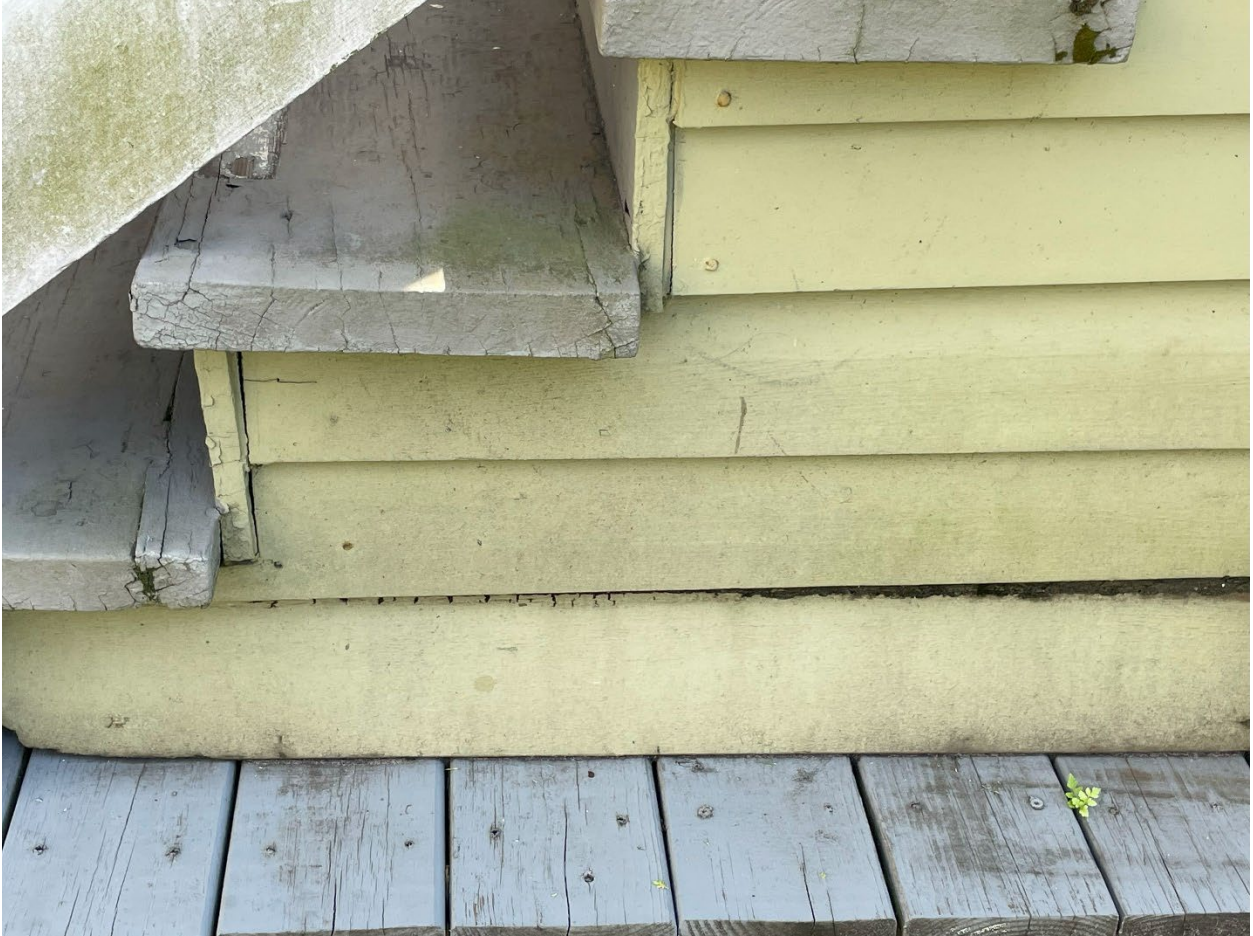
The wood siding of the Watson House is in good condition. Areas near the ground and within the porch appear to have the most deteriorated siding panels. In most cases, these boards are stained with dirt and algae as well as rust from weathered nails in some cases. Less common, though still present, are boards that are warped, which appear to have been caused by either water damage or stress. Such panels are primarily found on the porch. The majority of the siding, however, is in good condition. Aside from the aforementioned panels, the rest of the boards do not require any replacement, repair or repainting.

**Figure 4.** Low view of the exterior stairway on the porch of the Watson House. Note the condition of the steps, the siding, and the visible part of the railing.

- Routinely inspect the porch, especially the wooden posts, for structural stability and damage
- Replace warped, split, and rotten boards of wood siding with new treated and painted boards
- Clean, repair, and level the brick steps that lead up to the porch

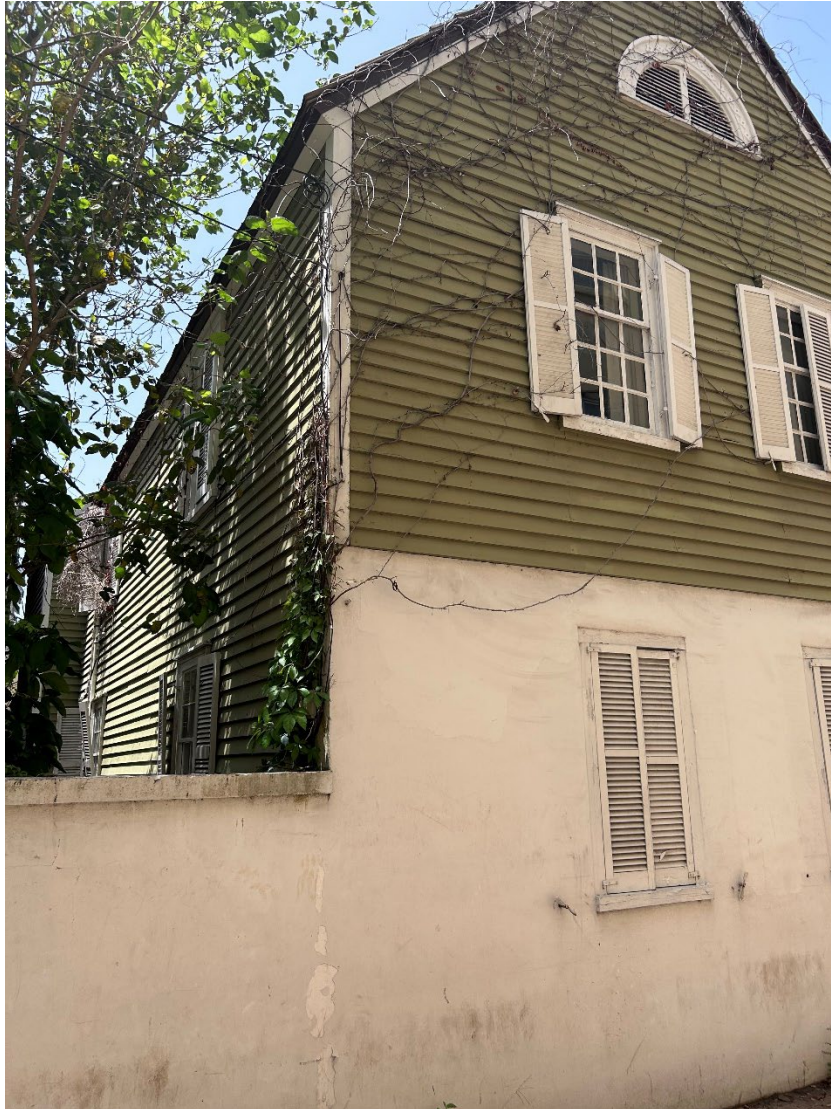
On both floors of the south façade and the second floor of the east facade, there are vines on the wood siding and windows (Figure 5). This vegetative growth has the potential to facilitate deterioration through moisture and can be a nuisance. The growth originates from the south alley behind the building which is unkempt. While the vines themselves are not of immediate concern, they are part of a larger landscaping issue between the south side of the Watson House and the neighboring building.

**Figure 5.** View of the east façade of the Watson House. Note the vines that begin in the southeast corner and run up the building to the exterior of the east side.

- Remove vegetation and detritus from around the foundation of the building, especially along the south side
- Remove the vines that extend from the south façade to the upper floor of the east façade
- Conduct routine maintenance and monitoring of the landscape and vegetation
