**The Watson House**

206 Charlotte Street, St. Augustine, Florida

HISTORIC STRUCTURE REPORT

Historic Preservation Program, DCP, University of Florida

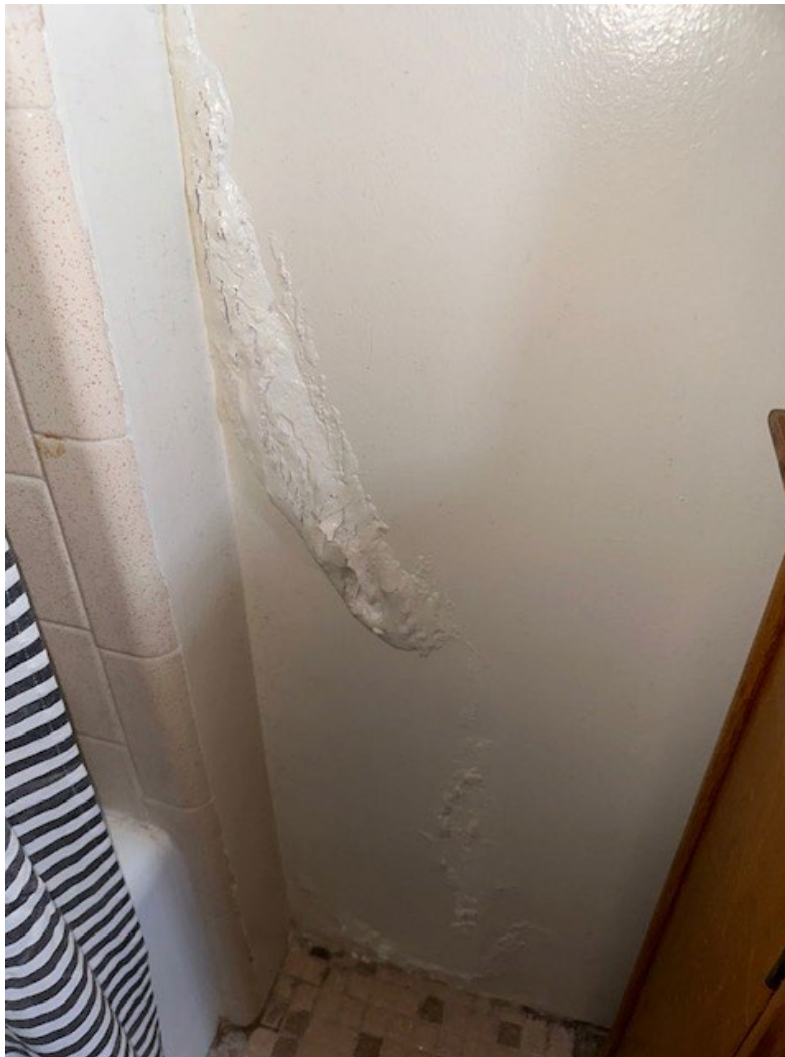
The paint on the interior is in good condition. Two rooms on the second floor appear to be the only areas inside the Watson House where the paint is deteriorating. The first is the bathroom where the paint appears to be blistering beside the shower (Figure 5). This is likely the result of moisture from the shower leaking and should be quickly addressed before more of the paint is affected. The living room is the other location with noteworthy deterioration of the paint. Above the fireplace is an area of approximately one square foot where the paint is cracking and peeling (Figure 6).

**Figure 6.** View of a blister in the wall of the second floor Bathroom. Note the proximity to the shower.

Two rooms of the Watson House's second floor interior have problems in need of treatment. First is the previously mentioned blister in the paint of the bathroom which requires further investigation. The second is a spot in the paint above the living room fireplace which is peeling. The repair of this patch is not an immediate concern. For further analysis and images, see the preceding "PAINT" section and Figures 5 & 6.

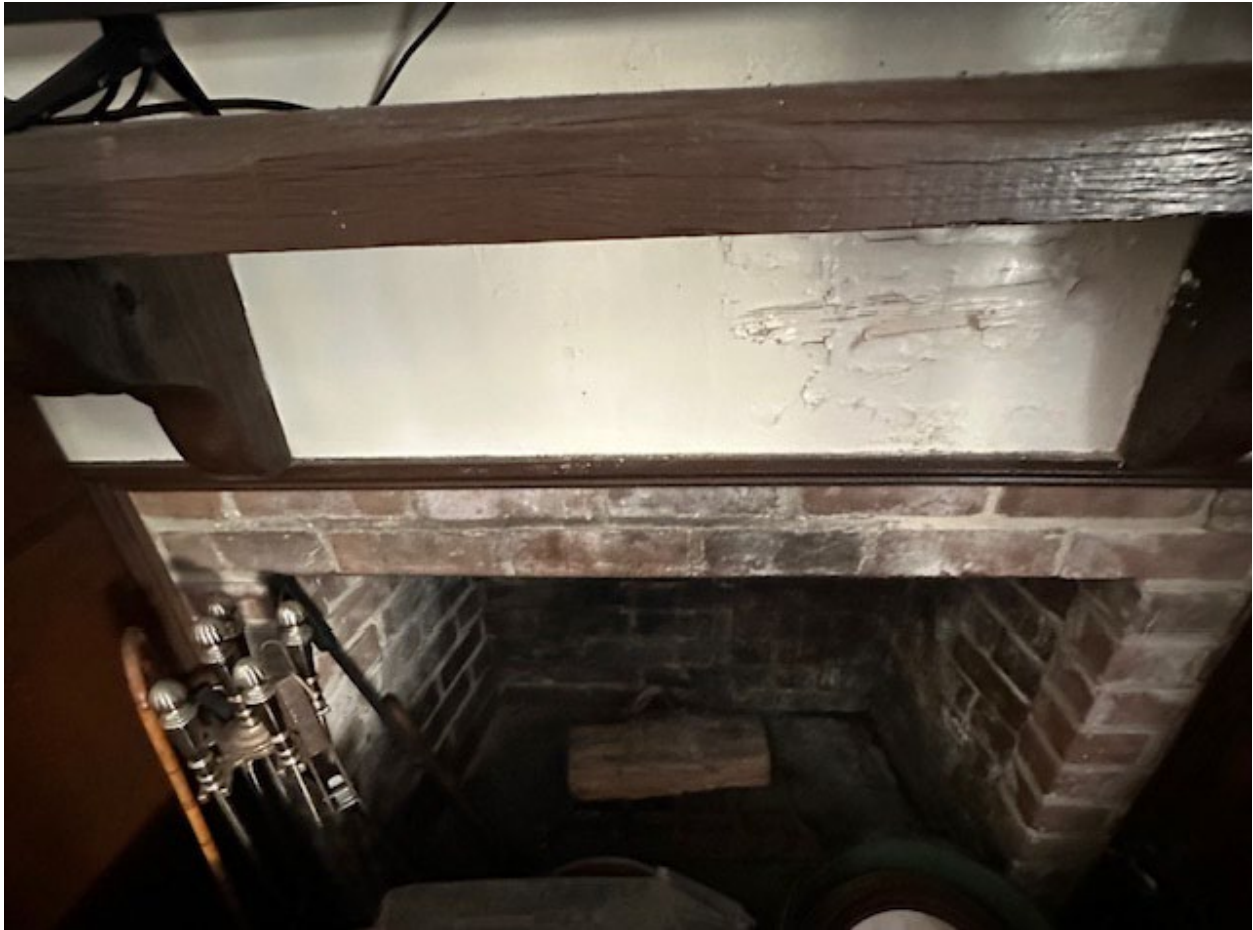
**Figure 7.** View of the fireplace in the second floor Living Room. Note the peeling paint below the mantel.

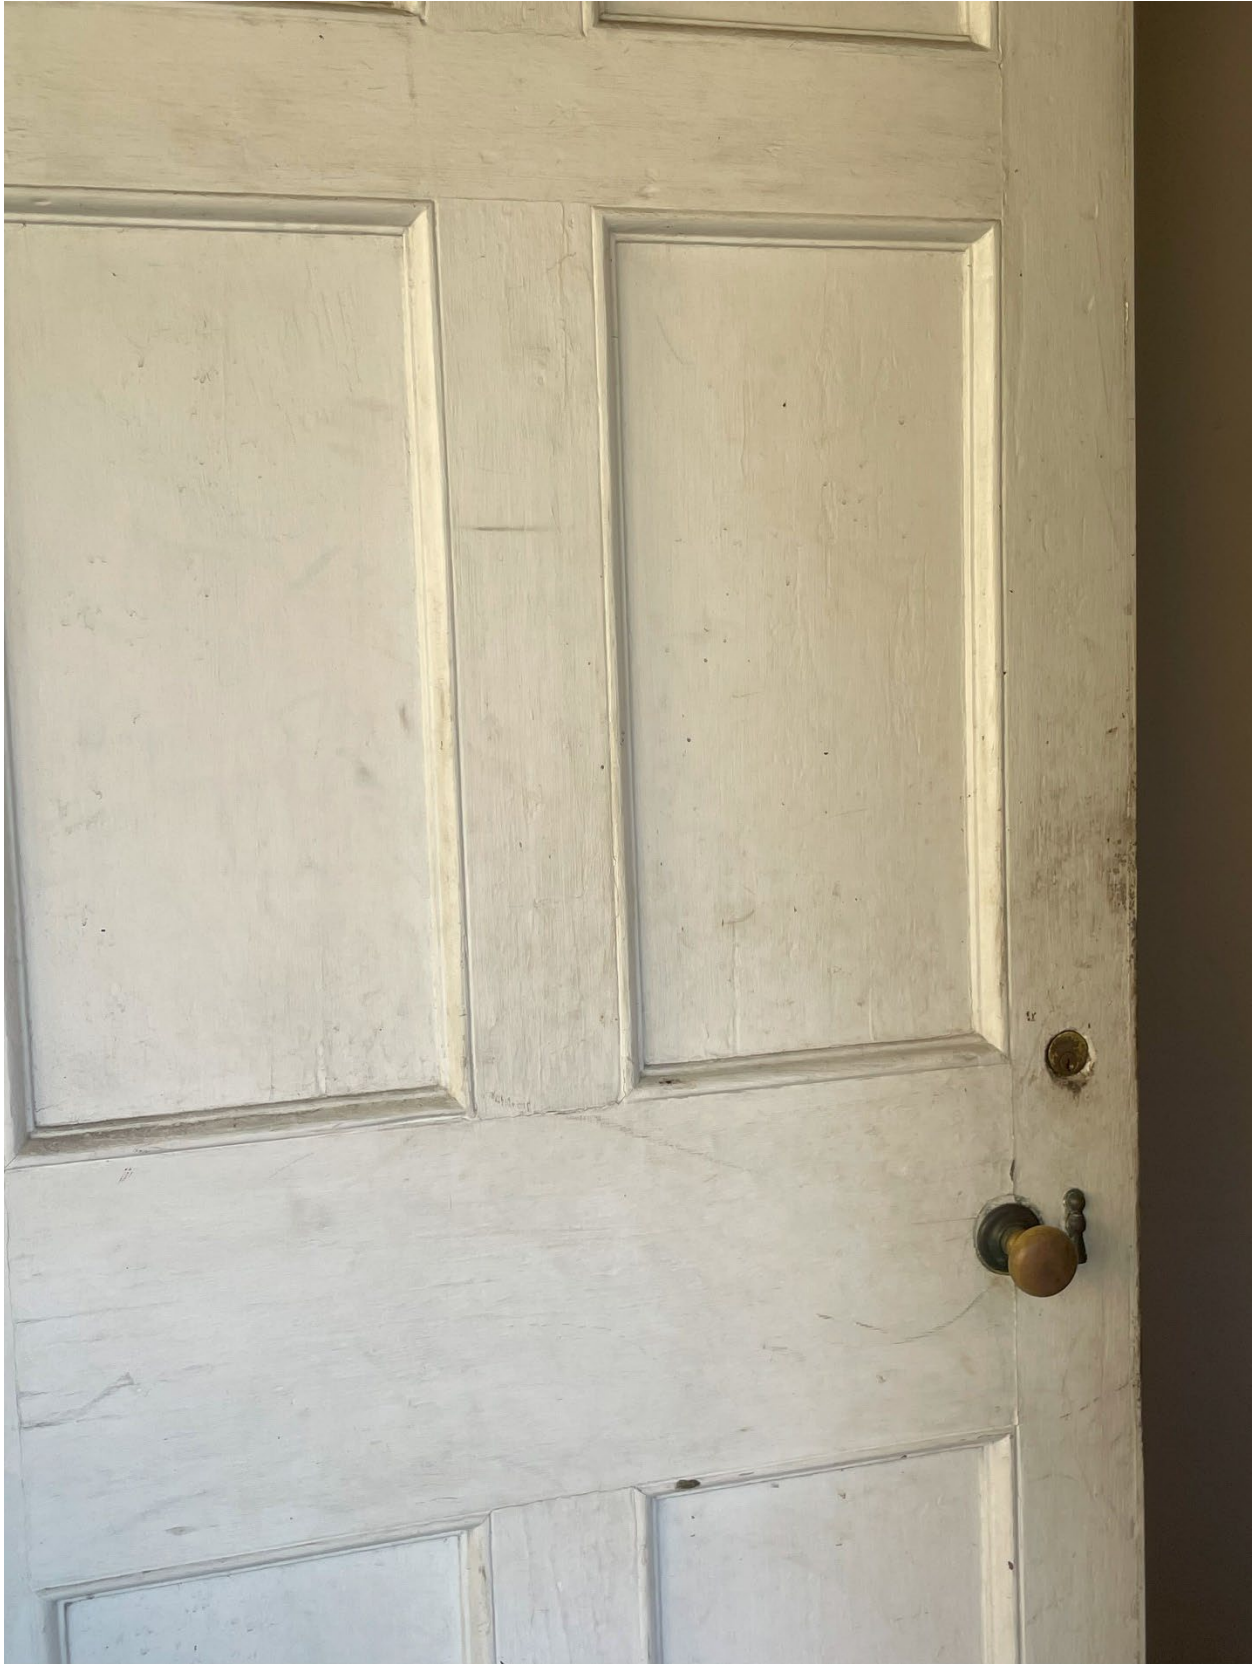
The doors and doorways of the Watson House are in excellent condition. The interior doors show little to no signs of damage, deterioration, or missing paint. The entryway doors on both the first and second floors have accumulated a moderate amount of staining and minor scratches on the exterior (Figure 7). None of the doors or frames of the Watson House require any immediate intervention.

**Figure 8.** View of the second floor Entrance door.

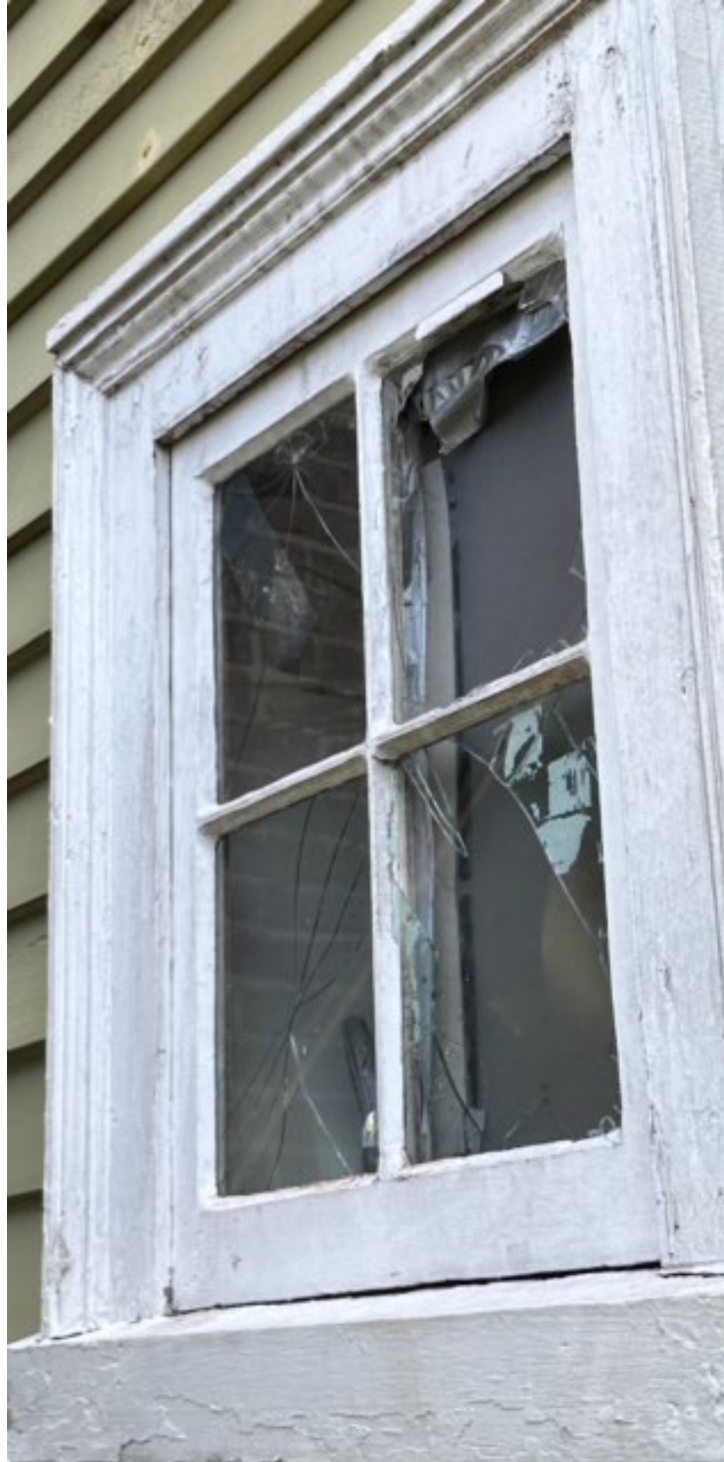
The glass panes of the windows are in good condition apart from a single window on the north façade on the ell of the first floor. The window is a fixed four-pane window of which every pane is broken (Figure 7). It appears that someone has attempted to cover the window from within, however, moisture and outside objects are not prevented from entering through the broken window. Furthermore, broken glass shards have yet to be removed from the panes, leaving the potential for injury. The repair of this window is of the highest priority.

**Figure 9.** View of the broken window on the first floor ell of the Watson House.

- Promptly repair the broken fixed four-pane window on the first floor ell. The replacement window should be in-kind with the other two windows on the ell with a wooden frame and four rectangular glass panes
- Inspect windows for damage after major weather events
- Consider implementing a form of protection against severe weather events
