THE JOANEDA HOUSE
57 Treasury Street, St. Augustine, Florida

HISTORIC STRUCTURE REPORT

Historic Preservation Program, DCP, University of Florida

2023

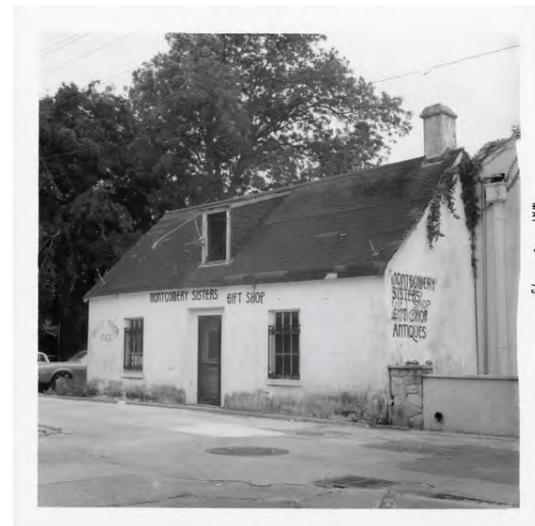
a secondary habitable area. Sometime by 1894, and perhaps as early as 1888, the central window on the north facade was changed into the principal entrance to the building. The former entry door from the south side was converted into a window. New access to the porch was provided by transforming the south window on the east facade into a doorway. Other late-nineteenth-century changes included: opening a window in the east facade's gable end, the repair and replacement of the window sashes, sills, and frames, and the possible rebuilding of the north dormer. The building underwent another change in the mid-1920s when the porch was enclosed and partitioned and a wood-frame, stuccoed wing was added to the south. Decorative metal grilles were installed to protect the windows (Figure 1). In 1971, the 1920s addition was demolished.

Figure 1 Joaneda House before restoration, ca. 1973

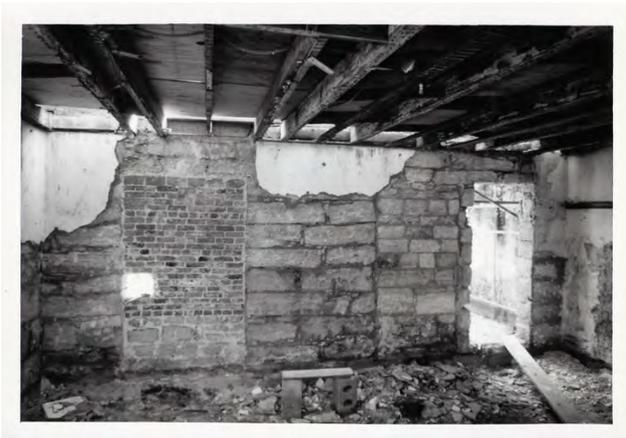
Figure 7 St. "Views of the Joaneda House Just Prior to Restoration Work," 1973.

Before the restoration, all masonry walls surrounding the original East and West rooms were sound, although some patching was required. The west wall of the South Room was sound. The south wall of the South Room was good; however, the architects suggested either installing a lintel over the door opening or filling in the opening to ensure structural integrity.⁴⁴ The east wall of the South Room required the replacement of cantilevered jamb stones above openings.⁴⁵ Removal of the plaster revealed original doorway between East and West rooms, completely sealed with coquina blocks and exhibiting a keystone lintel.⁴⁶ The architectural and archaeological evidence suggested that the doorway connecting West and South Rooms was present at the time of the building's construction (Figure 7).⁴⁷

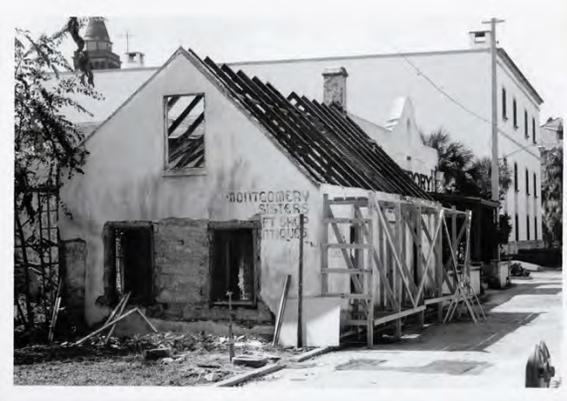
Figure 8 Restoration of Joaneda House from Treasury Street, Looking South. ca 1974. <https://ufdc.ufl.edu/USACH00110/00013/citation>.

Porch's roof.⁴⁸ The original Porch foundations excavated by archaeologists were sufficient to support a light shingled roof similar to the original.⁴⁹ Approximately 50% of attic floor joists and roof rafters deteriorated due to termites and/or rot near and at bearing masonry walls. Restoration architects suggested, if possible, reusing portions of members in good condition and those in poor condition replace with new or good used material spiced in. Otherwise, these members must be replaced (Figure 8).⁵⁰

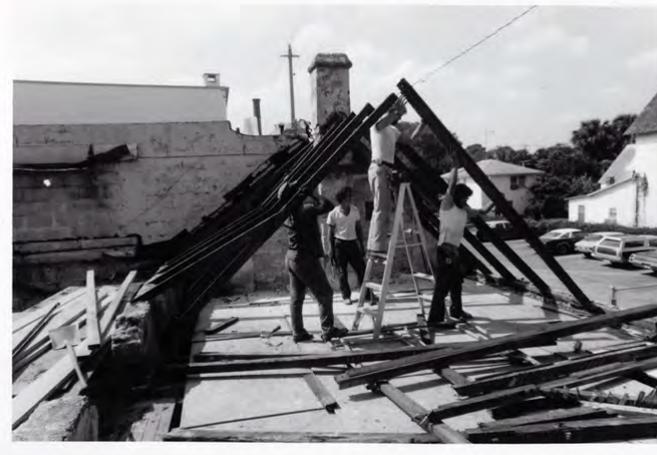
Figure 10 St. Augustine Restoration Inc. "Reconstructing the Roof of the Joaneda House," 1973. <https://ufdc.ufl.edu/USACH00415/00006/images/1>

According to the restoration architect, most of the original materials, extant from the original construction, were retained. However, the major problem was encountered in the roof, where previous repairs and deterioration had left only a few of the original rafters, or parts of the rafters, in sound condition. These were carefully salvaged and spliced where necessary into new rafters with epoxy adhesives. New materials were identified and recorded for the benefit of future architectural researchers (Figure 10).⁵⁵

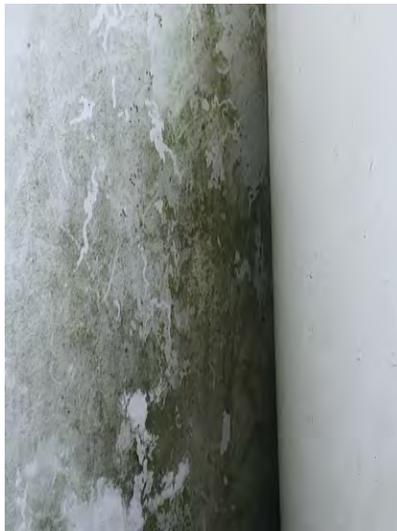
C: West façade, looking SE

Stucco and Paint: The painted stucco, that covers the building's exterior walls, is in fair condition (A). The stucco is chipping and thin cracks are located on exterior walls. Paint is peeling on facades, that were available for inspection during the field work (B). There are stains caused by mold on all of building's exterior walls (C).

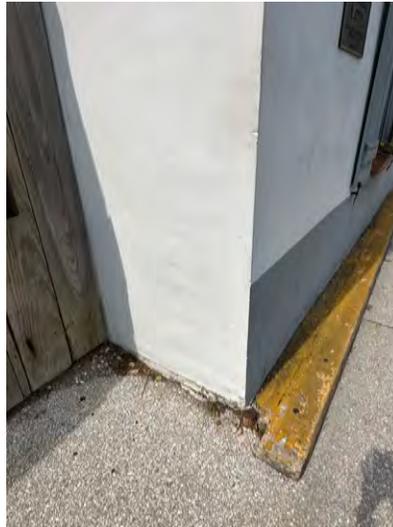
D: North façade, looking SW

Curb: The curb, that extends along building's north façade, is in poor condition (D).

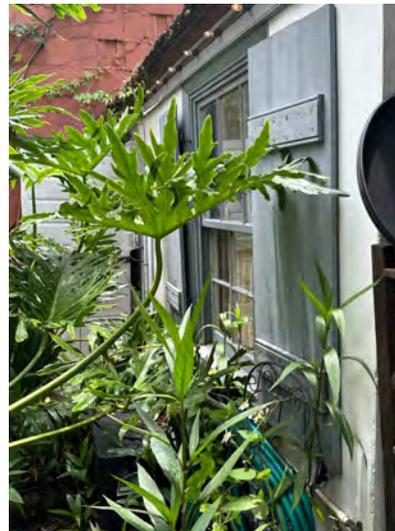
E: South façade, looking NW

Landscape: The landscaped areas of the Joaneda House's courtyard are in good condition. However, the plants that are located close to the building's exterior walls are causing damage (E).

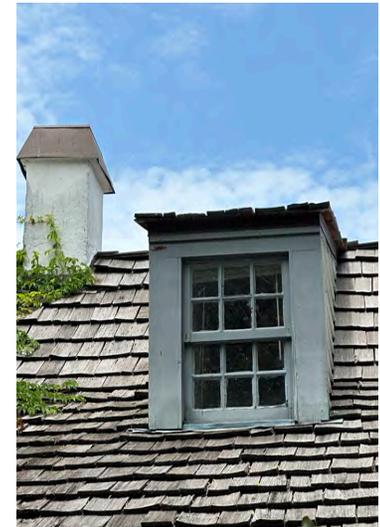
F: Roof, S side, looking N

Roof: The cedar shakes are in fair condition, especially on the north slope of the gable roof (F).

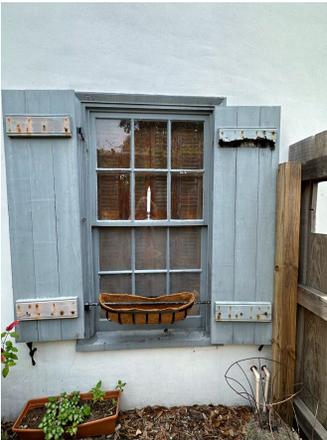
G: East facade, looking W

Windows: Most of the buildings windows are in poor condition (G).

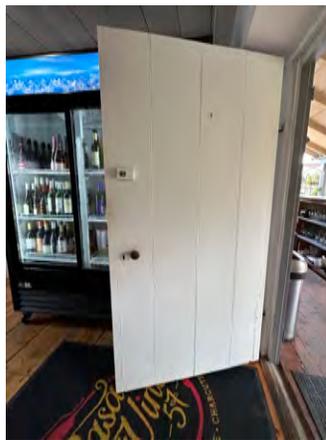
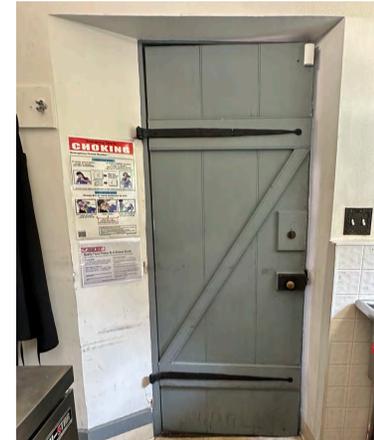
Doors: Most of the doors are in good condition (H, J).

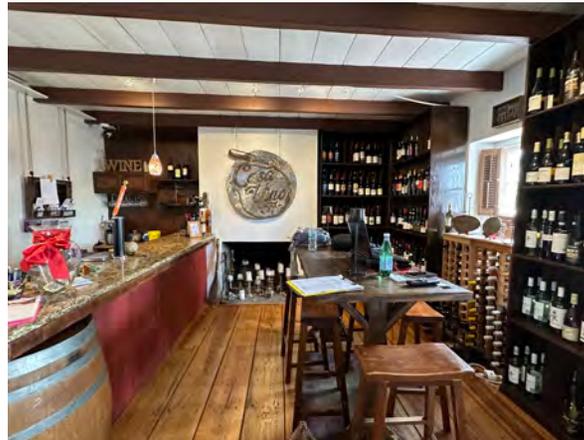
I: West Room, looking W

Interior: In general, the interior of the Joaneda House is in good condition. No major areas of concern are noted on either the ground floor or on the upper level. However, the equipment, such as wine shelves, bar, and storage shelves impeded the inspection of the condition of interior plaster (I).

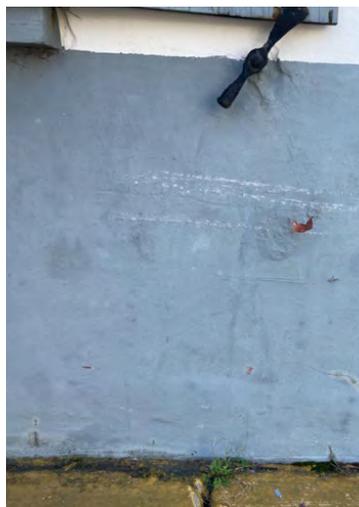
B: North façade, looking N

At the north-east corner of the building, where the wall meets the ground, there is damaged stucco (B). Similar damage is visible on the buildings northwest corner (C).

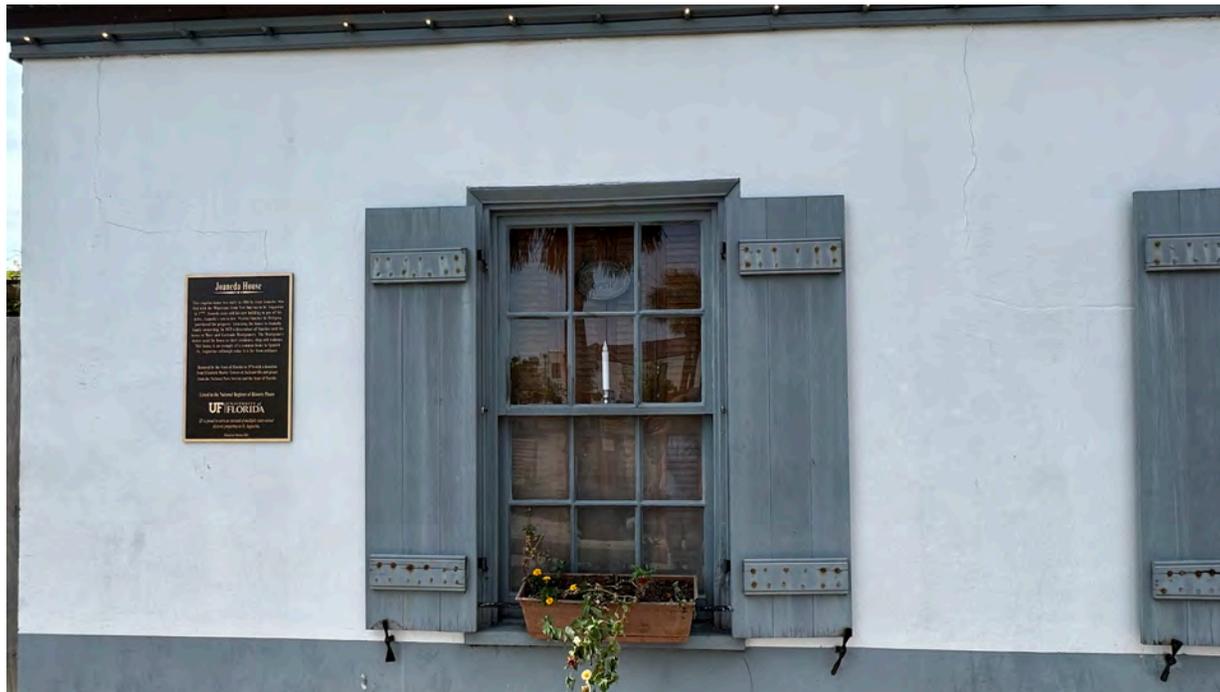
A: North façade, looking S

The painted stucco, that covers the building's north facade, is in fair condition. Two vertical cracks, joined by a horizontal crack, are located on north facades easternmost section (A) .

A vertical crack is located between the central and easternmost windows

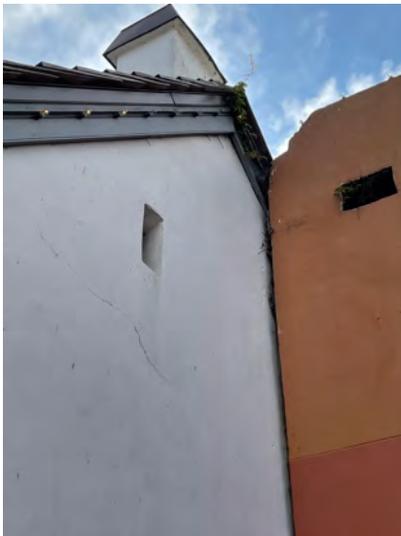
A: West facade, looking SE and up

A vertical crack is located on west façade’s northernmost section (A), and diagonal crack runs across the façade (B).

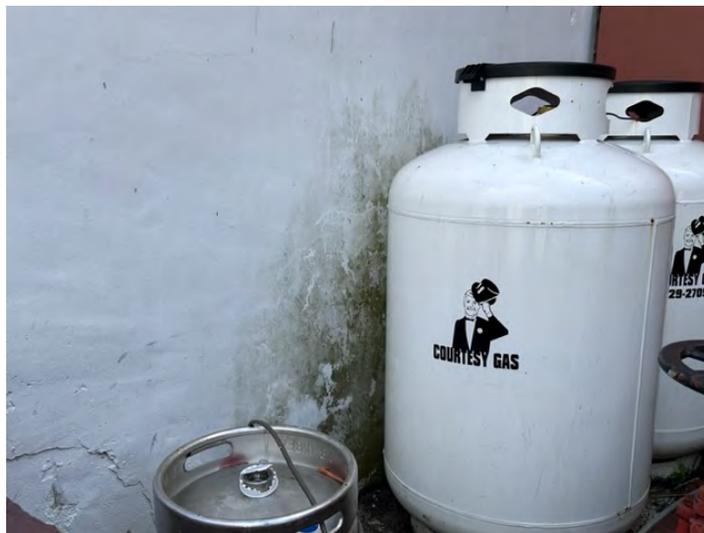
A: West facade, looking SE

The mold is forming at the intersection of West façade with neighboring building's wall and behind the gas tanks (A).

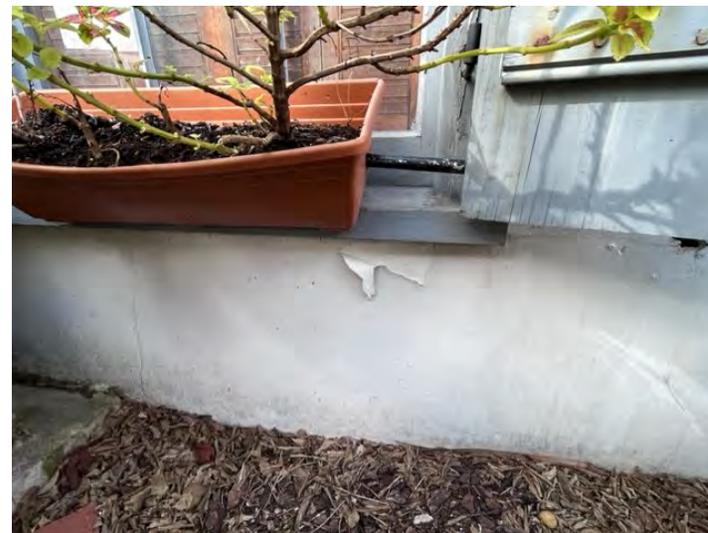
B: East facade, looking SW

The mold is visible on the East façade, underneath the windows and along the lowest section of the facade (B).

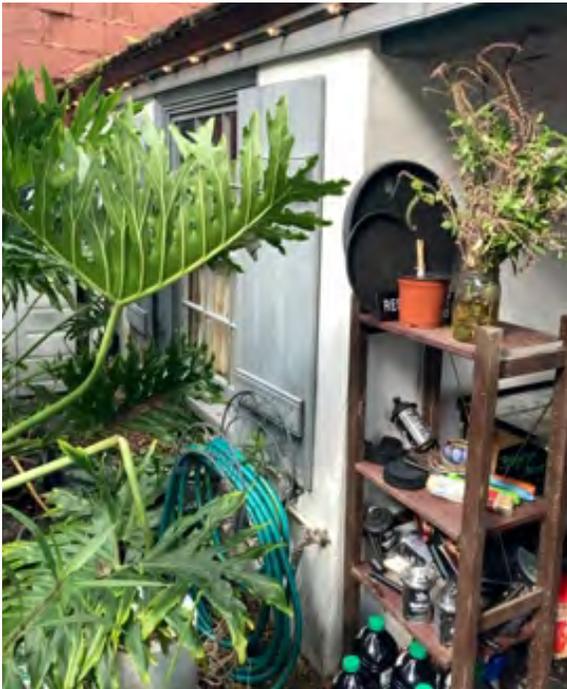
A: South façade, looking NW

The mold is visible on the South façade, underneath the windows (A) and along the lowest section of the exterior walls (B).

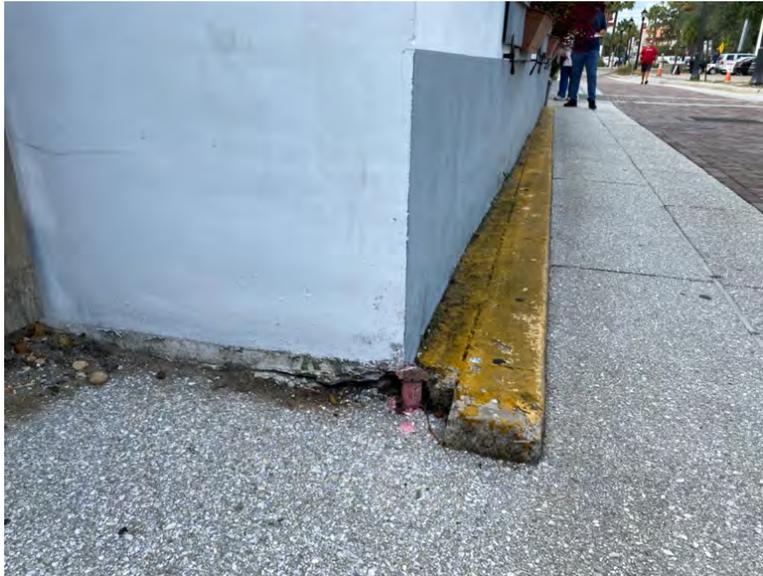
A: North façade, looking W and down

The yellow painted concrete curb along the building's north façade existed prior to the restoration. Currently, the westernmost part and the easternmost part of the curb are in poor condition (A; B).

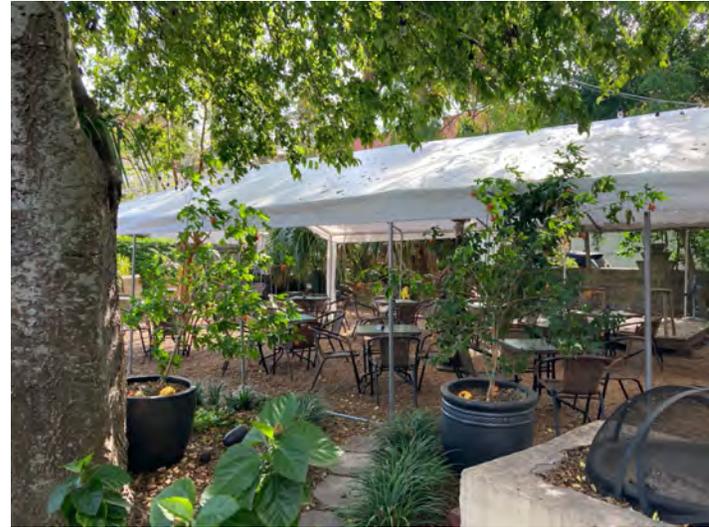
A: East façade, looking NW

While the landscaped areas of the Joaneda House's courtyard are in good condition (A), the plants that are located close to the building's exterior walls are causing damage (B). The plants, that grow underneath the window on the South façade, is damaging the wall and windowsill (B, C).

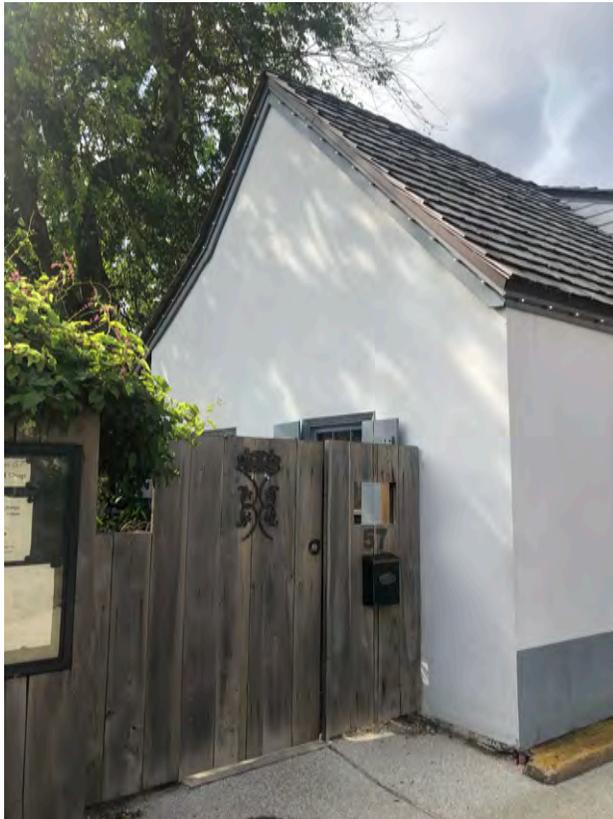
A: Roof, S slope, looking SW

The cedar shakes are in fair condition, especially on the north slope of the gable roof (A, B).

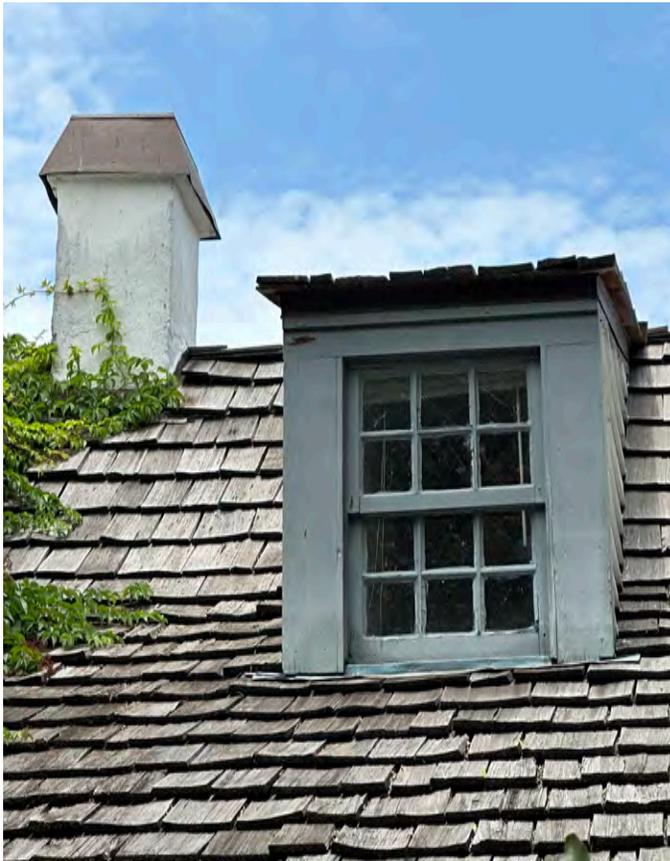
A: Roof, S slope, looking N and up

However, shakes are beginning to split and cup, especially on the south slope (B). Shakes also exhibit biological growth on the surface (C).

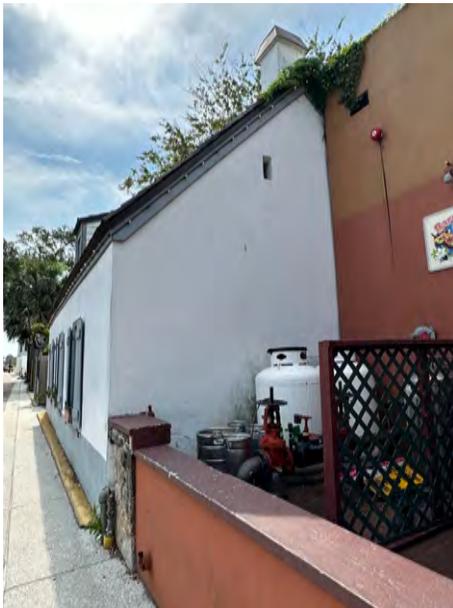
A: West façade, looking SE and up

There is a “V” shaped gap between the Joaneda House and the building, located to the on the west. It has accumulated debris, and vegetation is growing out of the space (A).

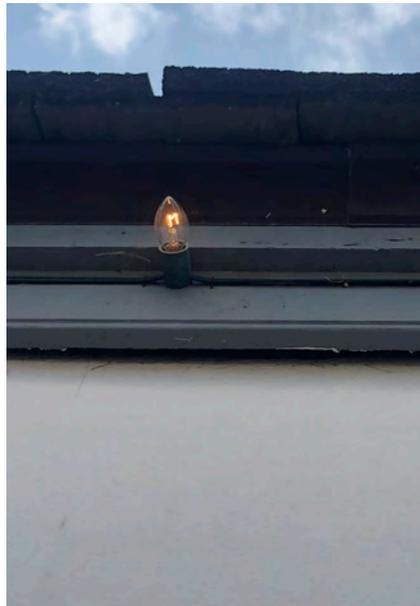
B: North façade, looking S and up

There is approximately 1” gap located between the beaded fascia and wall on all four facades of the Joaneda House and the building’s walls (E). The fascia is fastened with nails that are rusting and causing damage to the wood (D).

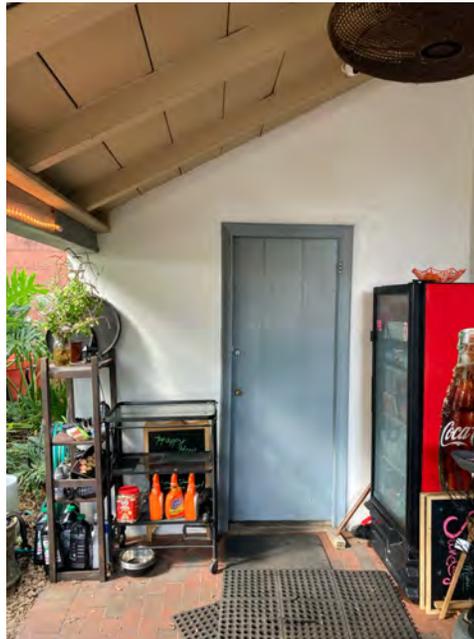
The plank ceiling above the Porch is overall in good condition with cracks in some of the wood planks ceiling deck boards (A, B).

B: Porch, ceiling, looking W

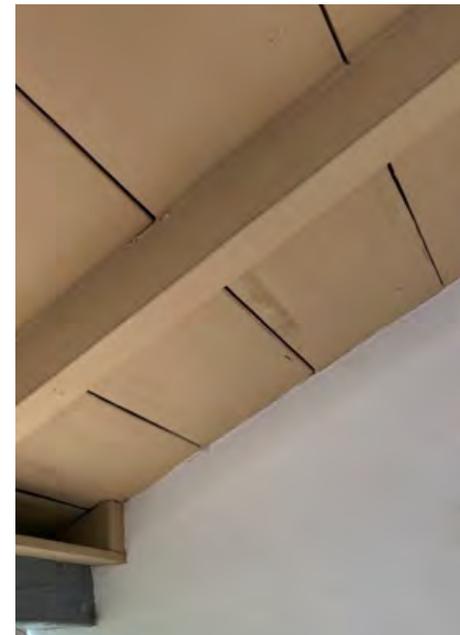
The paint is starting to peel on several planks (C).

C: Porch, ceiling, looking SW and up

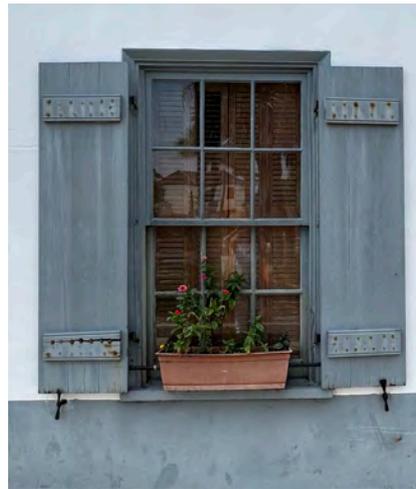
The shutters and window frames of windows 1W1, 1W2, and 1W3 are in poor condition (A, B, C).

B: Window 1W2, looking N

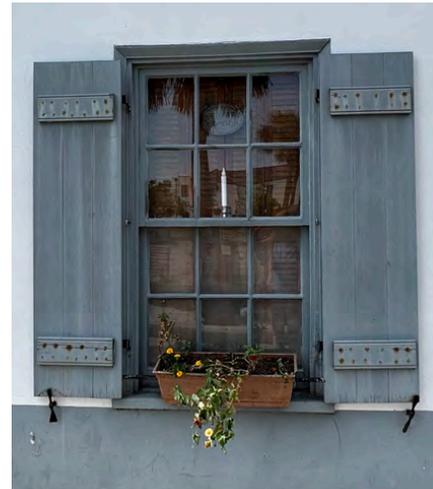
C: Window 1W3, looking N

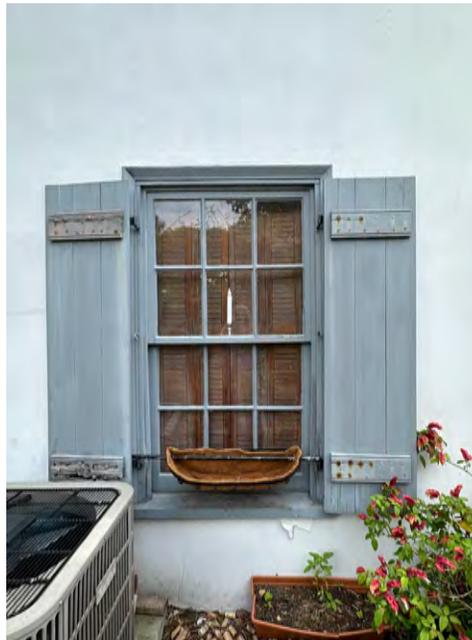
The shutters and window frames of windows 1E1 and 1E2 are in poor condition (A; B).

B: Window 1E2, looking N

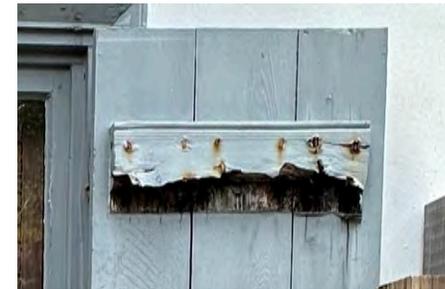
The wood shutters are rotting. The nails and hinges, are rusting and expanding, contributing to the deterioration of shutters (C).

C: Window 1E1 shutter, looking W

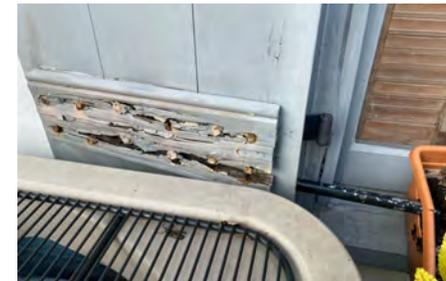
The metal rods, that hold flower boxes, are inserted between the window jambs, and are aggravating the condition (D).

D: Window 1E2, shutter, looking SW and down

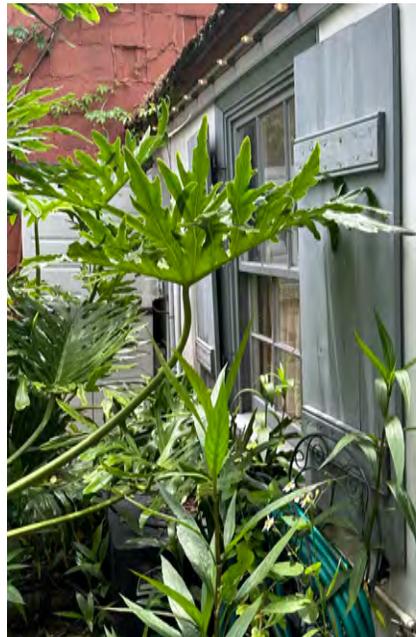
The shutters and window frames of window 1S2 are in poor condition. The wood shutters are rotting. The plants that grow beneath the window retain moisture against the wall and are aggravating the condition (B). The nails and hinges are rusting and expanding, and are contributing to the deterioration of shutters (C). There is a crack in one of the panes of window 1S2 (D).

B: Window 1S2, looking NW

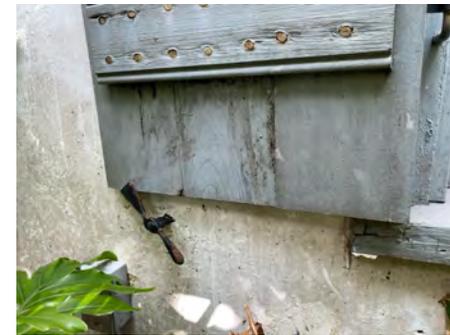
C: Window 1S2, shutter, looking NW

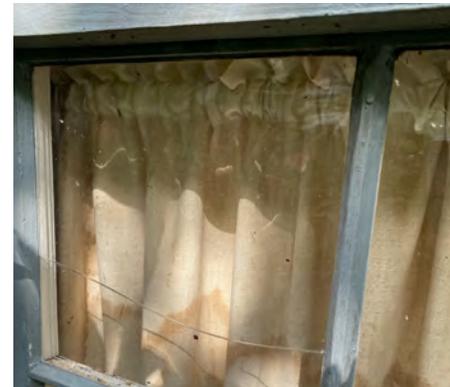
D: Window 1S2, pane, looking NW

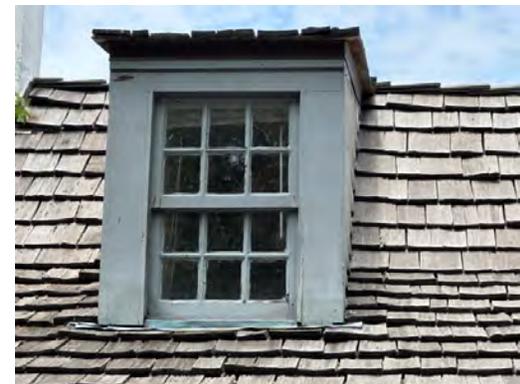
The windows 2S1 and 2S2 are located in the dormers and are in fair condition. The two south dormers have the bottom sash rails set directly onto the copper sill flashing. The bottoms of the vertical stiles of the frames exhibit splits in the wood grain and moisture damage where they intersect with the sill flashing and roof shingles (B, C). The paint on the frames is chipping (D).

C: Window 2N3, looking N and up

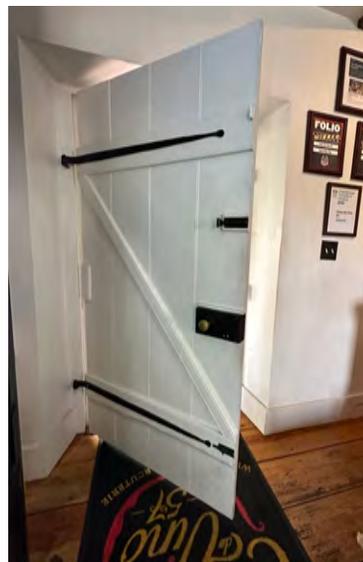
The two exterior entry doors, D1 and D2, are in good condition (A, C). The main entry door (D1) appears to be recently painted (B).

B: West Room, door D1, looking SE

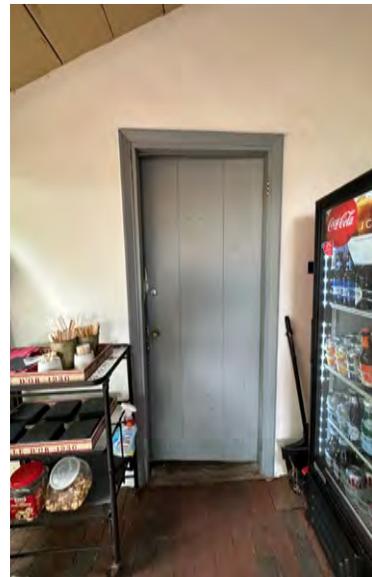
C: South Room, door D2, looking W

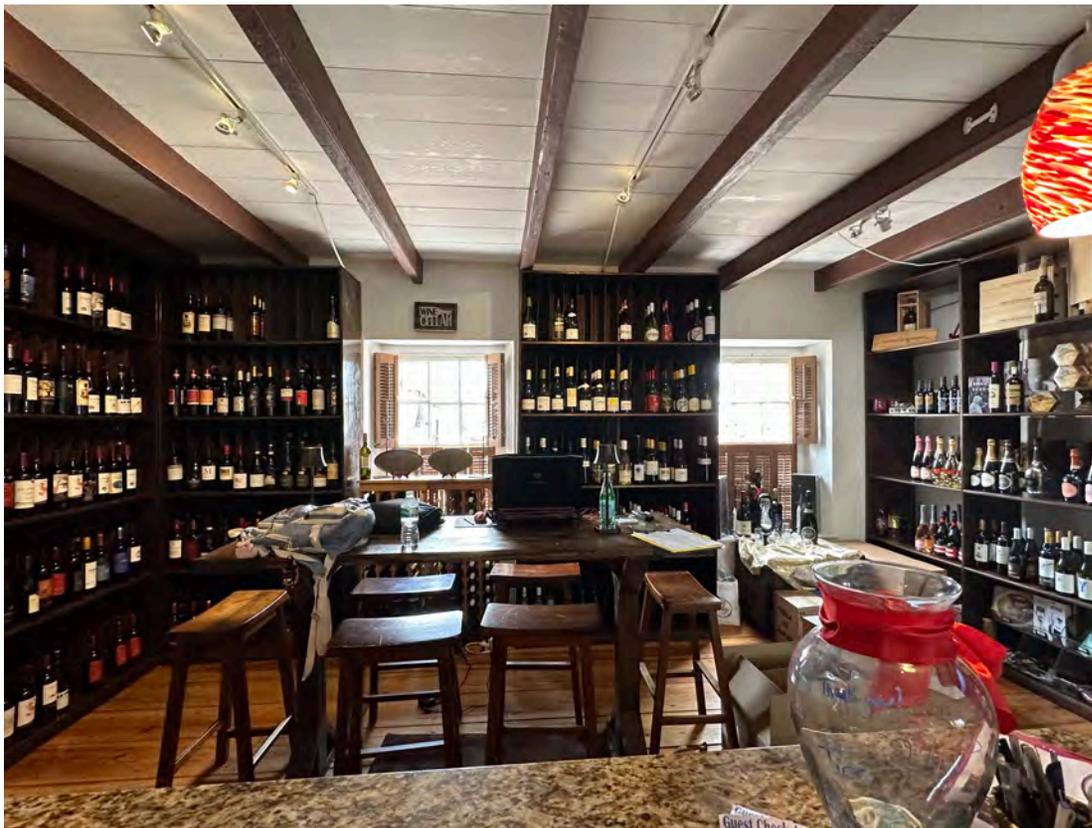
In general, the interior of the Joaneda House is in good condition. No major areas of concern are noted on either the ground floor or on the upper level. However, the equipment, such as wine shelves, bar, and storage shelves impeded the inspection of the condition of interior plaster (A). Several spots of plaster and paint damage were noted in the South Room (B).

A: West Room, looking N

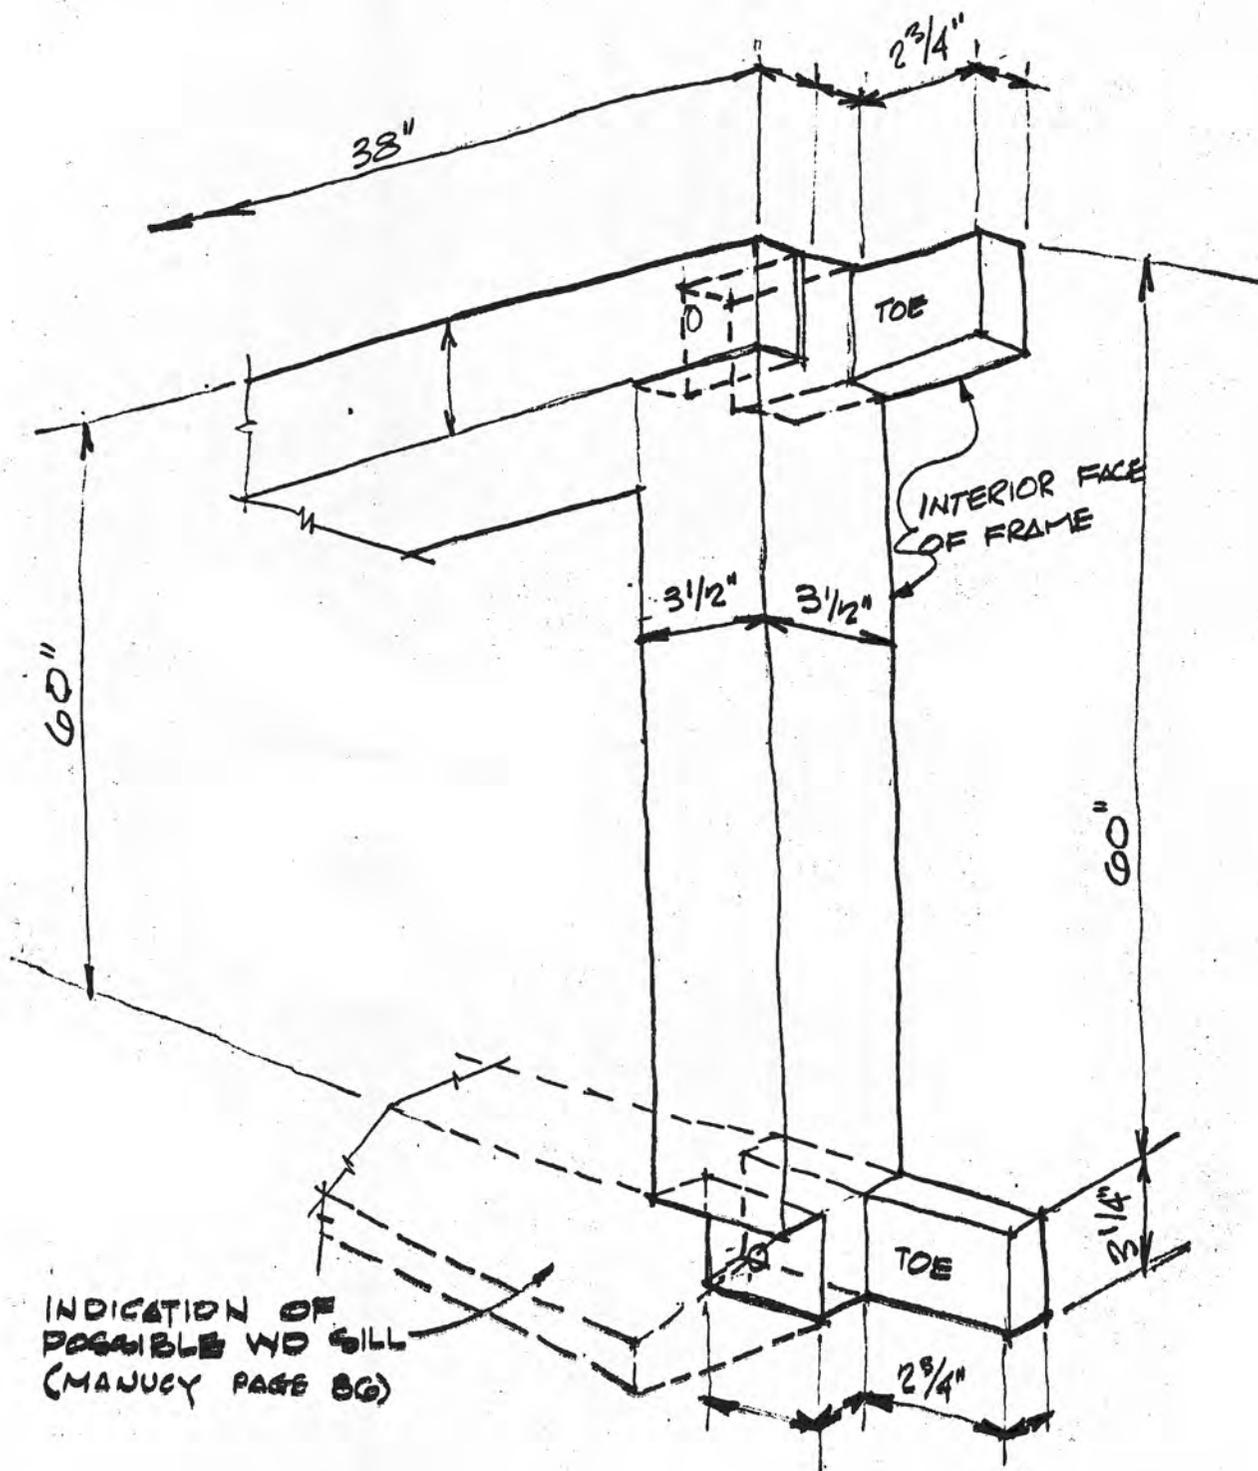
DETAIL OF FRAME - WINDOW NO 1
NOT TO SCALE

- 1) THE SILL DOTTED IN ABOVE IS SHOWN SIMILAR TO THE HOUSES OF ST. AUGUSTINE. HOWEVER THERE ARE INDICATIONS OF A FULL SILL THAT PASSED THE INTERIOR FACE OF PLASTER FINISH. SEE RELATED WALL SKETCH.
- 2) 1, 2, 3, 7 SIMILAR TYPE OF DETAIL INDICATED. HOWEVER WINDOW SILL MEMBERS HAD BEEN CUT OFF @ REPLACEMENT OF WOOD SILL W/ BRICK SILL.
- 3) INVESTIGATION OF WINDOW NO 2 @ SILL SHOWED EVIDENCE OF A WOOD SILL, & REMAINS OF TOE & JAMB AS SHOWN ABOVE.
