# **THE DEMESA-SANCHEZ HOUSE**

43 St. George St. Augustine, Florida

## **HISTORIC STRUCTURE REPORT**

Historic Preservation Program, DCP, University of Florida

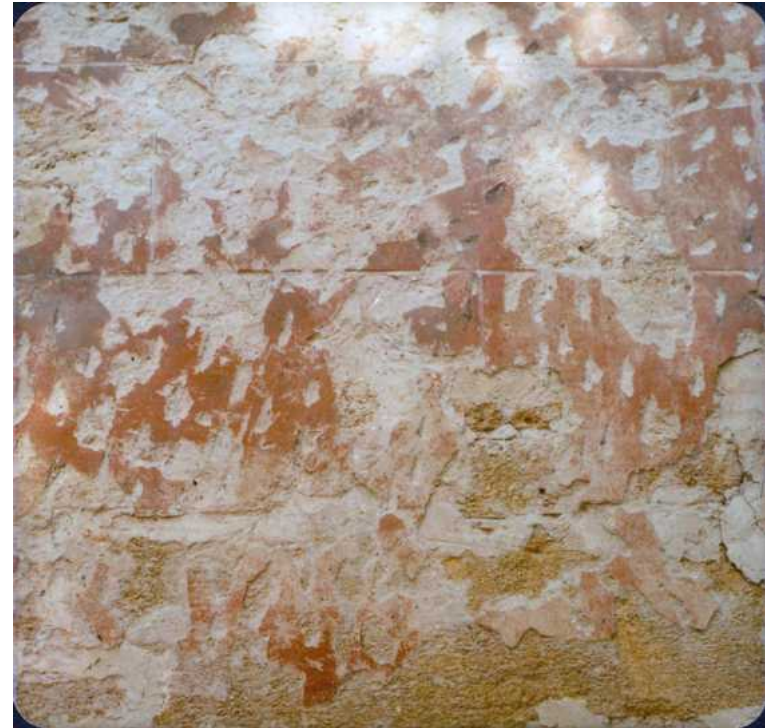
Figure 2 Stucco on East Façade of DeMesa-Sanchez House, 1979. <https://ufdc.ufl.edu/USACH00421/00020/citation>

At the September 10, 1980, meeting, Dr. Gannon displayed a color chip based on research conducted by Welsh, and the board voted to paint the house based on the investigation (fig. 2).<sup>6</sup> At the board meeting, H. Shepard admitted: "I am sure that it's the ashlar finish that will create much more uneasiness to the public and to the

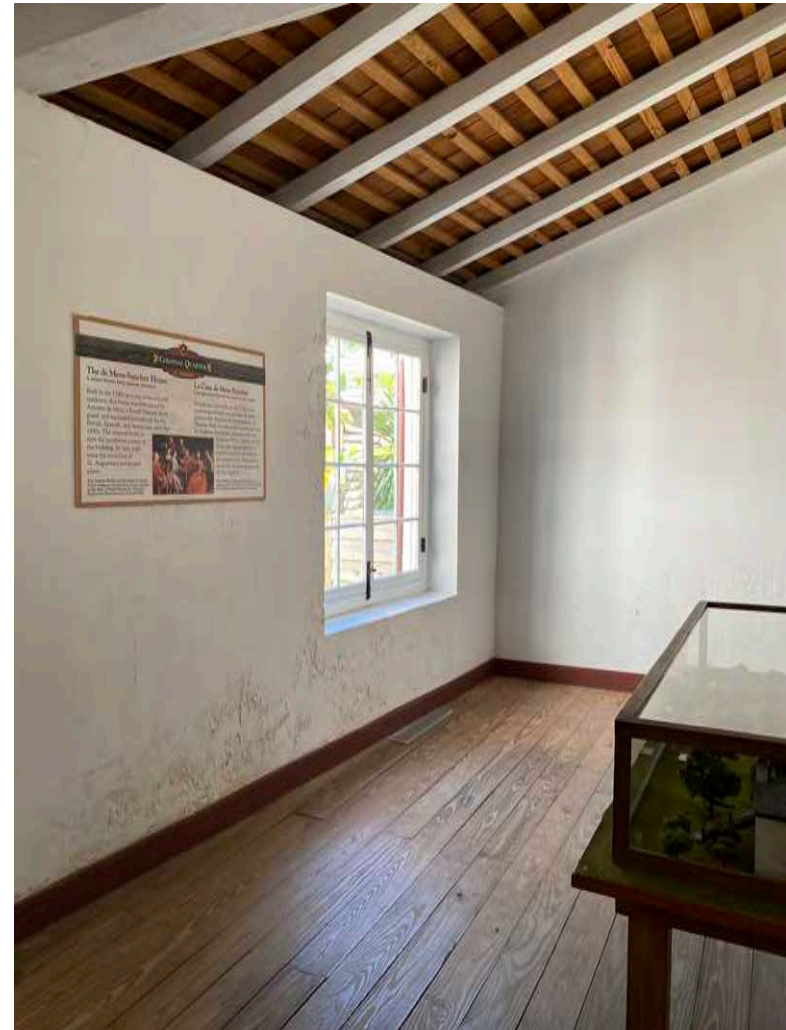
In the Fall of 2020, the UF HP Program research team and representatives of Sarah Ryan Architects, Inc. performed research on the condition of the DeMesa-Sanchez House to prepare the 2021 publication "Flood Mitigation Design Guidance for Historic Coquina Buildings." Researchers emphasized that while DeMesa-Sanchez House experienced minor flooding effects in pre-2021 storm events, heavy localized rain poses a periodic concern. The building is air-conditioned, but not enough to cause vapor drive or condensation problems.<sup>14</sup> However, the air conditioning's unique underfloor distribution system provides a potential pathway for water infiltration. The site is not walled and is open to adjacent properties. Of the three ground-floor door openings, the one on the West Wing's west façade has the highest threshold height, with the others are almost at grade level. The first floor suffers from rising damp issues in areas with minimal roof overhangs, and the floor of the kitchen addition is at grade level.<sup>15</sup>

*DeMesa- Sanchez House, Room 104, east wall, looking SE, 2020. Photo: Sarah Ryan*

Researchers acknowledged that the DeMesa-Sanchez House should be protected against future water damage. They suggest the protection by temporary measures, including removable pressure-fit floodgates at the three doorways. Installing a sump and pump to remove water infiltrating the air condition system would be helpful if the underground floor distribution system is inundated in future flooding events.<sup>16</sup>

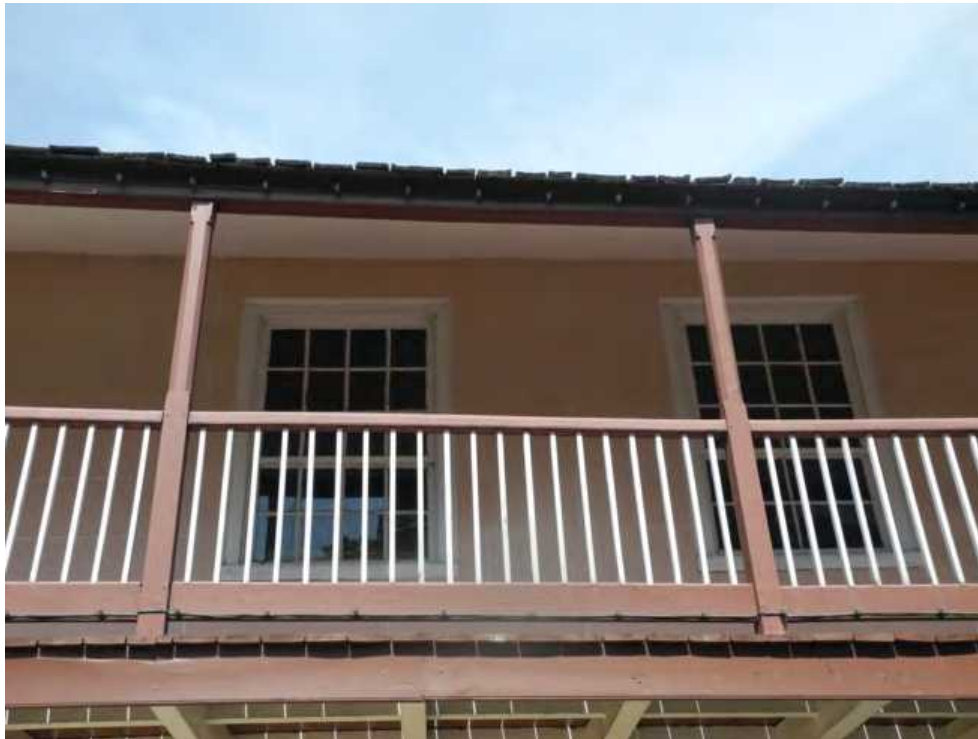
A: West Wing, balcony, looking E and up

The balcony, sheltered by a shed roof, extends along the West Wing's west facade. The roof is supported by chamfered wood posts. The balcony, except for the square balusters, is painted dark brown. The balusters are painted white (A).

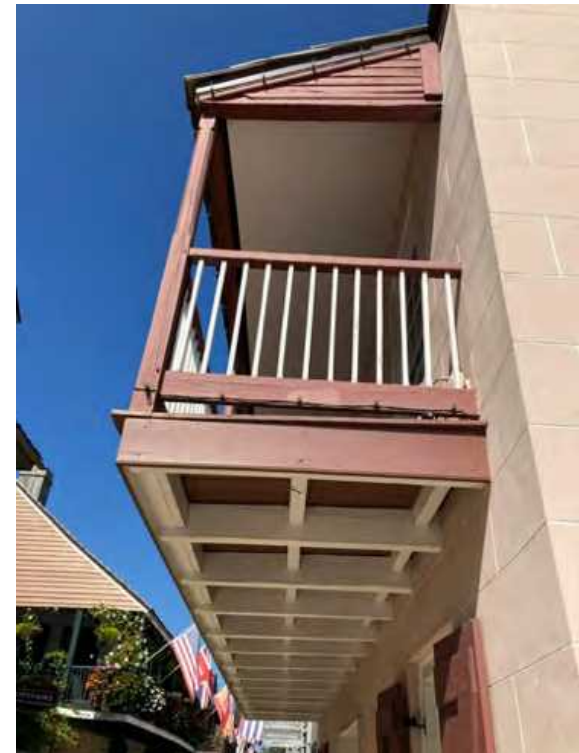
B: West Wing, balcony, looking N and up

The soffit boards under the roof are painted white. The entire balcony, including the balusters and posts, was installed during the 1980s restoration (B).

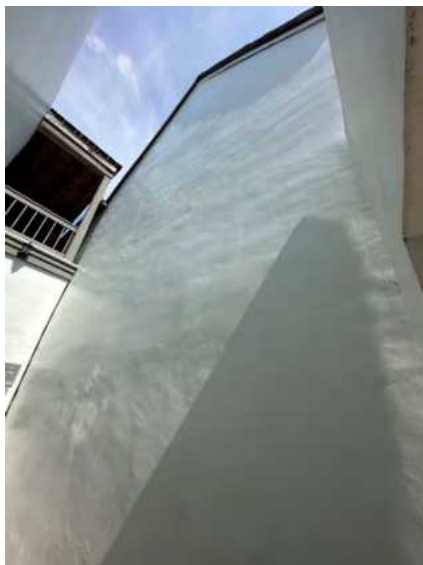
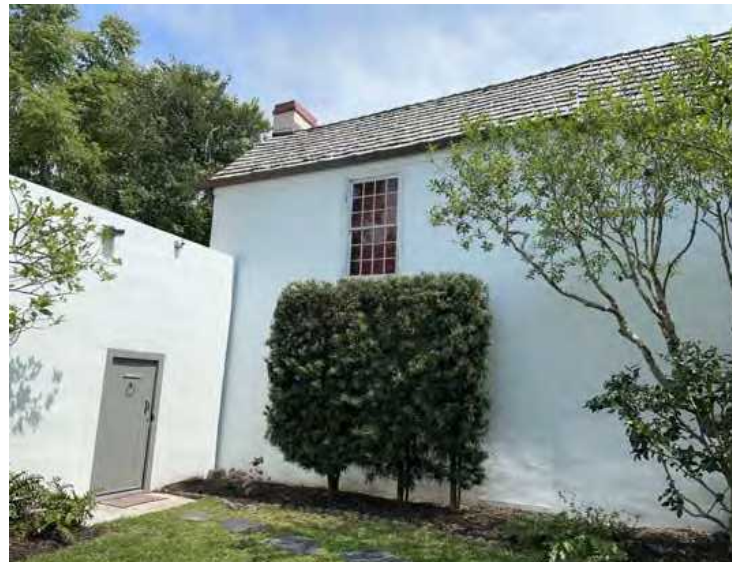
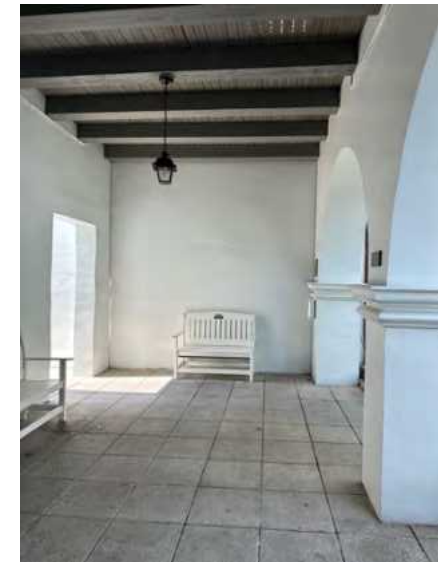
As part of the work of the 1980 restoration, the building was returned to the Territorial Period appearance. These alterations included the enclosure of three windows on the north facade's first level and two window openings on the second level. There are ghost marks visible on the façade where these openings existed (A; B, C).

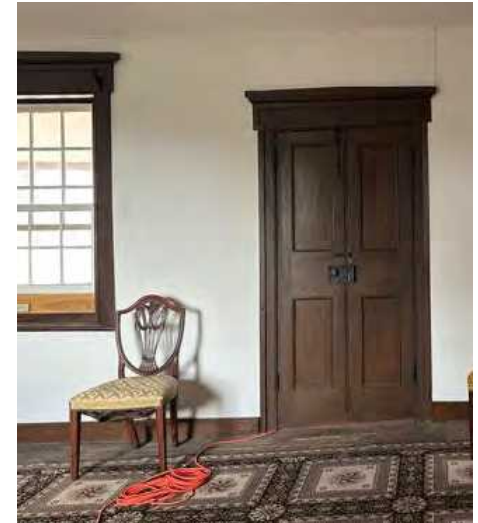
*A: Room 101, looking N*

**Electrical System.** Restoration architect H. Shepard specified that no electrical equipment should be visible after finishing the restoration project. Portable extension cords and power strips are used to provide electricity to interior and exterior spaces (A).

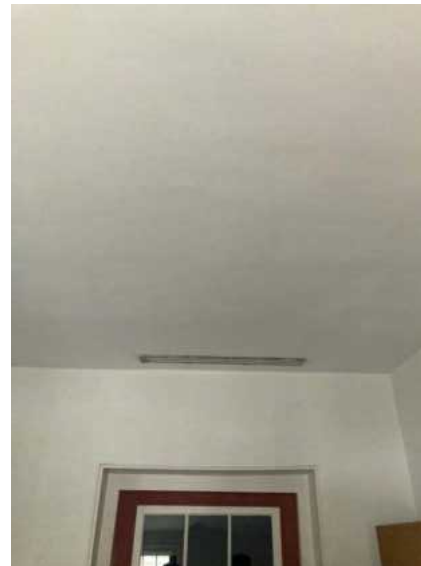
*C: Room 204, looking N and up*

**Air-conditioning and Heating.** A partition wall was constructed east of the original wall between rooms 106 and 108 to accommodate air-conditioning equipment. At the first floor level, air-conditioning and heating ducts were installed under the floor during restoration (B). On the second level, air-conditioning ducts are located above the ceilings (C).

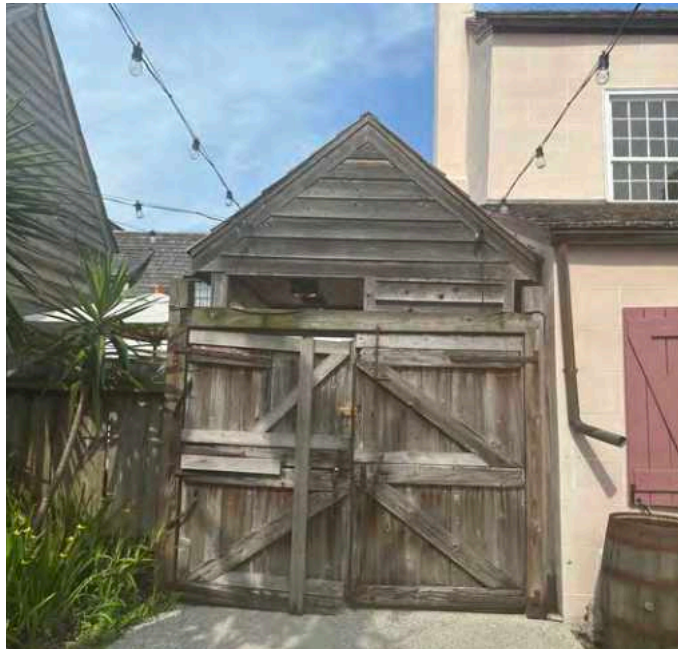
The white-painted, low wood picket fence and gate, placed along St George Street between the Colonial Quarter sign and post and the southwest corner of the west wing are in fair to good condition. Plants at the southwest corner of the west wing are in contact with the building walls, potentially trapping moisture.

The wood ticket booth and taller wood fence set back from the west property line are in fair condition. The south gate into the courtyard is sagging from the hinges. The placement of the ticket booth's north wall against the house west wing's south stucco wall may contribute to moisture damage in this location.

*A: West Wing, S facade, looking NE*

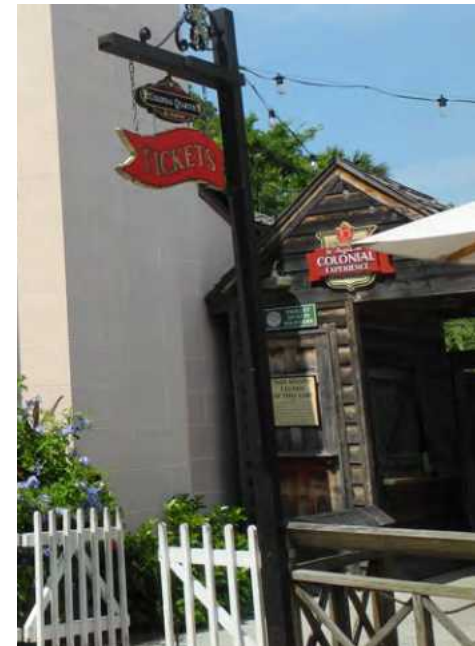
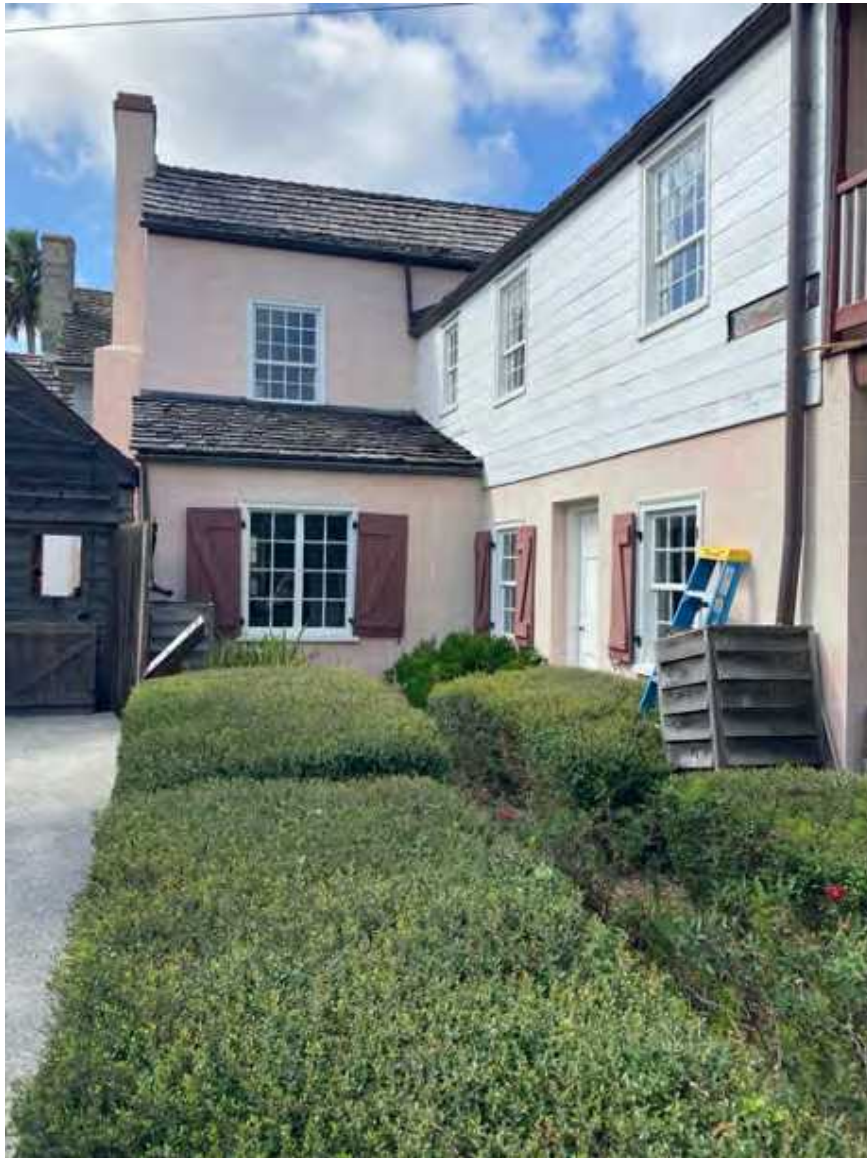
*B: Ticket booth, looking W*

*C: Ticket booth, looking NE*

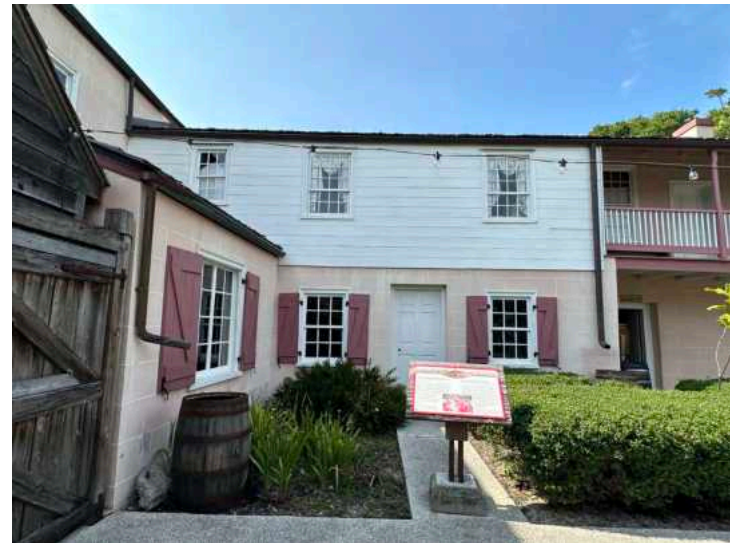
Along the south and east walls of the building, some foundation plantings are too close to the masonry walls and serve to trap moisture.

*D: Plants along E and S facades, looking NW*

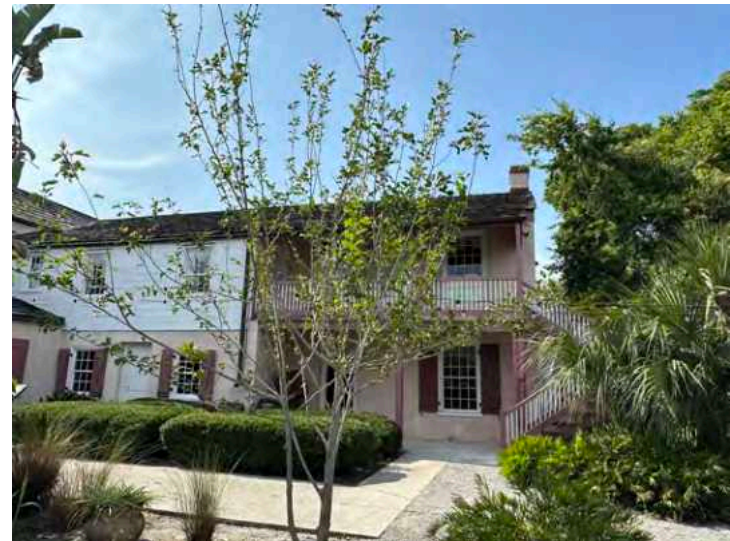
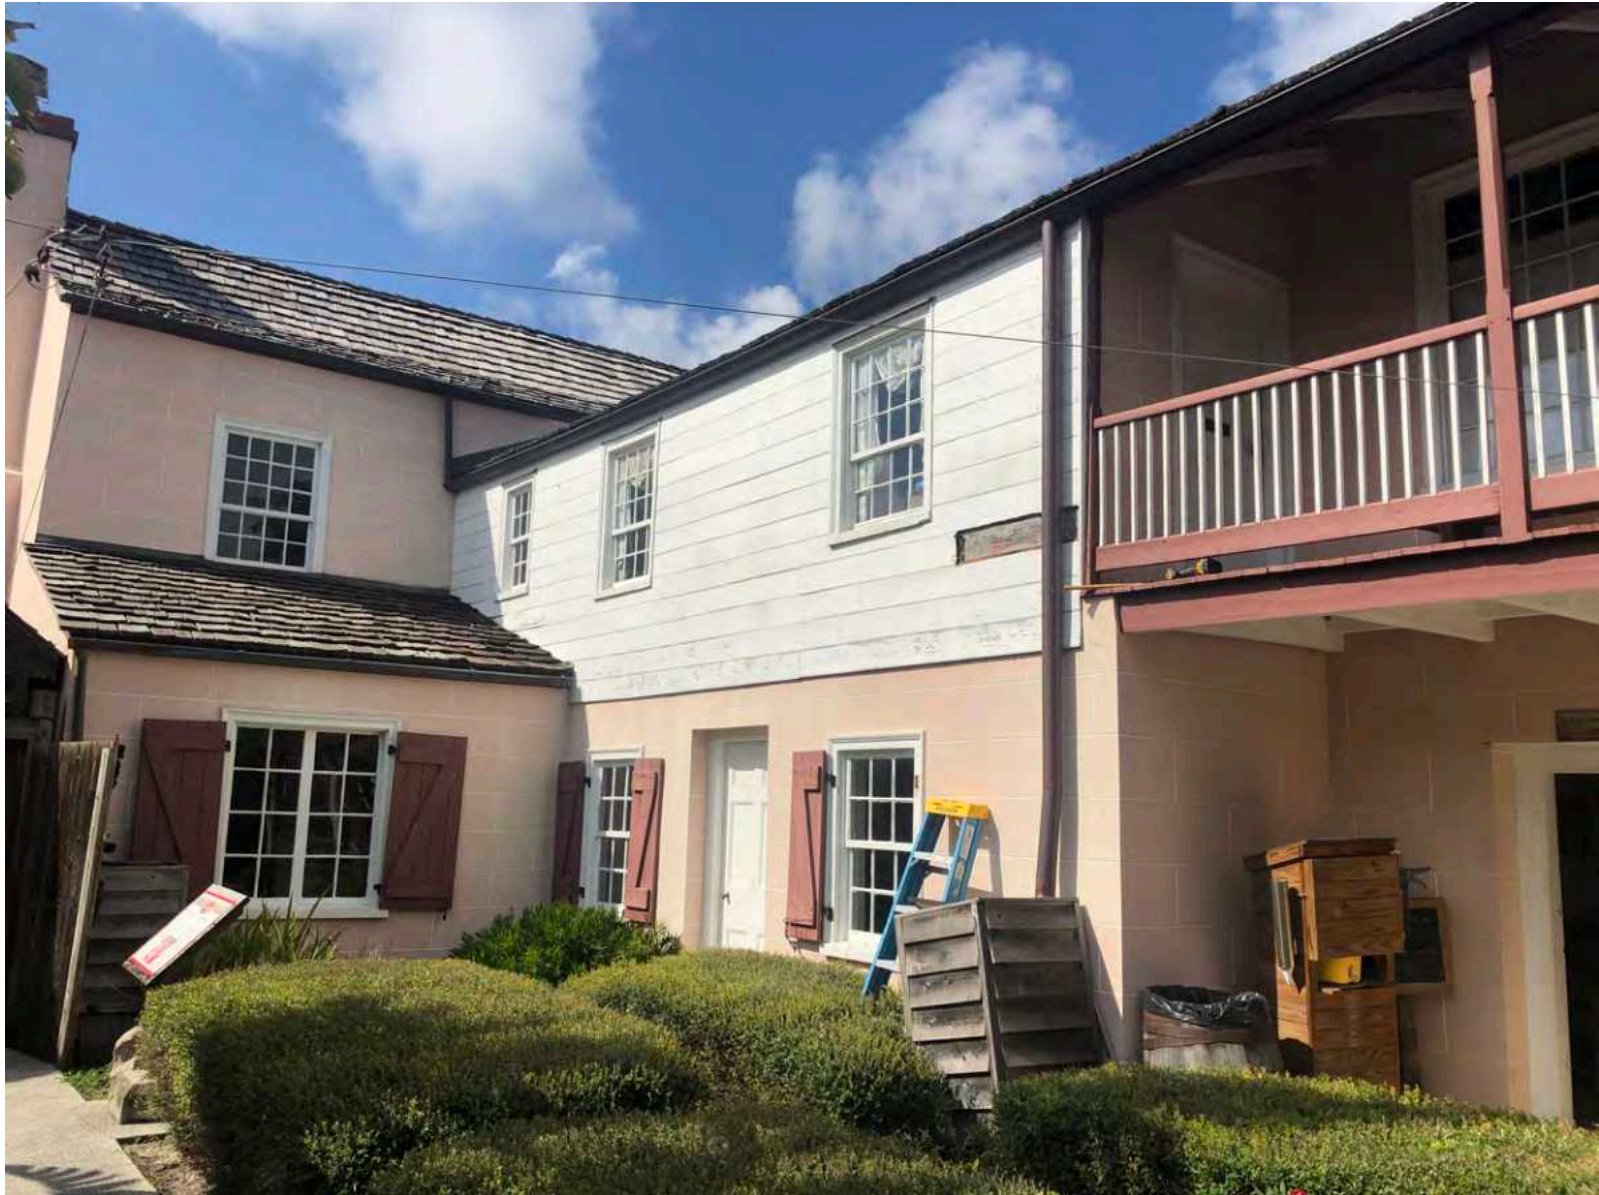
Some paving and site features impede site water flow away from the building. The westernmost concrete walkway that leads to the south façade should be either removed or replaced to promote drainage of water away from the building.

*E: Concrete walkway, looking N*

*E: Concrete walkway, looking NW*

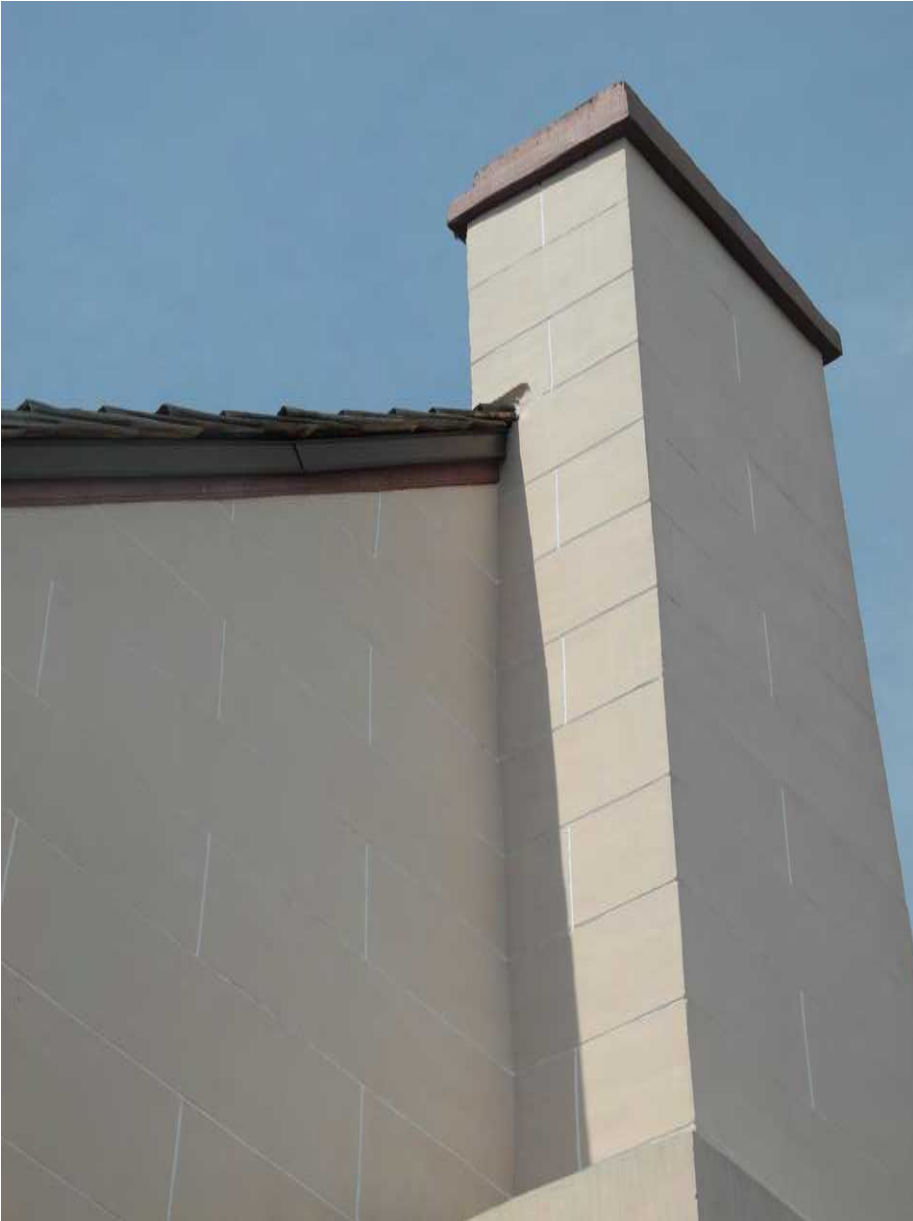
Overall, the flashing materials appear to be in good condition at the chimney/roof penetrations at the east chimney and the south chimney. The drip edges appear secure and in good condition. The gutters and downspouts appear to be well-fastened and in good condition (C).

*C: West Wing, roof's Eslope, looking NW and up*

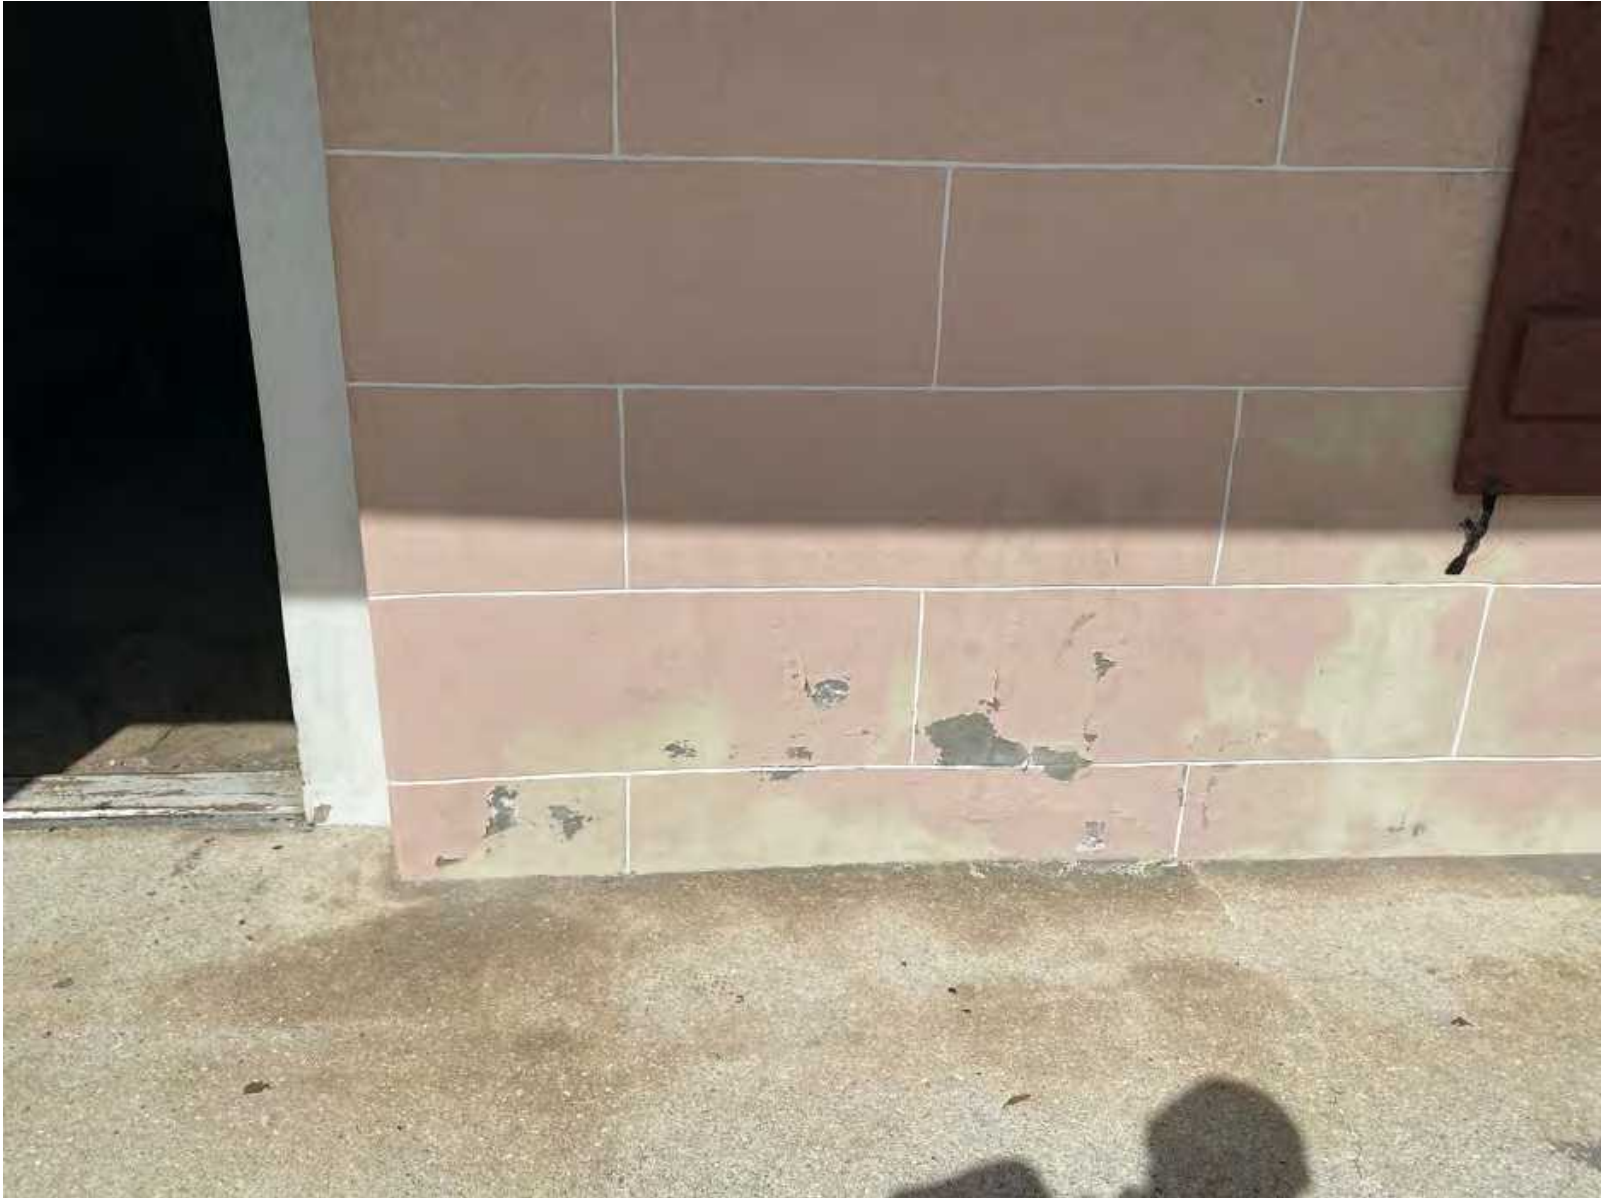
*A: East Wing, S facade, looking N*

Overall, the painted stucco on the east wing's south and east façades is in good condition. There is some minor fading of the paint color in various locations. There are a few areas of mold discoloration and wear, mostly near the ground level (A, B, C).

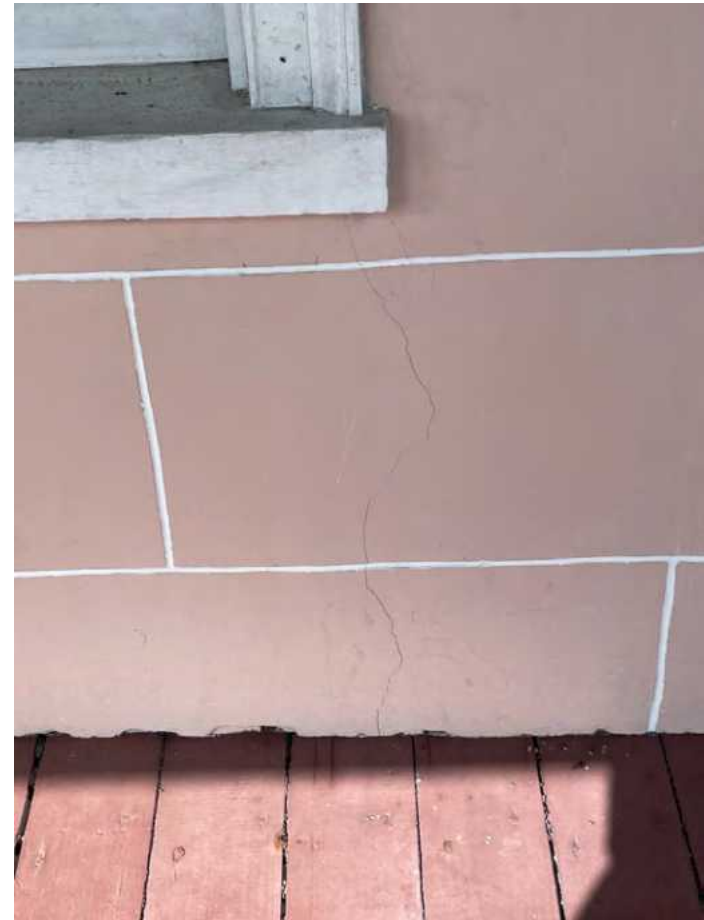
*B: East Wing, S facade, looking N*

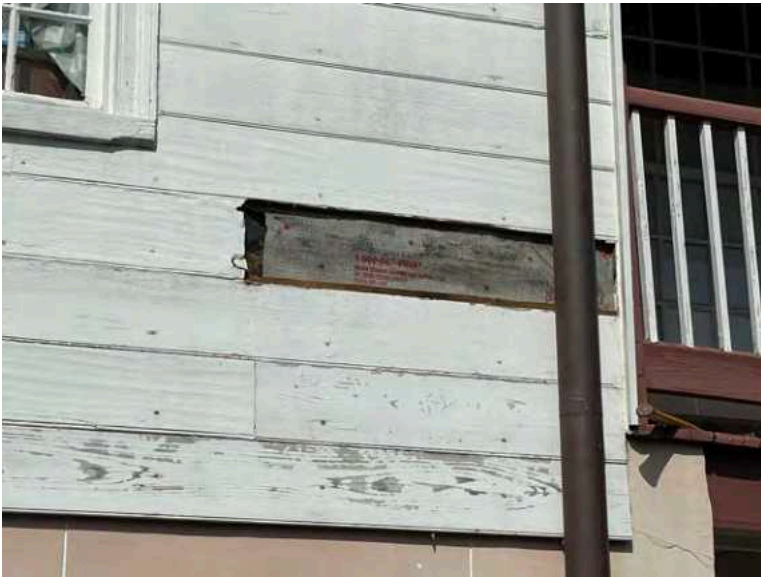
*C: East Wing, S facade, looking N*

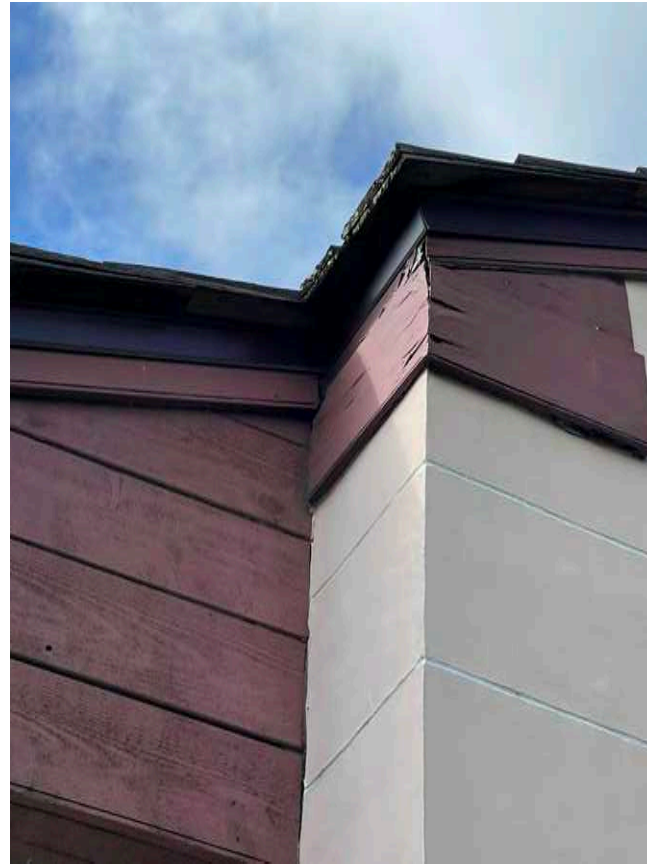
Most of the wood elements of the balcony are in good condition (A, B, C, D). The woodwork applied to the façade at the upper south-west corner displays some minor damage and chipped paint (E).

*D: West Wing, Balcony, looking NE and up*

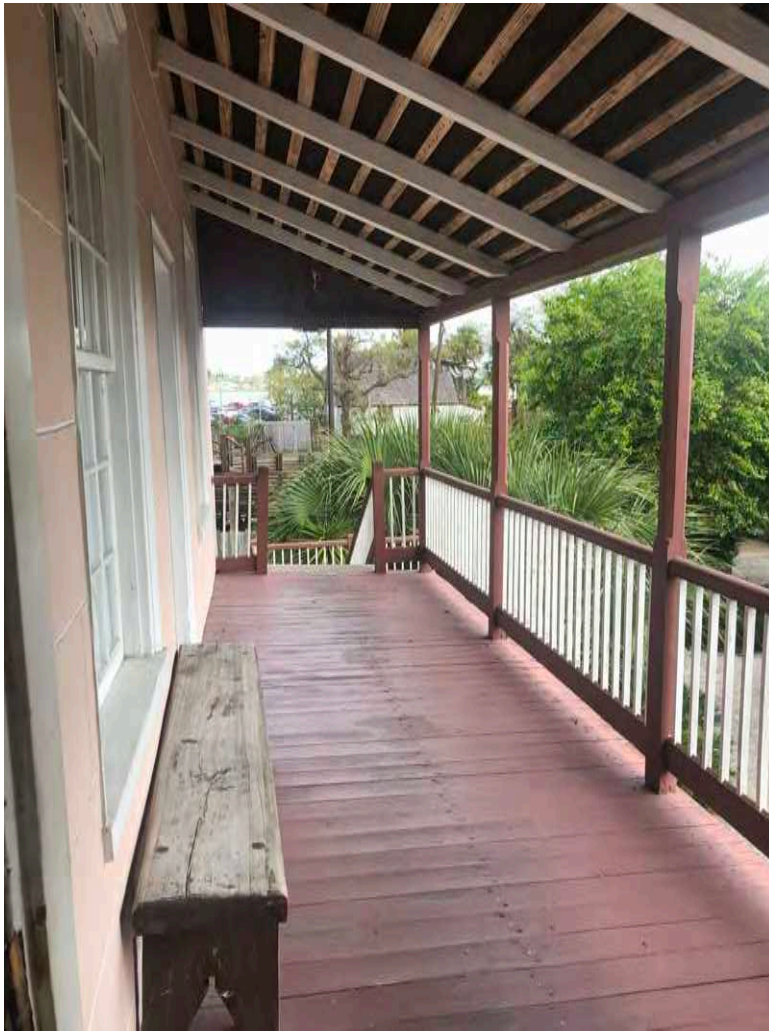
*E: West Wing, Balcony, looking NE and up*

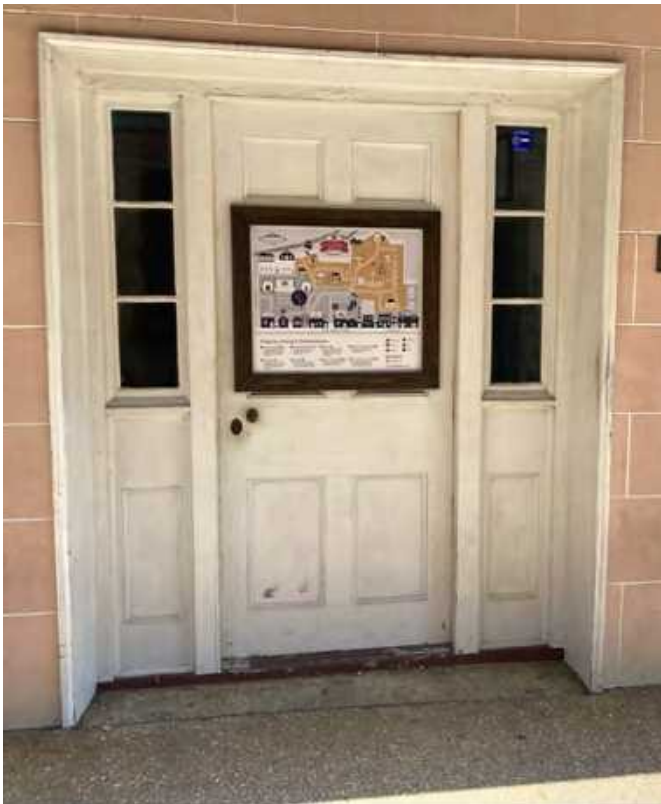
The west entrance door, frame and sidelights (D1) are in overall good condition (A). The wood sill has some areas of chipped paint, and the lower sections of the frame have minor evidence of wea (B)..

A: Door D1 West Wing, W facade, looking E

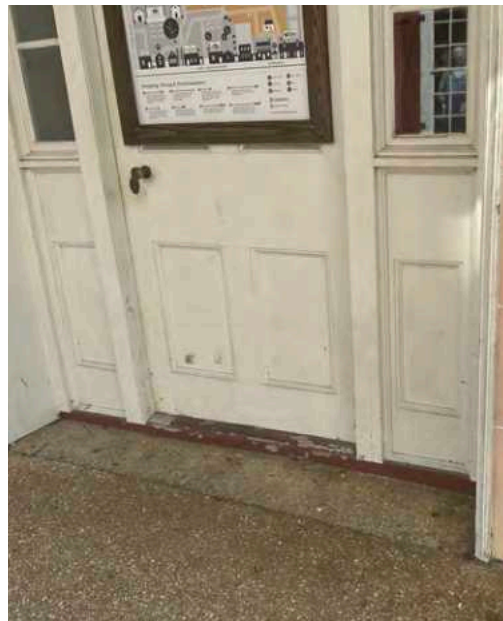
B: Door D1 West Wing, W facade, looking NE

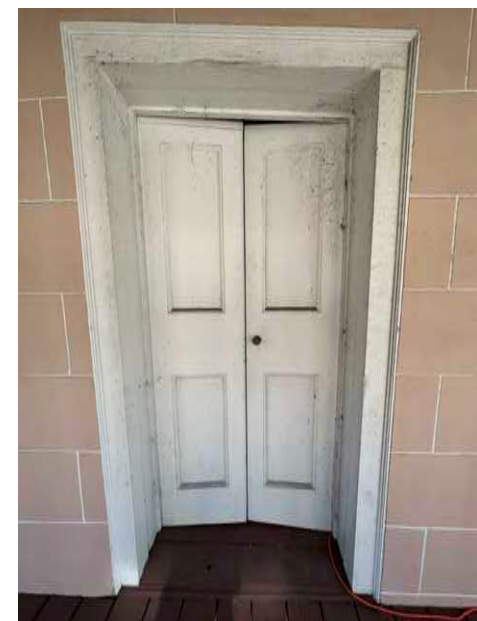
The west façade Balcony door and frame (D14) are in good condition (C).

C: Door D14 West Wing, W facade, looking E

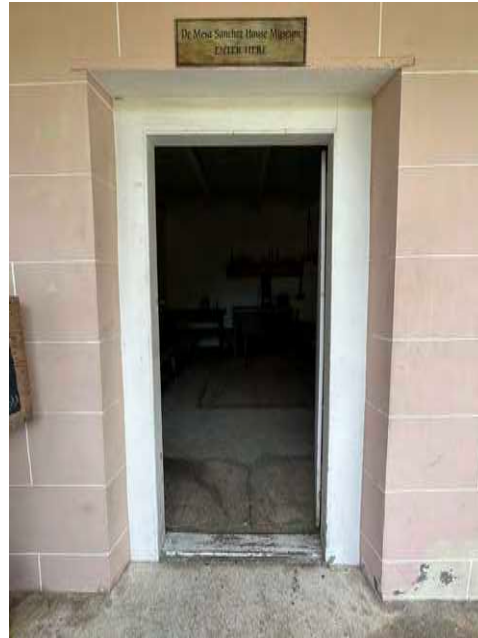
The south façade, east-side door and frame (D11) are protected by the Loggia above (A, B). The paint finish exhibits some chipping, especially at the wood sill and lower area of the door casings, and the bottom of the door planks indicates some moisture absorption into the wood.

*B: Door D11 East Wing, S facade, looking N*

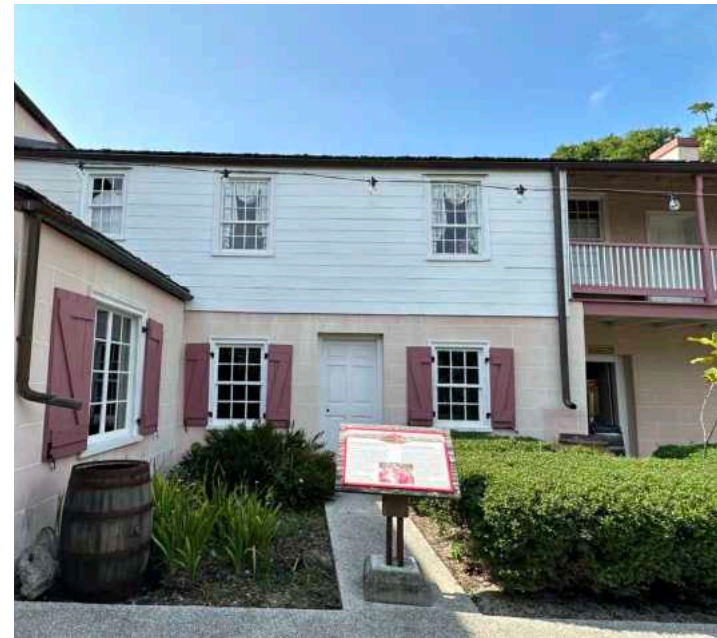
The south façade, west-side door and frame (D13) are in fair condition on the exterior (C). The interior face of lower wood panels indicates significant rot and damage to the painted wood.

*C: Door D13 East Wing, S facade, looking N*

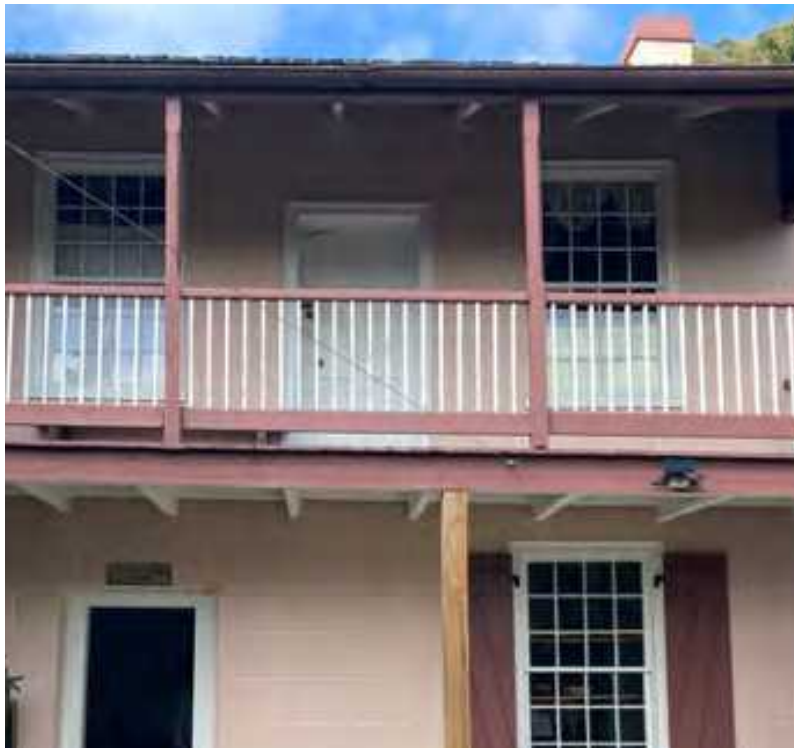
The east façade door and frame (D23) from the Loggia is in good condition (A).

*A: Door D23 East Wing, S facade, looking N*

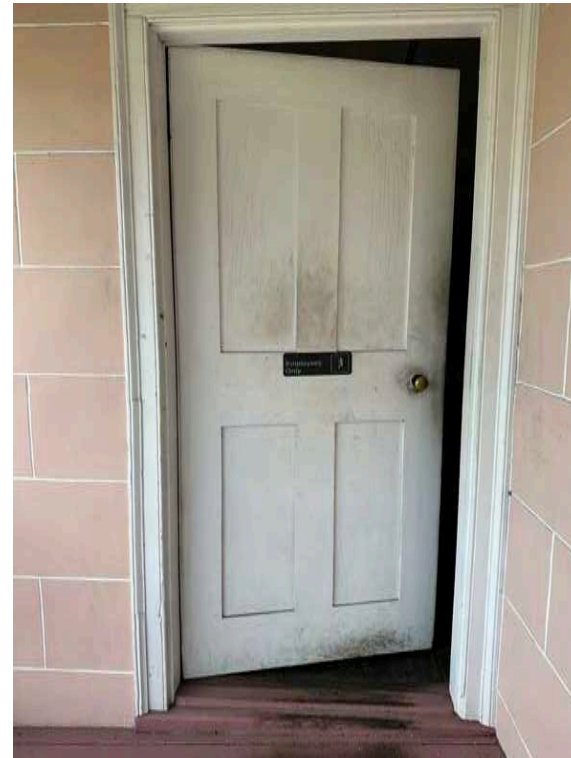
The south façade door (D24) from the Loggia is in good condition (B).

*B: Door D24 East Wing, Loggia, looking W*

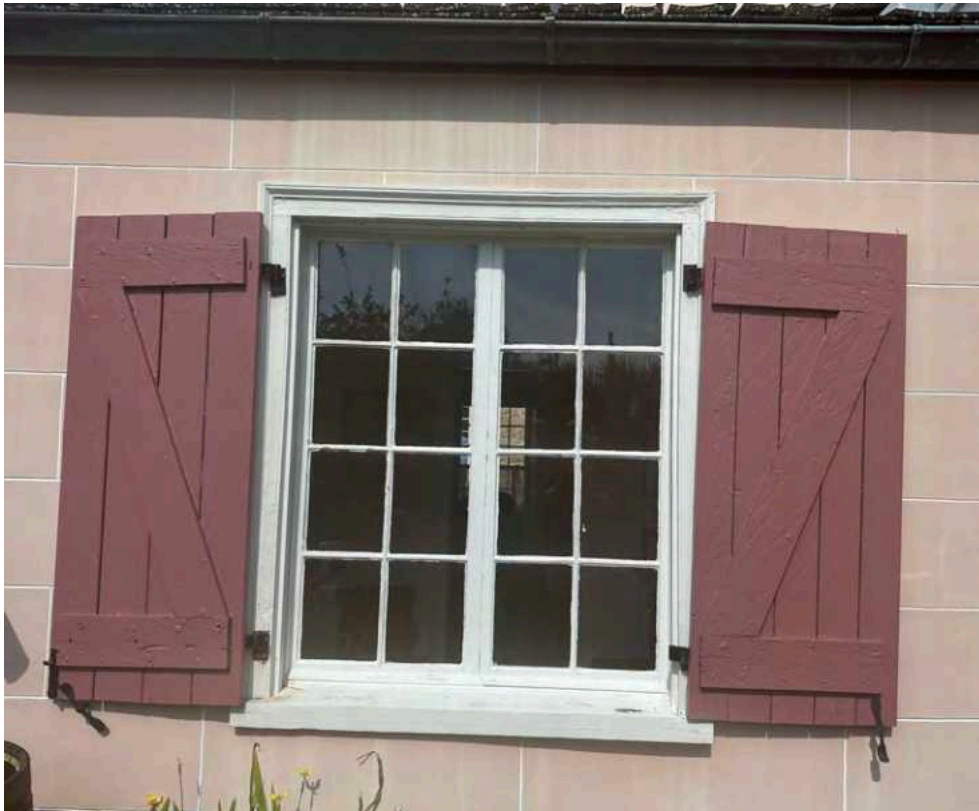
Window 1E2 is in good condition (A). Window 2E6 is in good condition (B)

Shutter at window 1E2 is in good condition (A).

*A: West Wing, E facade, window 1E2, looking W*

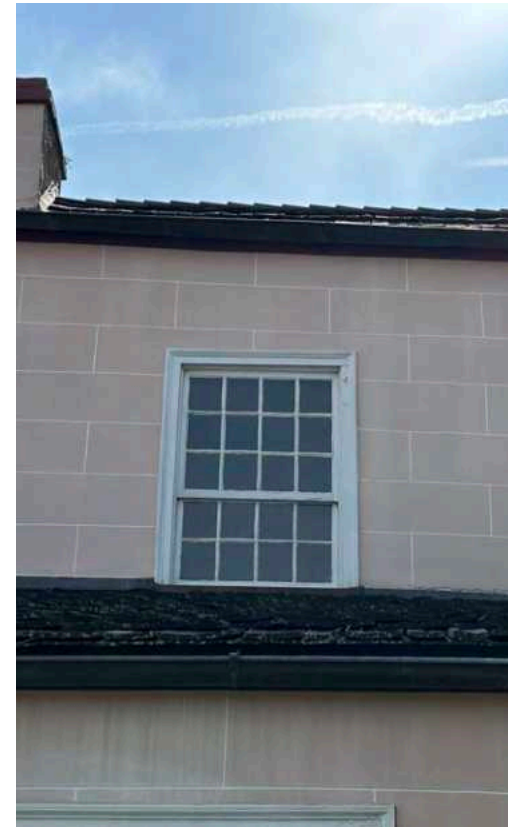
*B: West Wing, E facade, window 2E6 looking W*

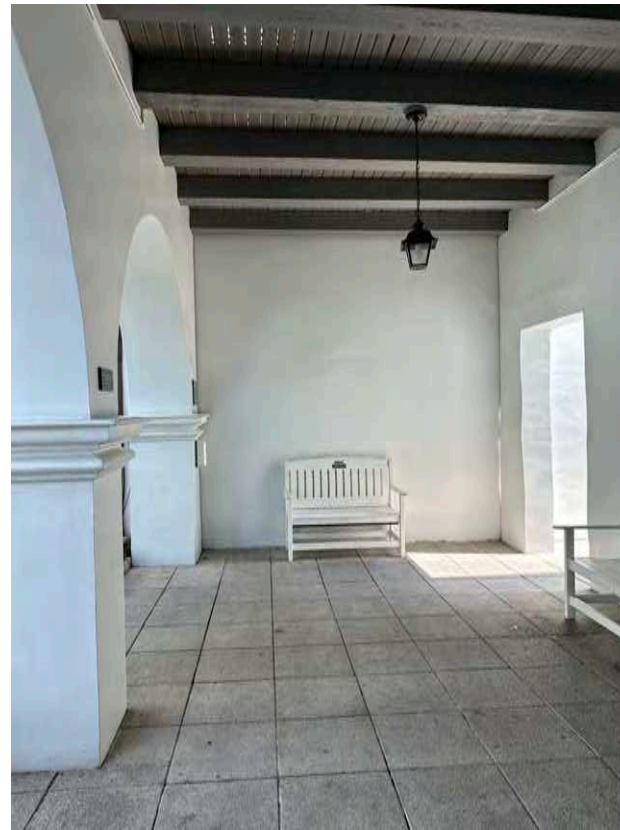
Window 2N1 was not accessible for viewing from the exterior of the adjacent property (B).

*B: East Wing, N facade, looking S Window 2N1, not accessible for viewing*

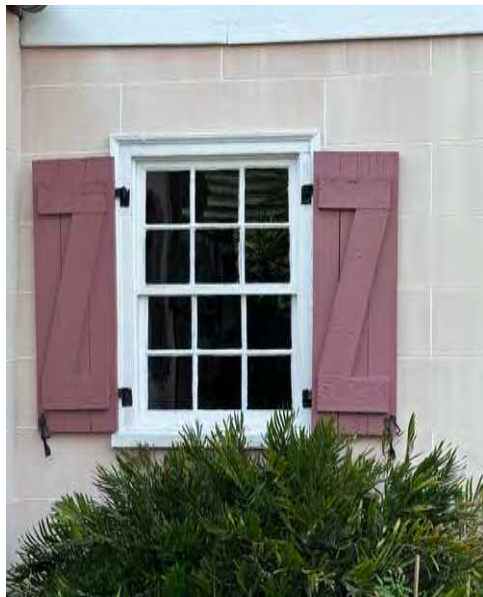
Shutters at windows 1S1, 1S2, 1S3 are in good condition (A, B, C).

*A: East Wing, window 1S3, looking N*

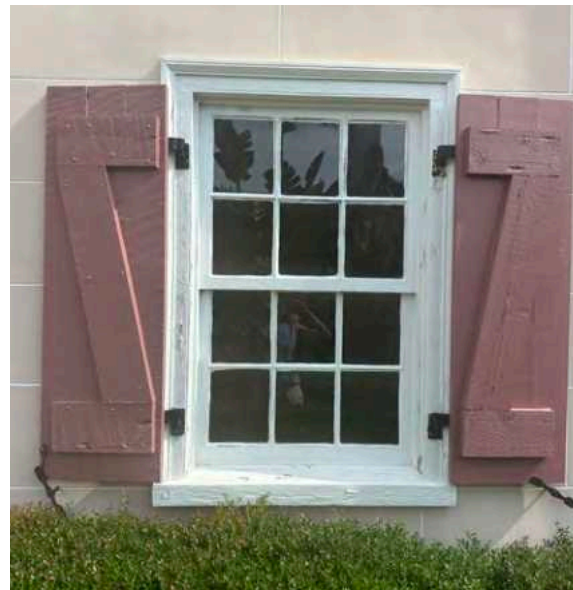
Window 1S2 is in good condition, with minor chipping and small amounts of loss of glazing putty in upper sash (B).

*B: East Wing, window 1S2, looking N*

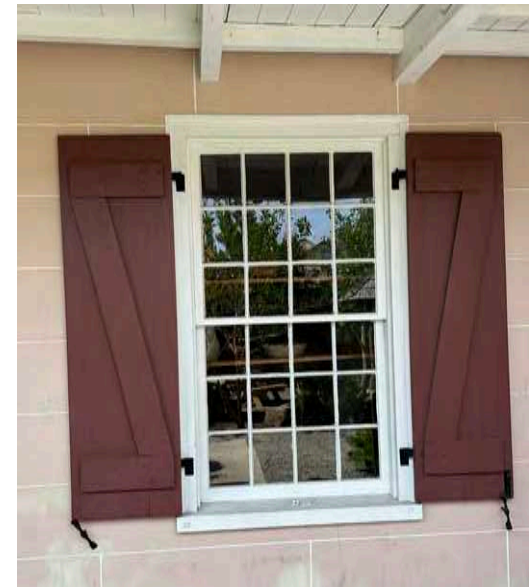
Window 1S1 is protected under the loggia floor and roof above and are in good condition (C).

*C: East Wing, window 1S1, looking NE*

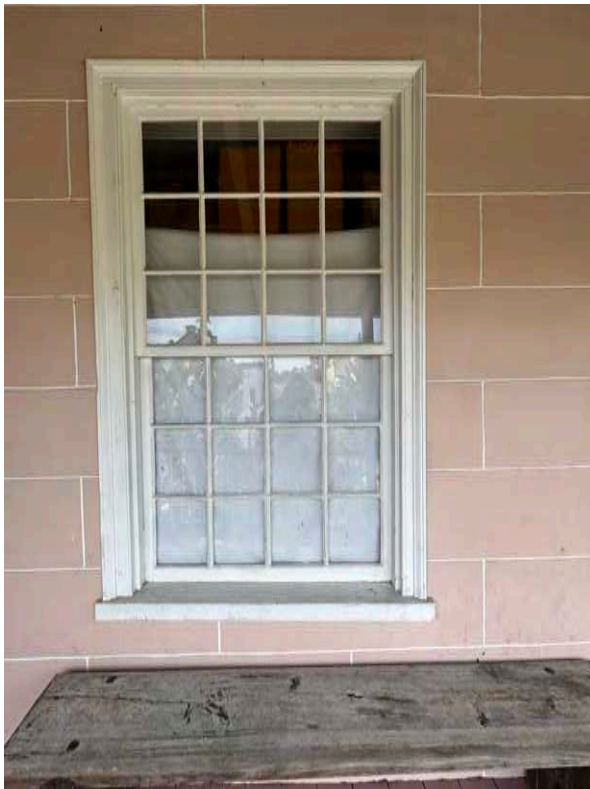
2S1 and 2S2 are protected by the Loggia roof and are in good condition (A, B).

*A: East Wing, window 2S2, looking N*

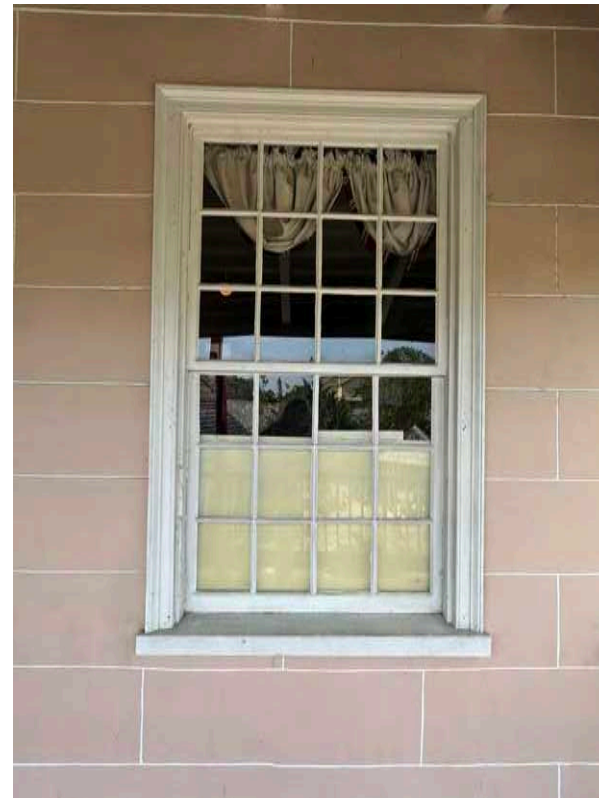
*B: East Wing, window 2S1, looking N*

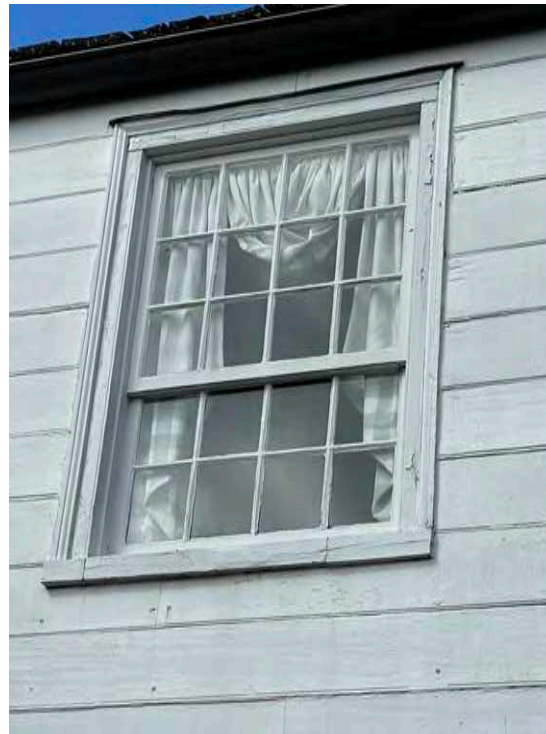
Window 2S4 is in overall good condition, there is cracking and splitting of the wood of the projecting sill piece (B).

*B: East Wing, window 2S4 looking NE and up*
