# **THE DEMESA-SANCHEZ HOUSE**

43 St. George St. Augustine, Florida

## **HISTORIC STRUCTURE REPORT**

Historic Preservation Program, DCP, University of Florida

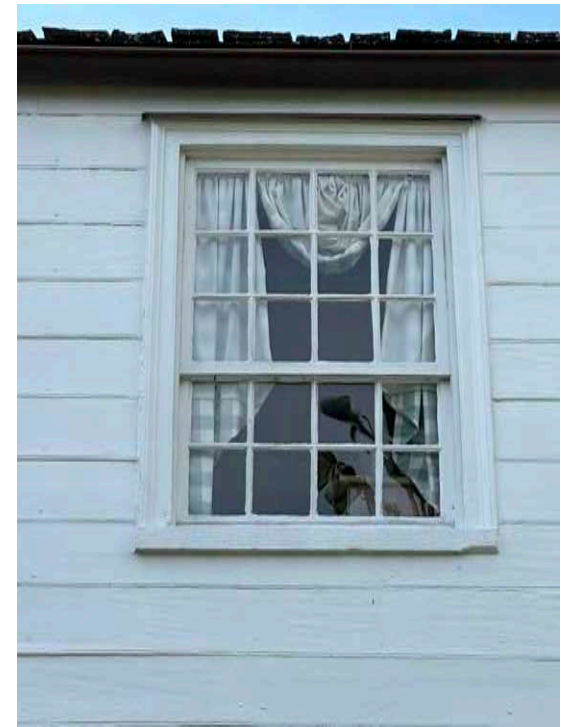
.Windows 2S3 and 2S5 appear to be in overall good condition (A, C).

*C: East Wing, window 2S3, looking N and up*

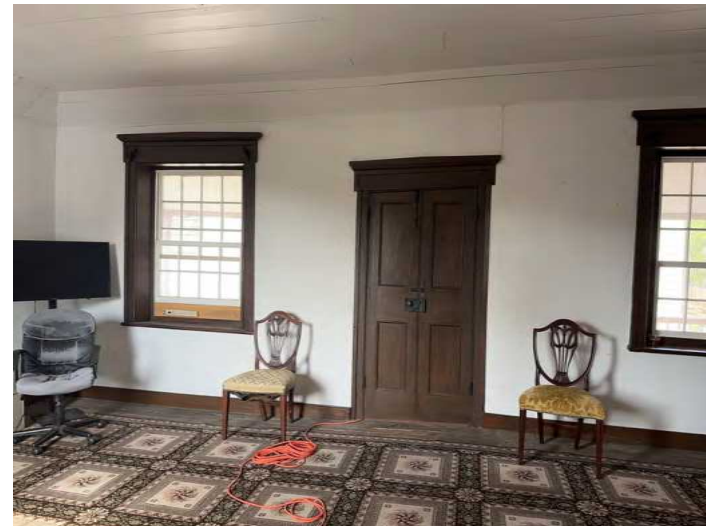
*B: Room 201, W wall, looking SW*

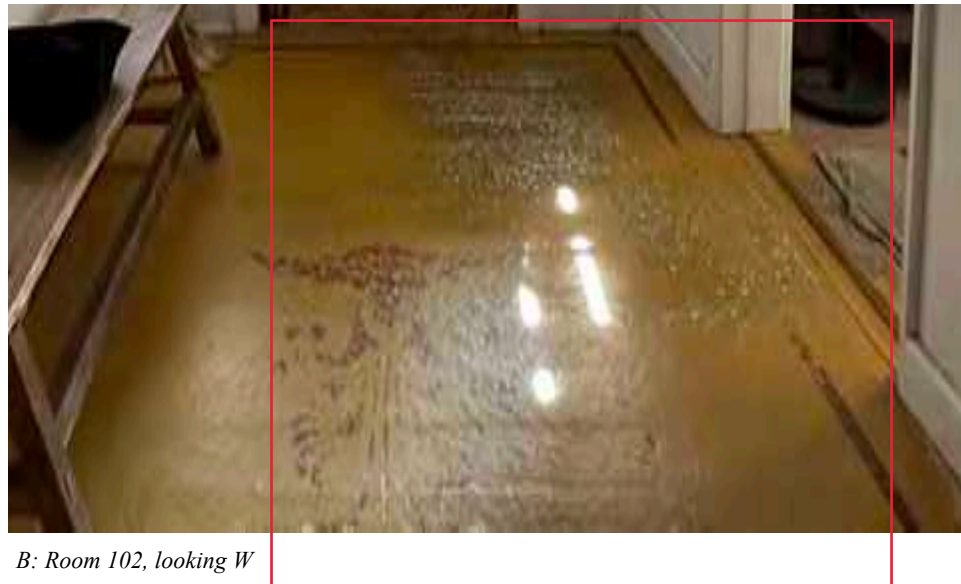
Painted ornament on the wood floor is fading away (B).

*B: Room 102, looking W*

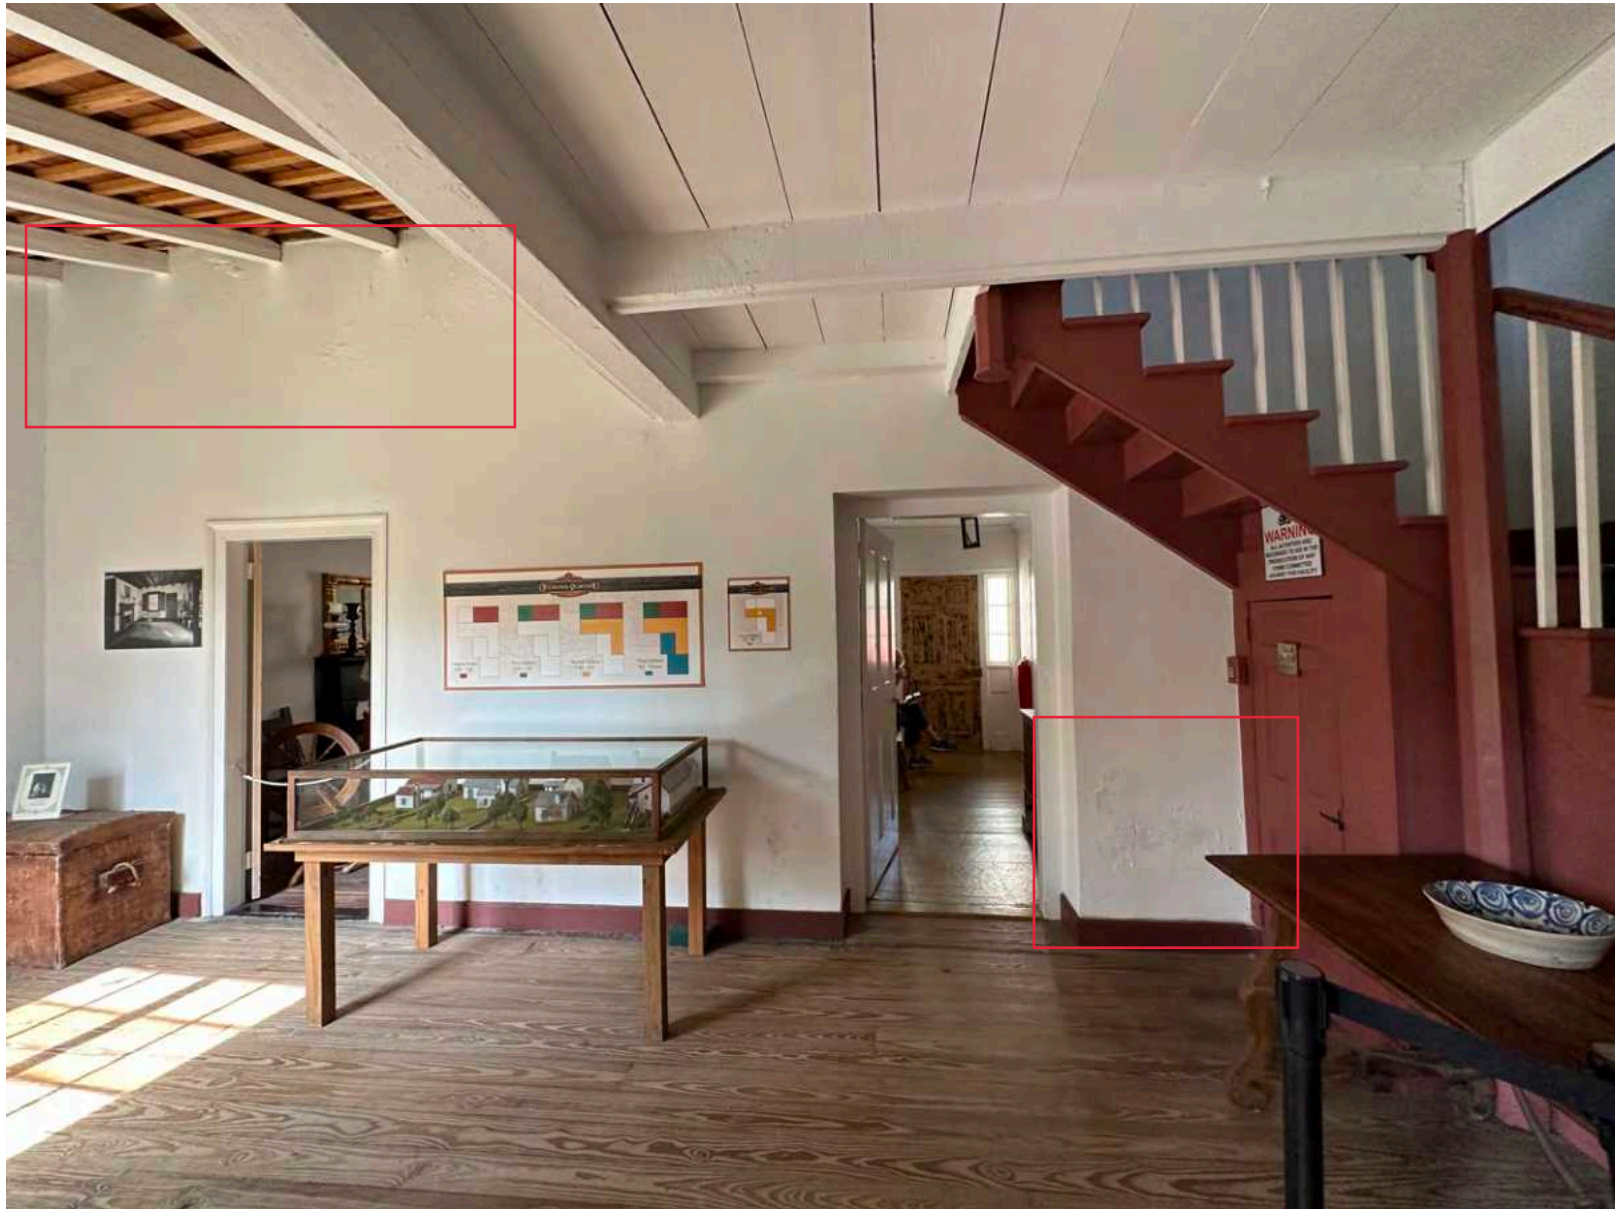
*A: Rooms 104 and 105, looking SW*

This space has several areas of damage to the plaster walls, indicating moisture infiltration in the masonry wall:

- west wall, high on the wall under the exposed beams (A)
- west wall, low on wall next to the wood staircase (A)
- south wall, low on wall below sill height (B)
- east wall, around the window opening (1E1), more extensive plaster damage along the wall below the window sill height (C)

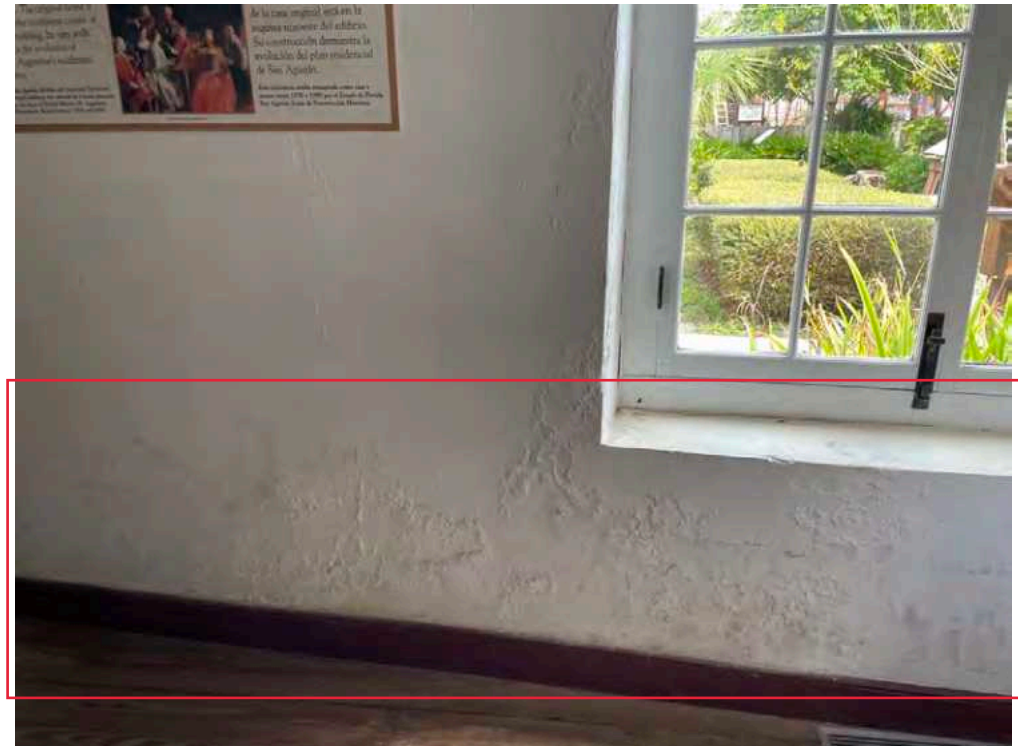
*C: Rooms 104 and 105, looking E and down*

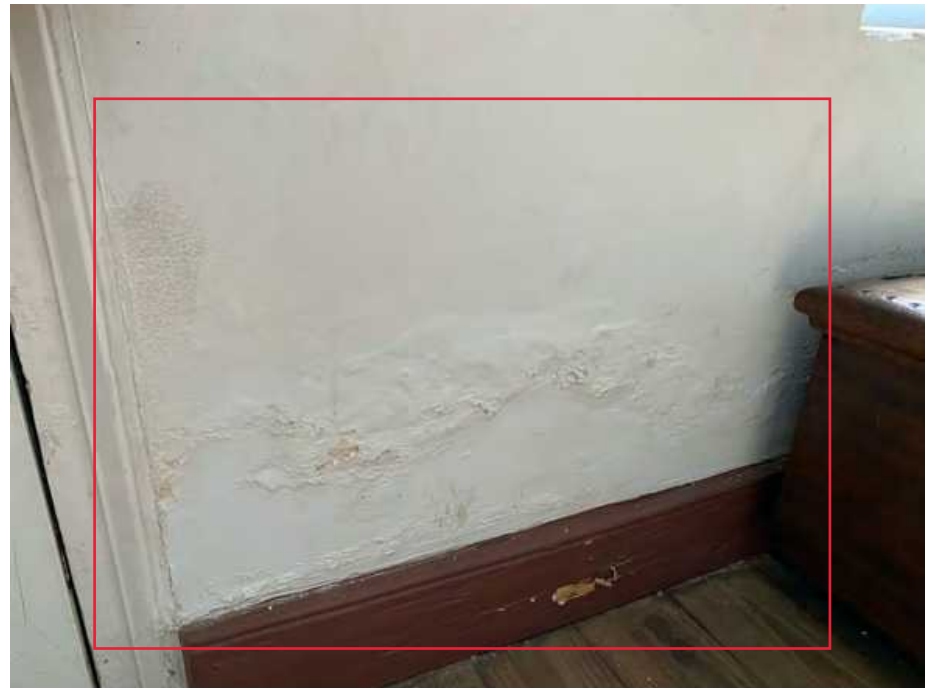
Plaster damage on north wall and low on the south wall (A, B).

*B: Room 107, looking SW and down*

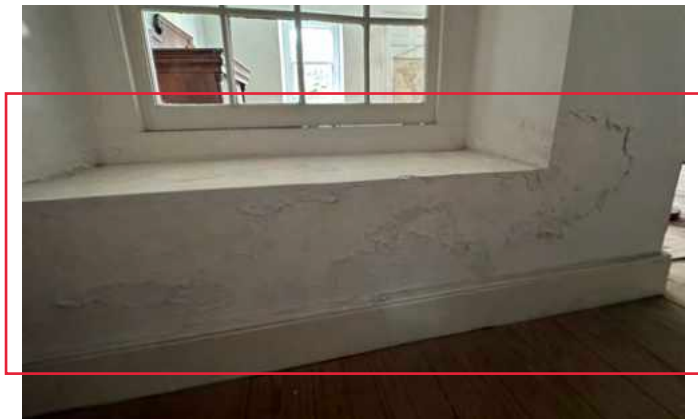
Plaster damage at all walls (A, B, C). At north wall damage is with corresponding water stain on wood floor. Significant deterioration of plaster along the south wall.

*B: Room 108, looking SW*

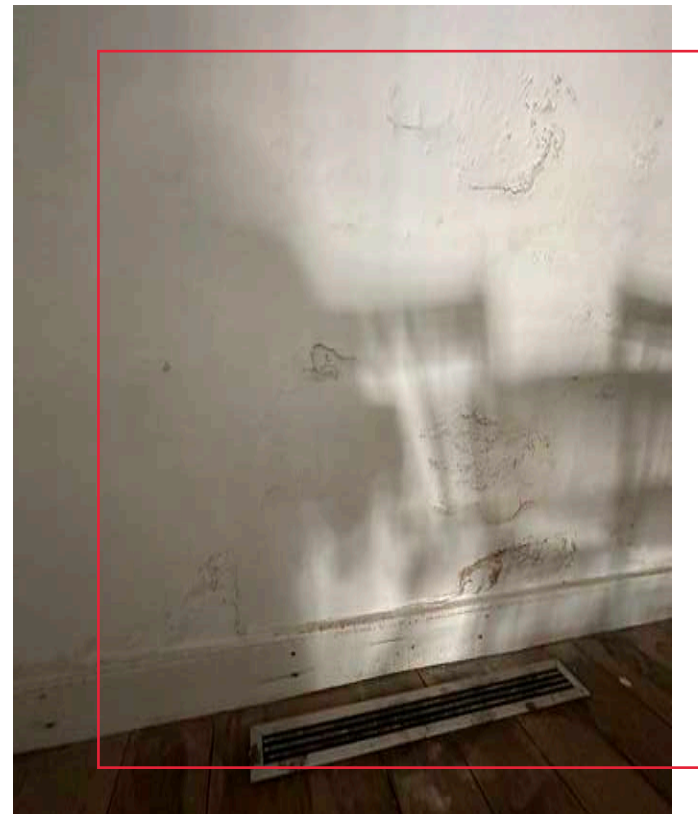
*C: Room 108, looking NE*

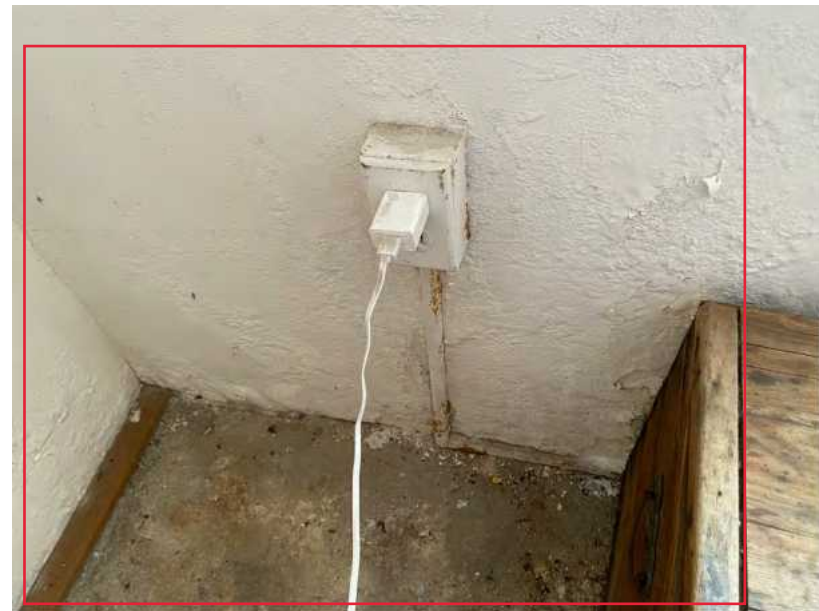
Plaster damage at south and east walls (A, B).

*B: Room 110, looking S and down*

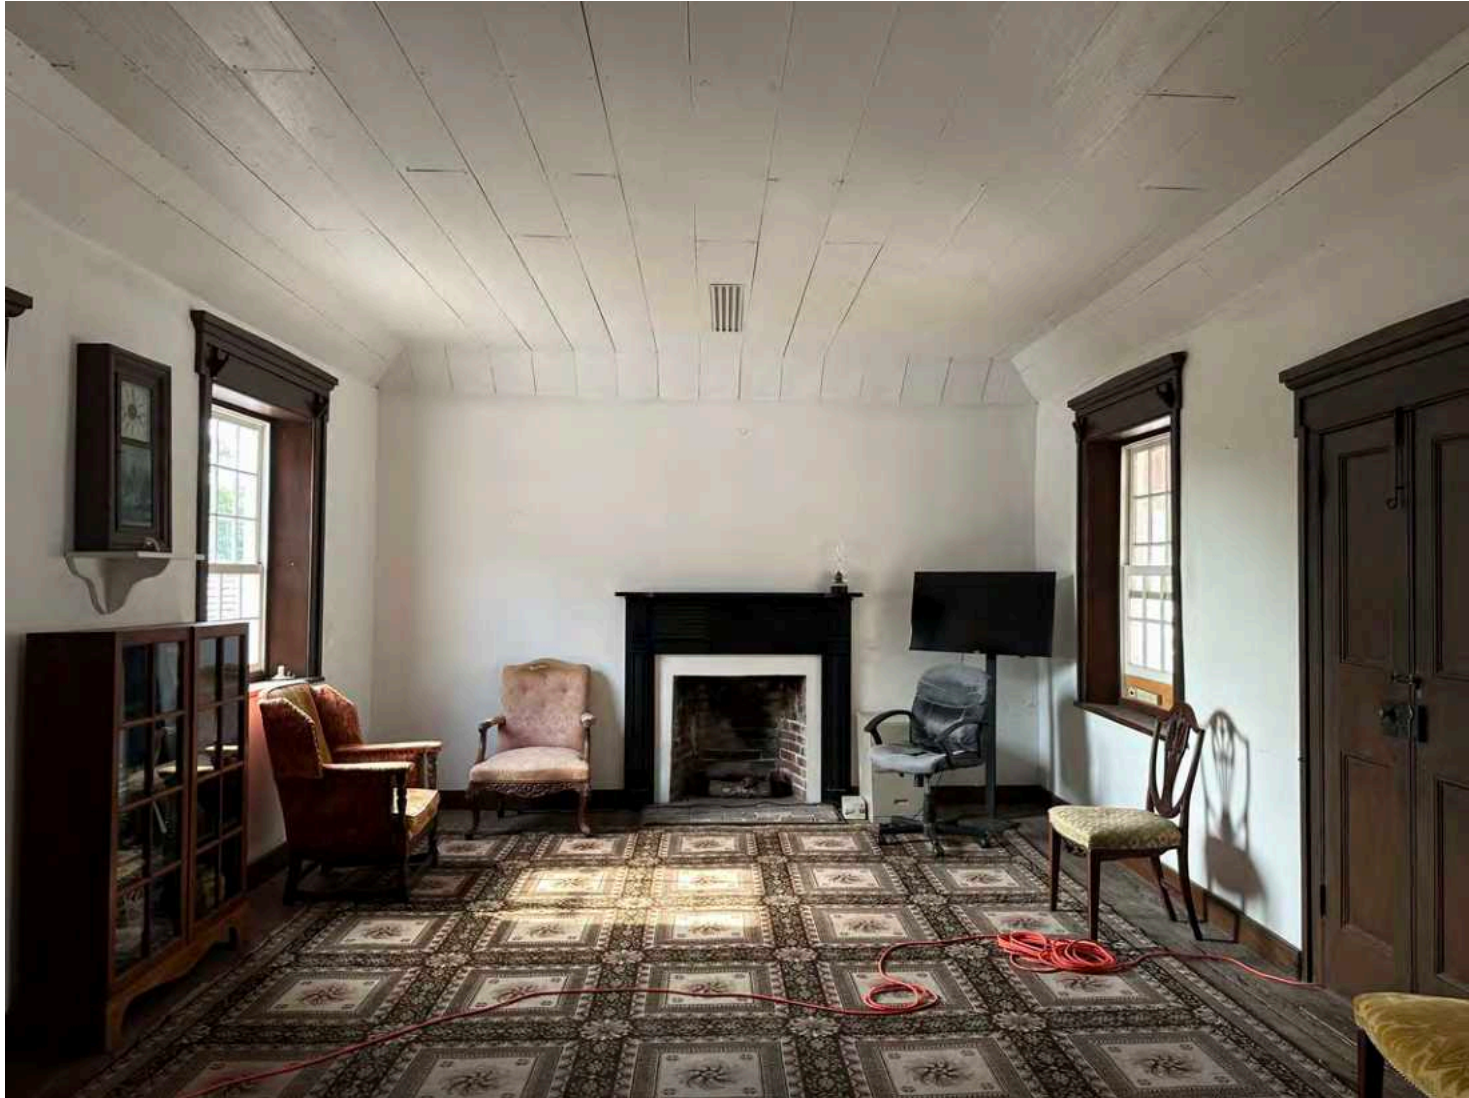
*A: Room 201, looking S*

Room 201 is an interpreted museum space (a).

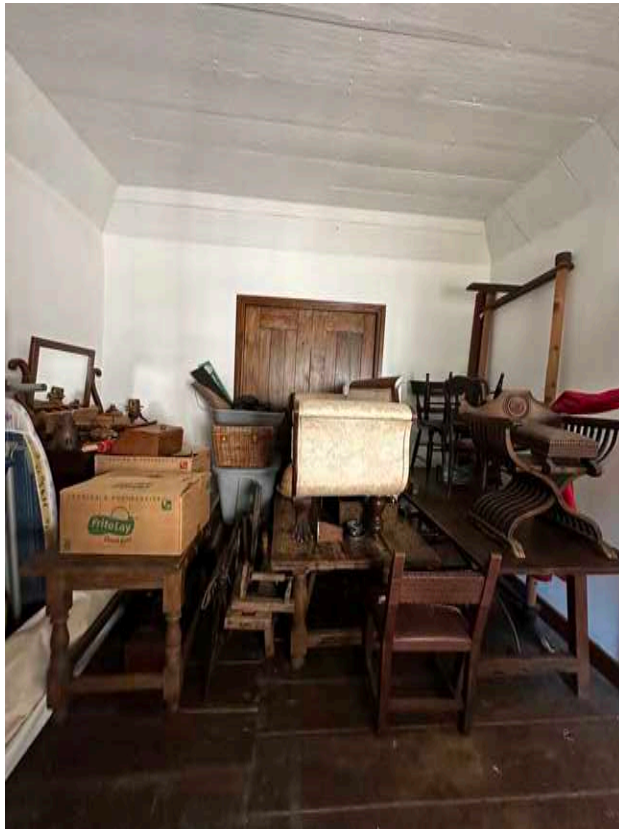
The other second floor rooms are used for furniture storage (Room 202), tenant operations (rooms 206, 207, 208 and 208A), and equipment and supply storage (room 210), thereby limiting direct observation of the condition of some ceilings, and the walls and floors (B, C).

*B: Room 202, looking E*

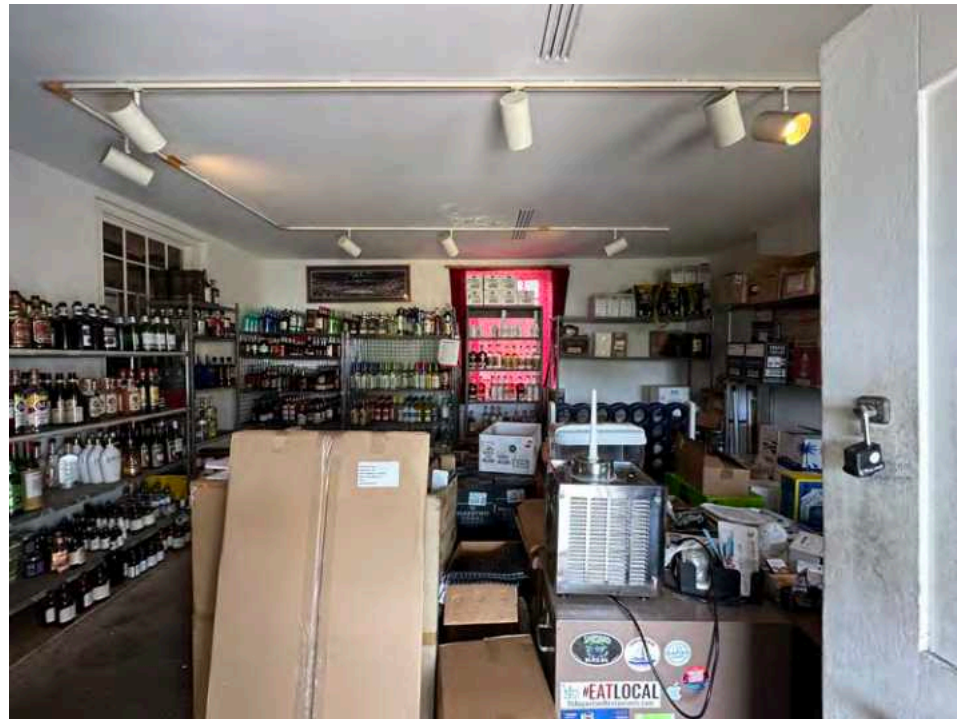
*C: Room 210, looking N*

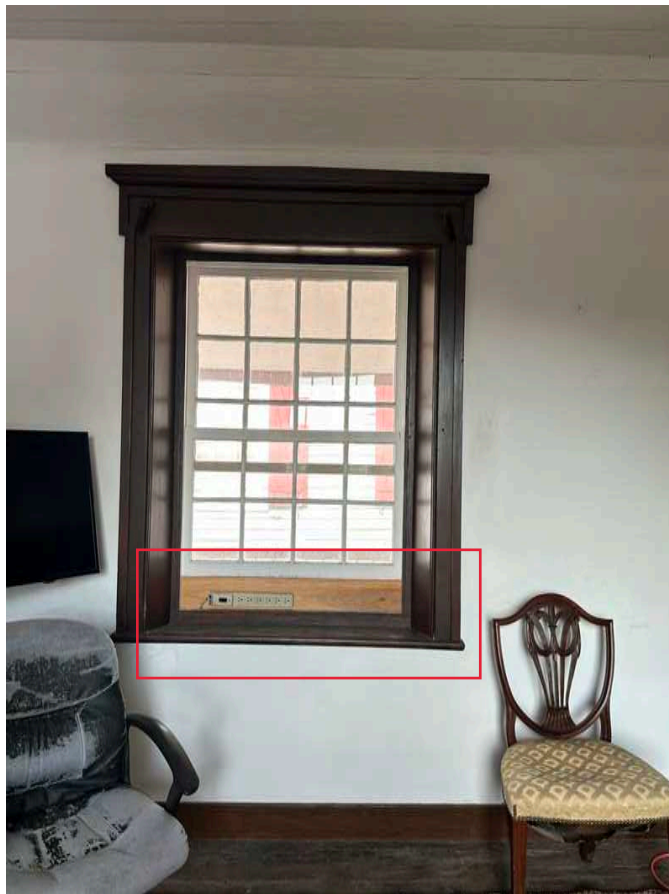
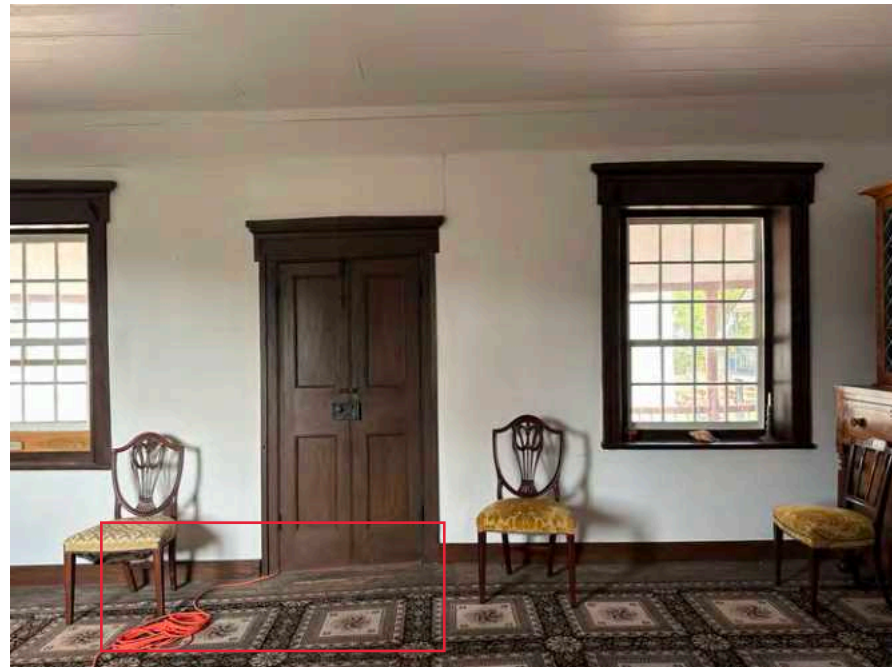
No adverse conditions were noted on wood ceilings, plasters walls, woodwork, fireplace or wood floors. Window 2W1 has a power strip inserted in the board that displace the lower sash, and a temporary power cord is run through the room under the Loggia doors to the exterior.

A: Room 201, looking W

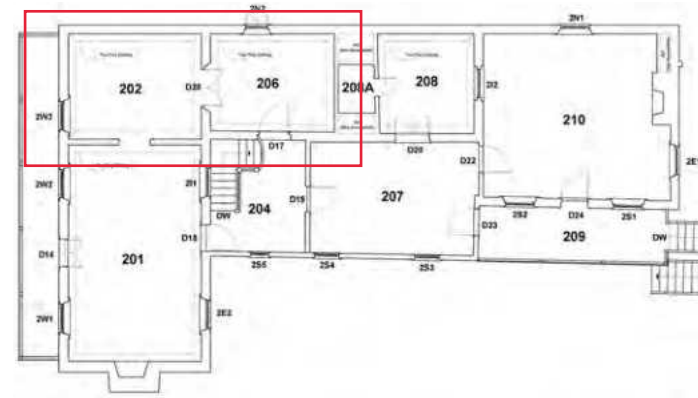
Limited visibility, no adverse conditions were noted on wood ceilings, plasters walls, woodwork. Wood floor showing some wear (A).

A: Room 202, looking N

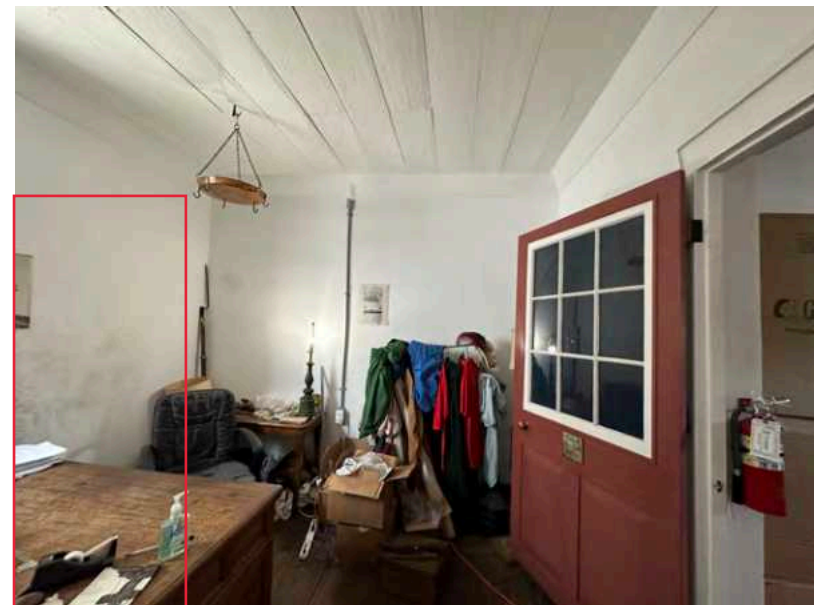
Limited visibility, plaster damage on the north (exterior wall), and around the window 2N1 sill area (B).

B: Room 206, looking E

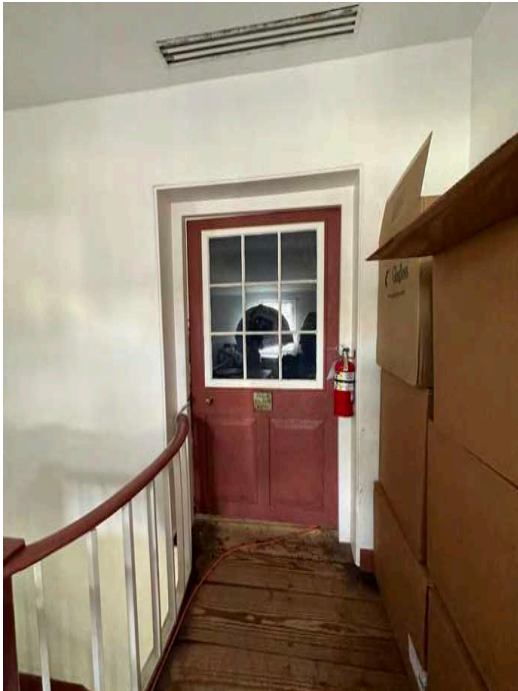
Limited visibility. No adverse conditions were noted on ceilings, woodwork, interior window (211), railing, stairs (where visible) (A, B, C).

*A: Room 204, looking NWN*

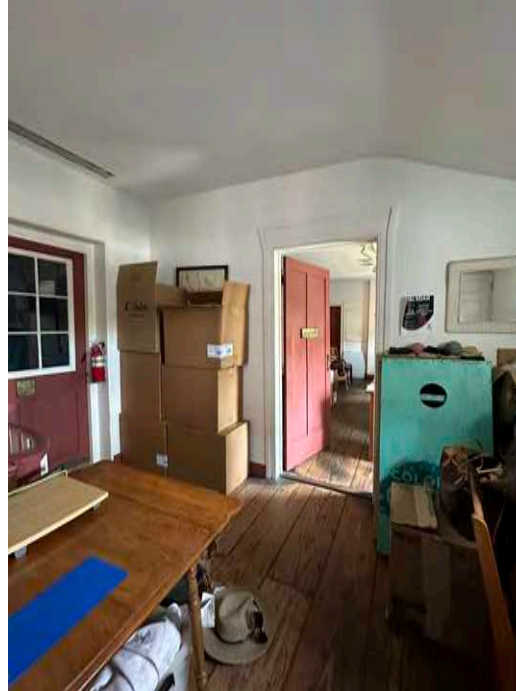
*B: Room 204, looking NE*

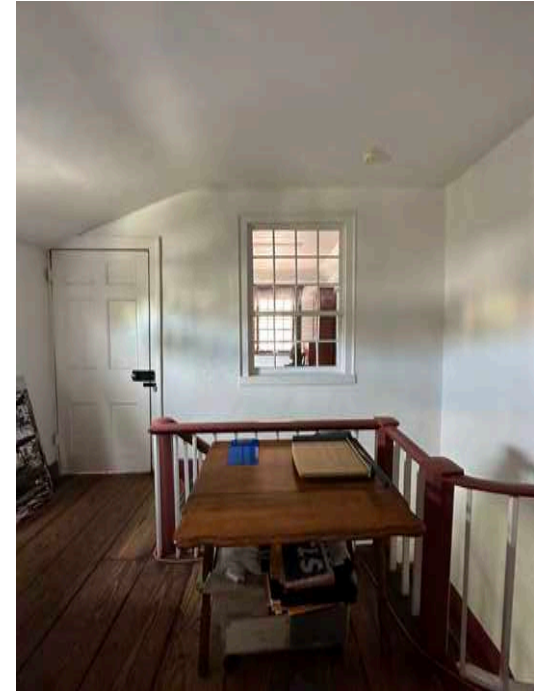
*C: Room 204, looking W*

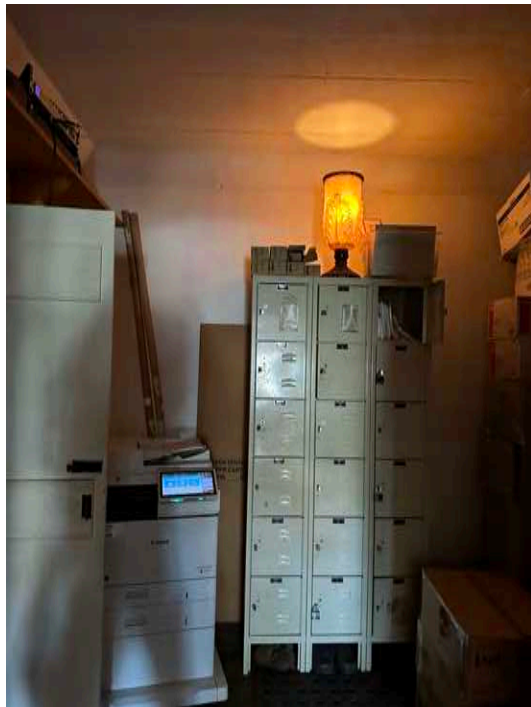
No adverse conditions were noted on ceilings, plaster walls, floors, interior woodwork (C).

*C: Room 208 looking N*

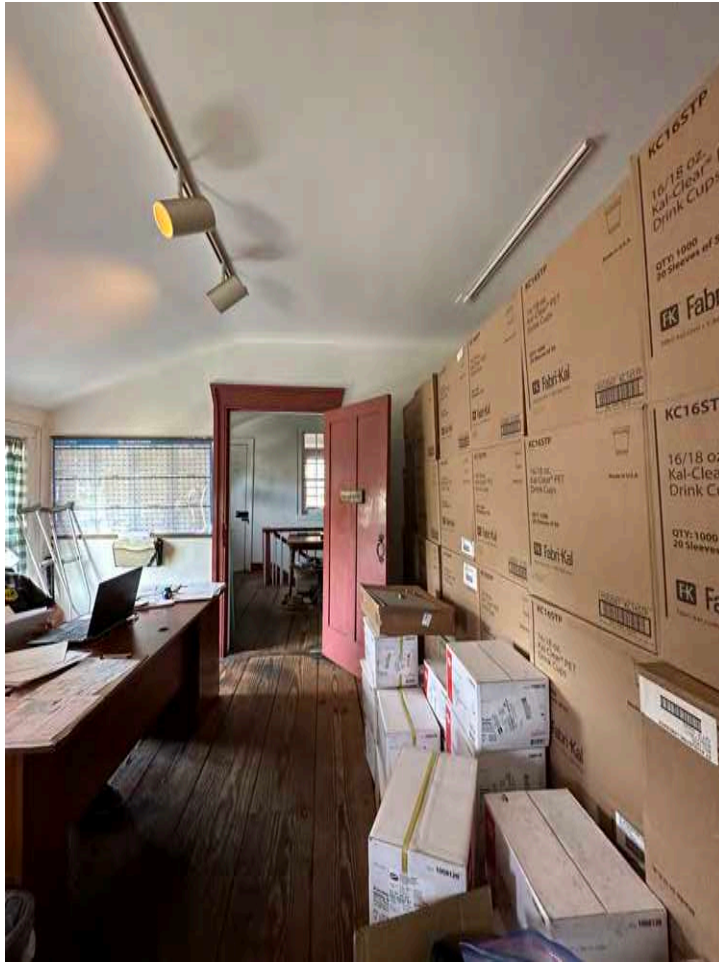
Limited visibility due to contents of space, plaster damage around perimeter of window 2S (A, B).

*A: Room 207, looking W N*

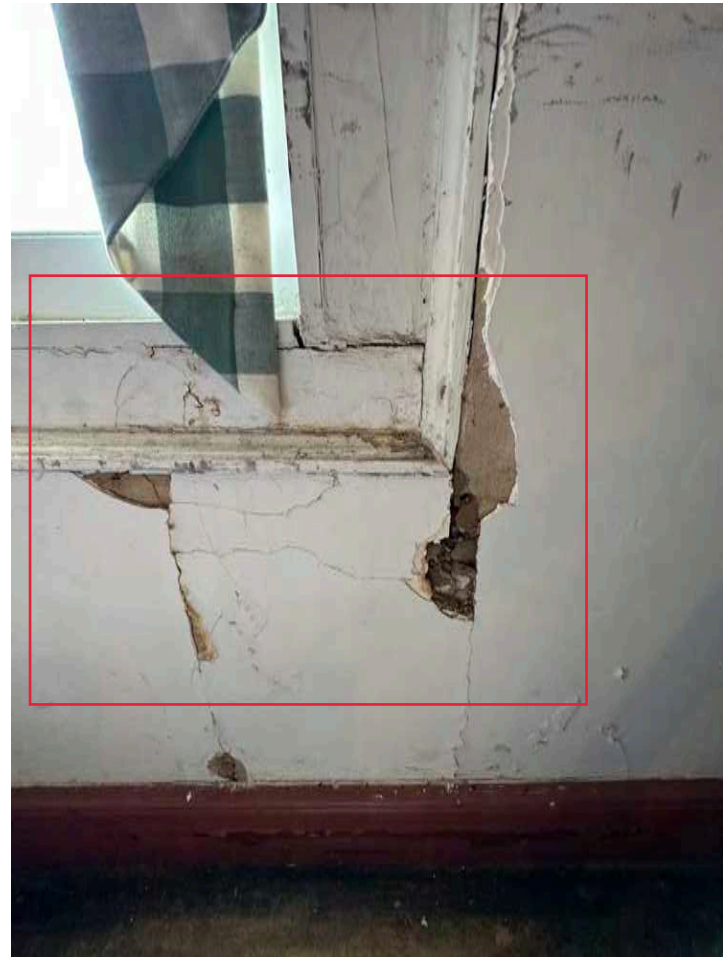
*B: Room 207, looking S*

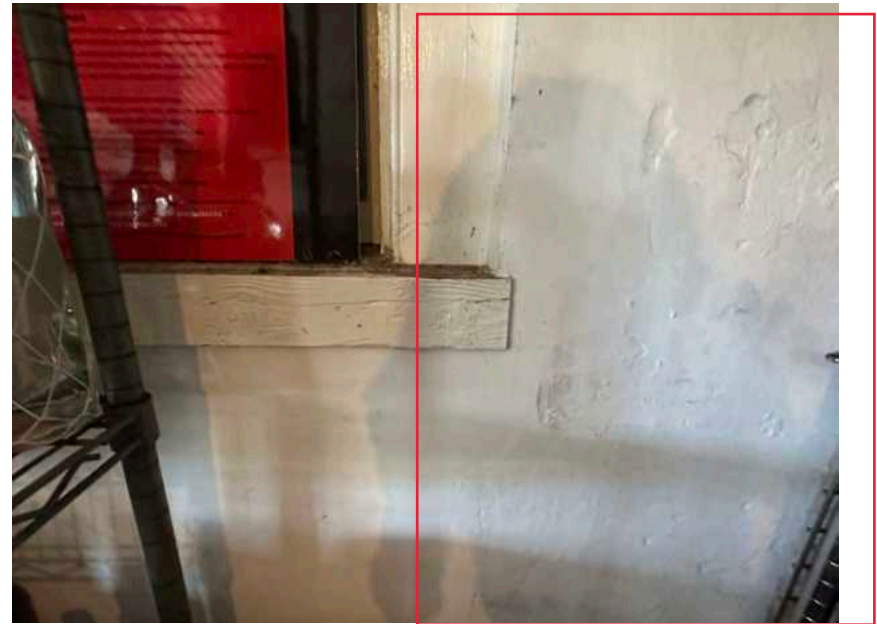
Limited visibility due to contents of space, plaster damage at ceiling near north wall (A, C) and near the window 2N1 (B).

*B: Room 210, window 2N1, looking N*

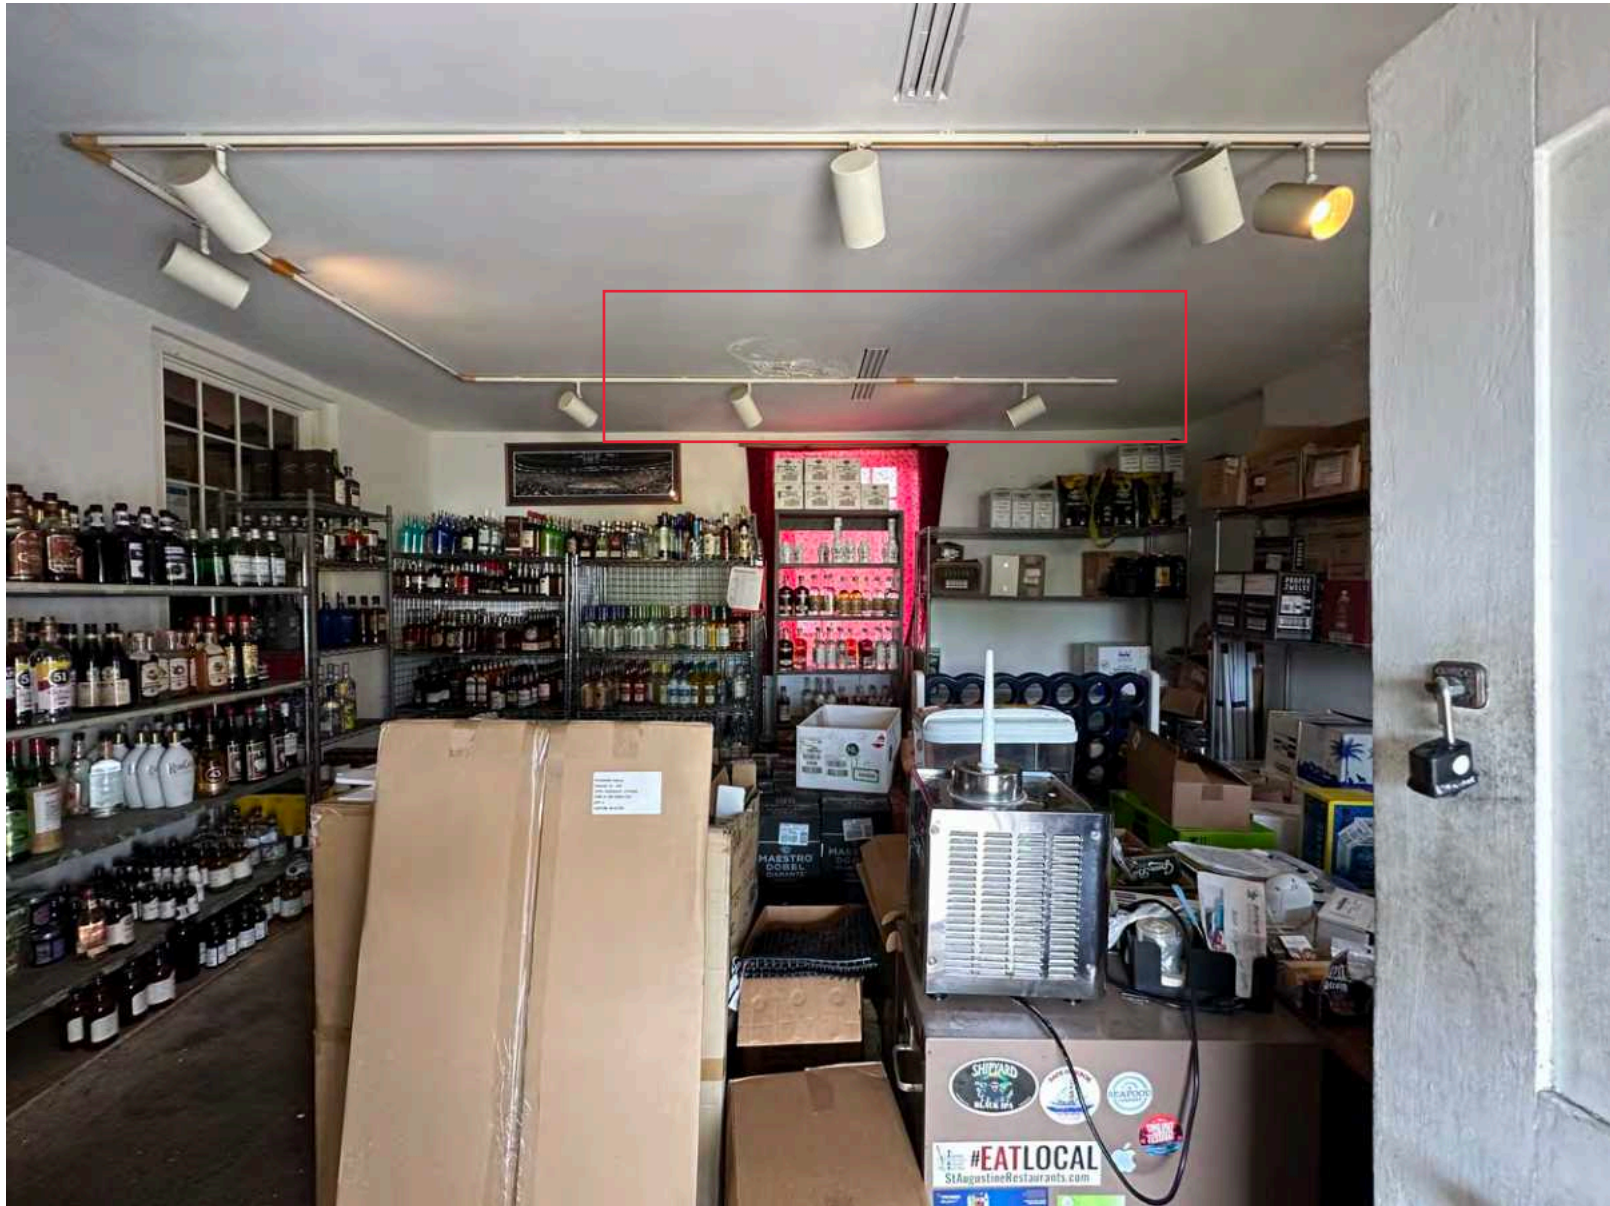
C: Room 210, looking N

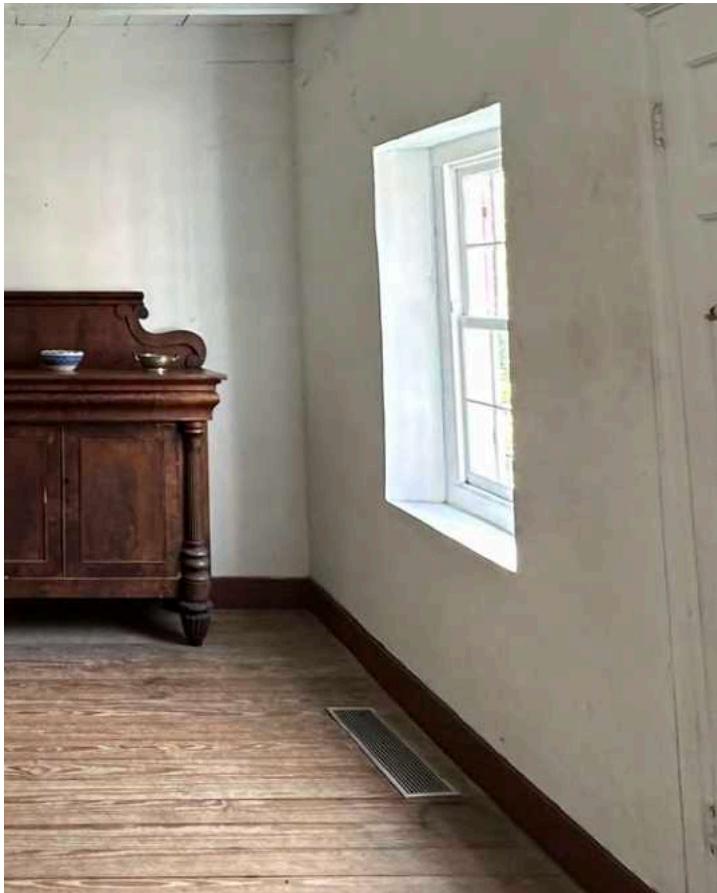
The most visible component of the mechanical system are the supply grills embedded in the first floor wood and concrete floors, and the grills in the second floor wood or plaster ceilings (A, B). The system was in operation on the date of the site visit. See Recommendations for future considerations for the mechanical system.

*A: Room 107, looking SE*

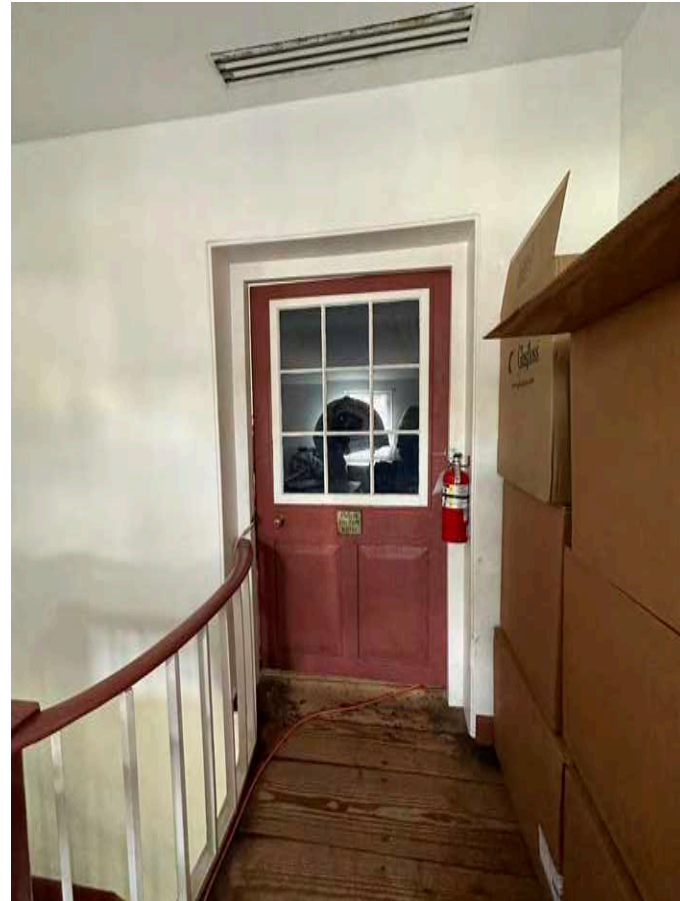
*B: Room 204, looking NW*

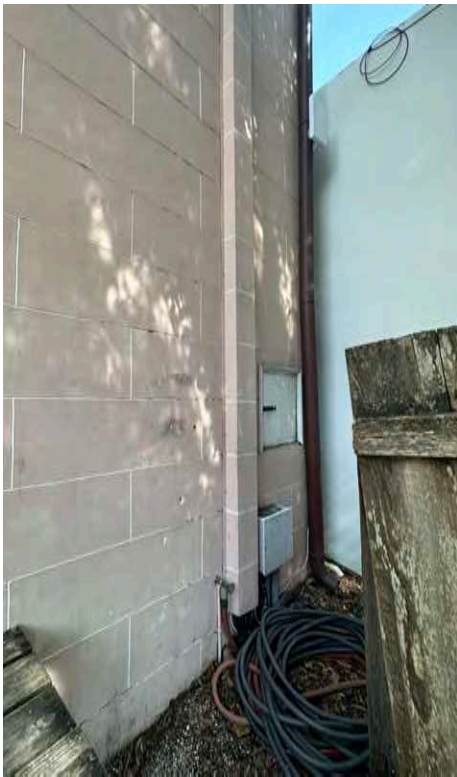
The electrical meter is recessed in a void space on the east wall that is covered by a painted wood access door, painted finish is in fair condition (A).

*A: East Wing, east facade, looking NW*

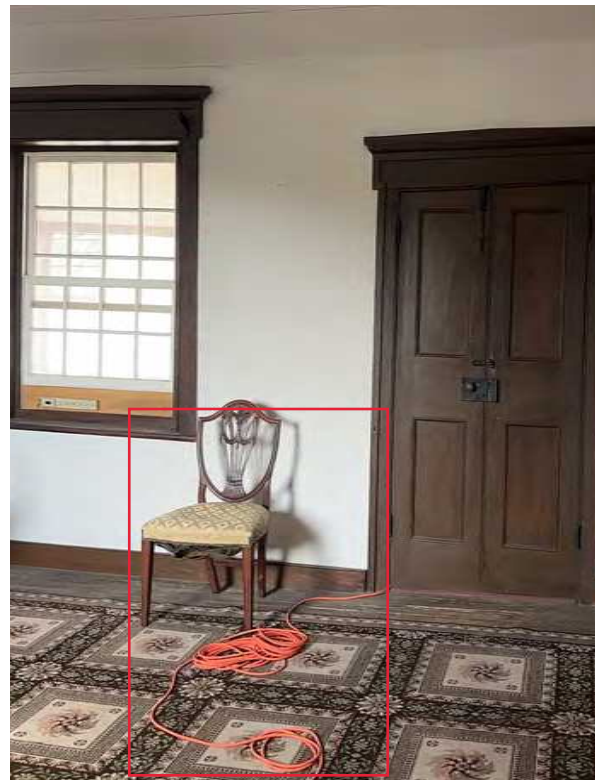
Room 201 had a temporary power cord running to the door at the balcony, then to the exterior for lighting (B). See Recommendations for future considerations for the electrical system. Power cords are running from the Room 208 (C). Consider future system adaptations for a more permanent solution to electrical needs for the building.

*B: Room 201, looking SW*

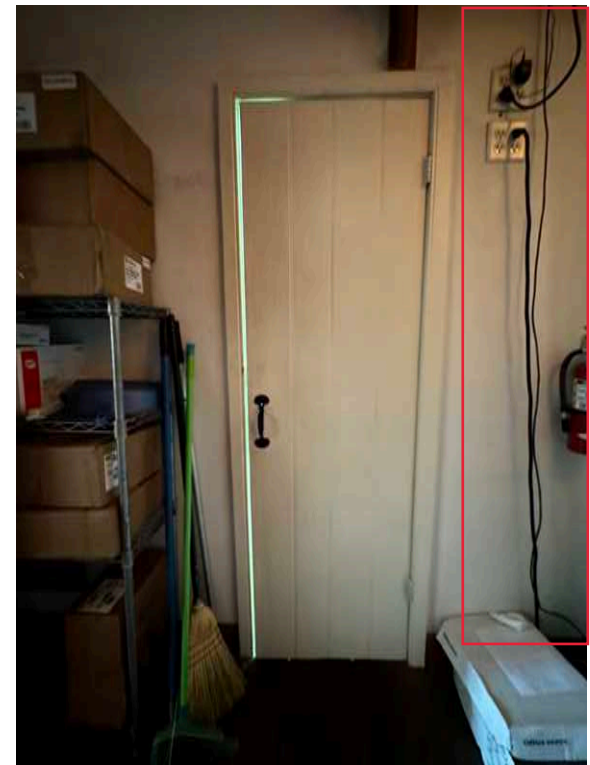
*C: Room 208, looking W*
